KCGM

Kaltails TSF Hydrogeological Review

June 2006

Reference: 0051522

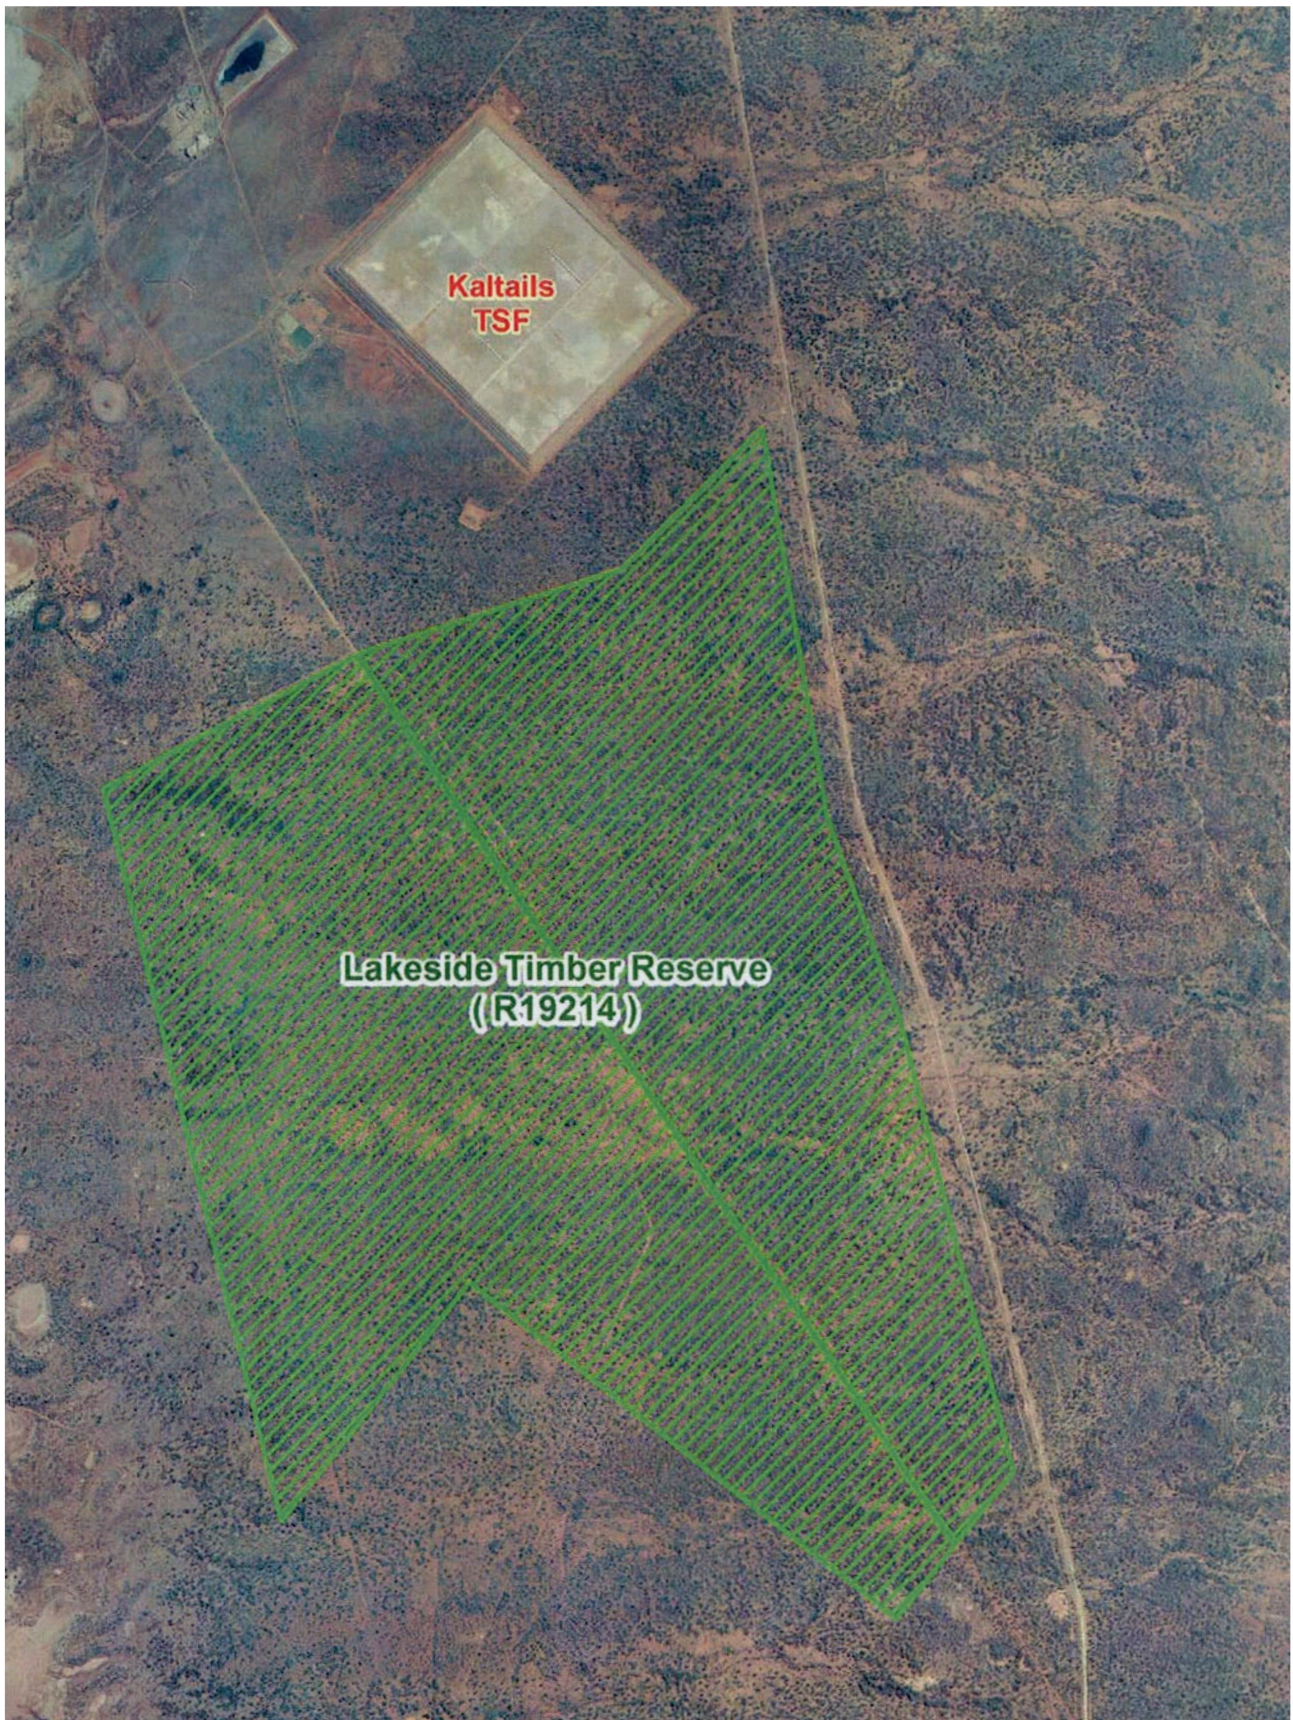
Figure 2

The Lakeside Timber Reserve location is indicated on *Figure 2*, a figure produced by ENVIRON and included in the Preliminary PER. This location was formerly closer to the Kaltails TSF and was revised to excise the area of environmental degradation that occurred in the early 1990s due to the operation of the TSF. Preservation of the vegetation from rising water levels is an important consideration in any decision regarding approval for raising the Kaltails TSF. This Figure is derived from aerial photographs and an area of degraded vegetation is discernible as a light green discoloration extending south and southwest from the TSF and encompassing the former Kaltails plant site and process facilities, still discernible on the air photograph. Notably the area of discoloration does not extend into the current Lakeside Timber Reserve.

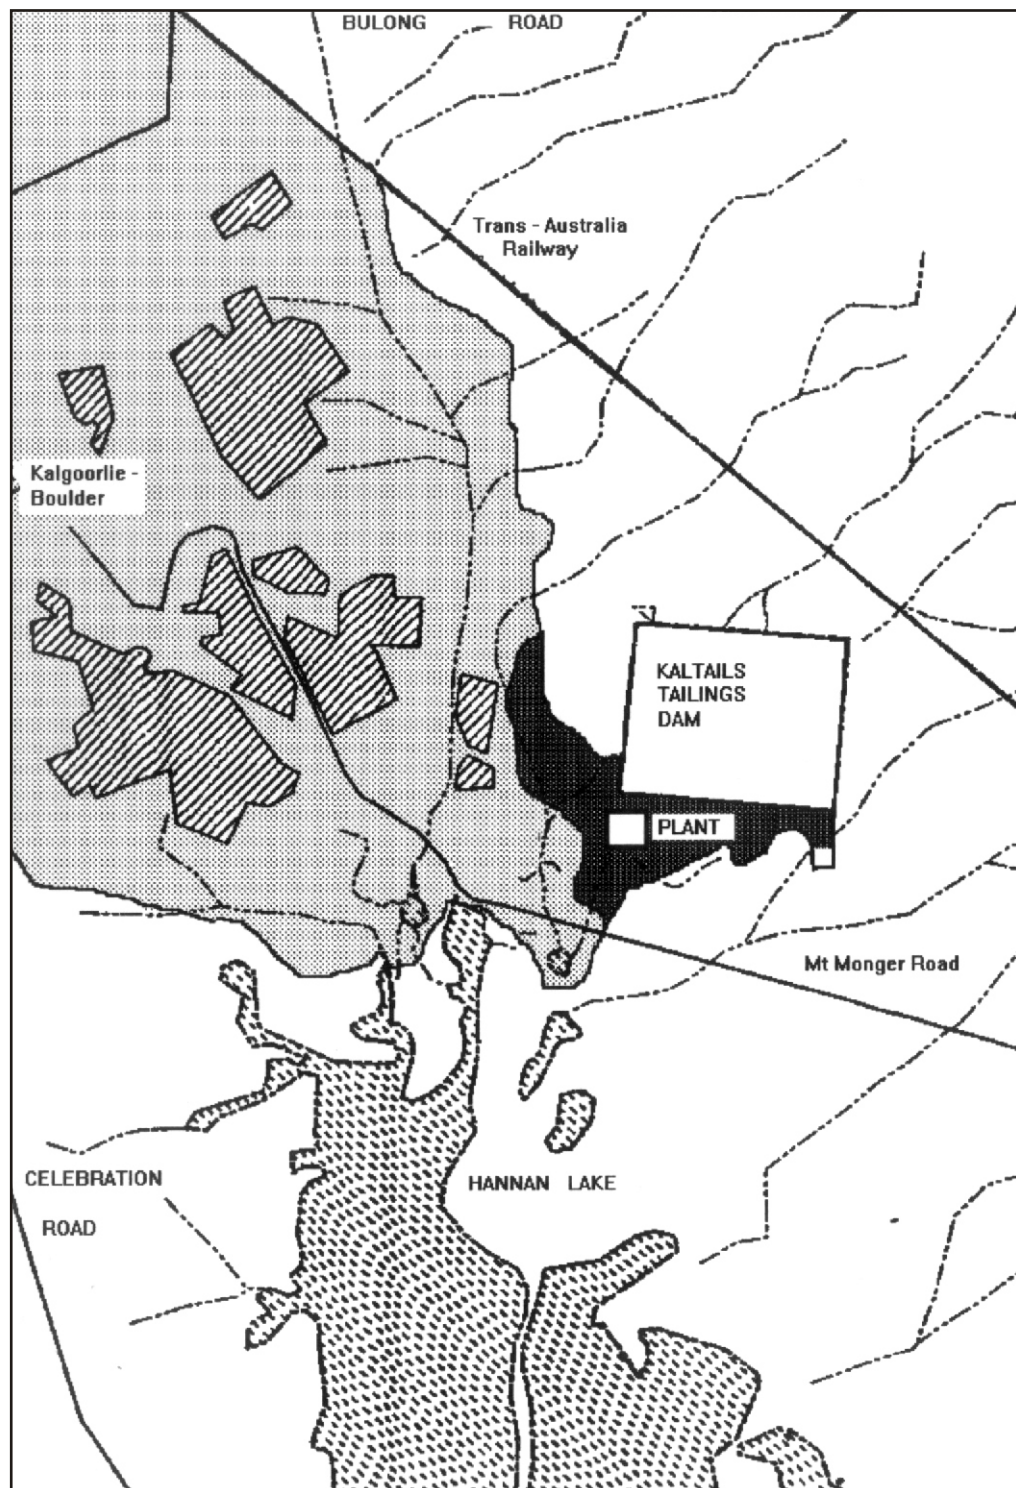
Figure 3 (source unknown) shows the area of degradation pre- and post-1998. It matches very closely the area of degradation visible on the air photograph and suggests that this degradation is related not only to seepage from the TSF but also from processing and saline water storage ponds used over the period of operation of the Kaltails TSF. However experience from the Oroya TSF which was located west of the Fimiston II TSF and is now covered by a waste dump indicated that tree deaths are related to water table rise rather than to increased groundwater salinity. The Oroya TSF had received fresh water tailings for 15 years and had raised the water table to within 2 m of the surface causing tree deaths.

Model predictions also indicated that groundwater levels were expected to be above ground surface in an area south of the TSF and north of Mt Monger Road (note that this is the area shown to be degraded on *Figure 3*). The area immediately south of Bay 1 of the TSF and north of the plant site (refer *Figure 1*) was predicted to have a water table within one metre of the ground surface. The final predicted recovered water levels were consistent with the inferred levels believed to exist prior to commissioning of the TSF in 1989.

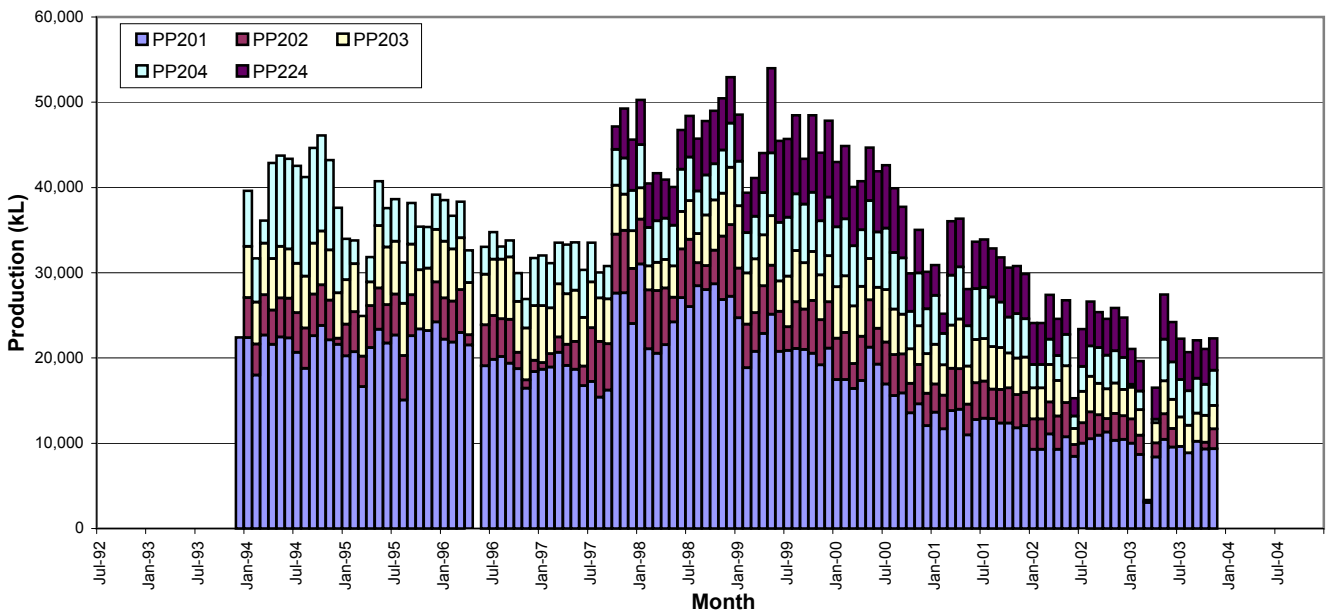
Monthly Production - South Wall Bores

The graphs indicate that records for groundwater recovery commenced in January 1994 with recovery concentrated along the south wall (about 40,000 kL/month) and lower rates of recovery along the west wall (8,000 kL/month), east wall (5,000 kL/month), north wall (5,000 kL/month) and outer bores (6,000 kL/month). The area to the south and southwest of the TSF was also used for plant and process, both using large volumes of saline water and generating losses to the shallow aquifer. The south sumps and drains were not installed until mid-1997 and recovery peaked at about 13,000 kL/month in 1999 immediately prior to the cessation of tailings deposition on the TSF. Recovery in all sectors tended to peak in 1999 and then gradually declined as recovery was scaled down in line with reducing water levels towards the agreed target levels. Recovery from the south sumps and drains ceased at the end of 2000, from the outer bores in mid 2000, from the east wall bores at end of 2002 and from the west wall bores until mid 2003. However significant recovery (>20,000 kL/month) was continuing from the south wall bores until end of 2003 and currently, year 2006, six recovery bores are still operational recovering between 12,000 and 18,000 kL/month. Peak recovery from all dewatering installations occurred in 1999 and in aggregate was about 127,000 kL/month.

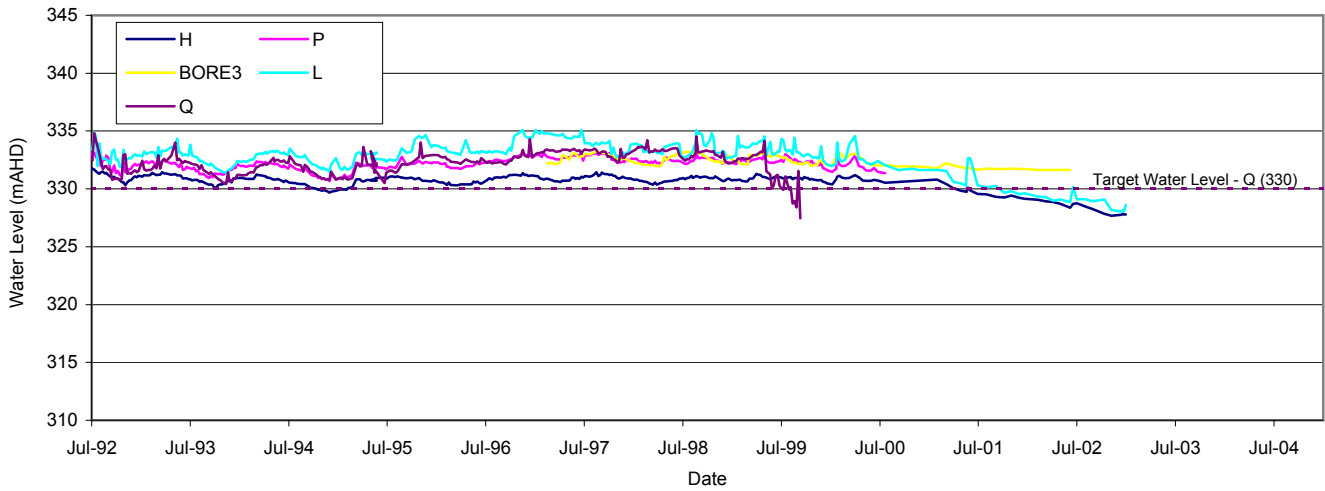
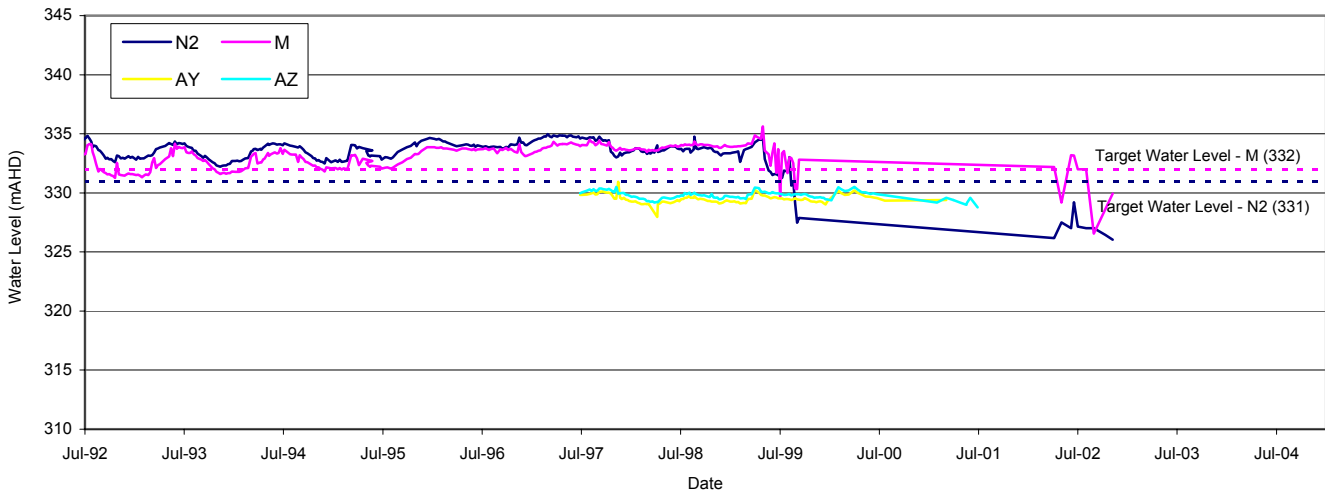
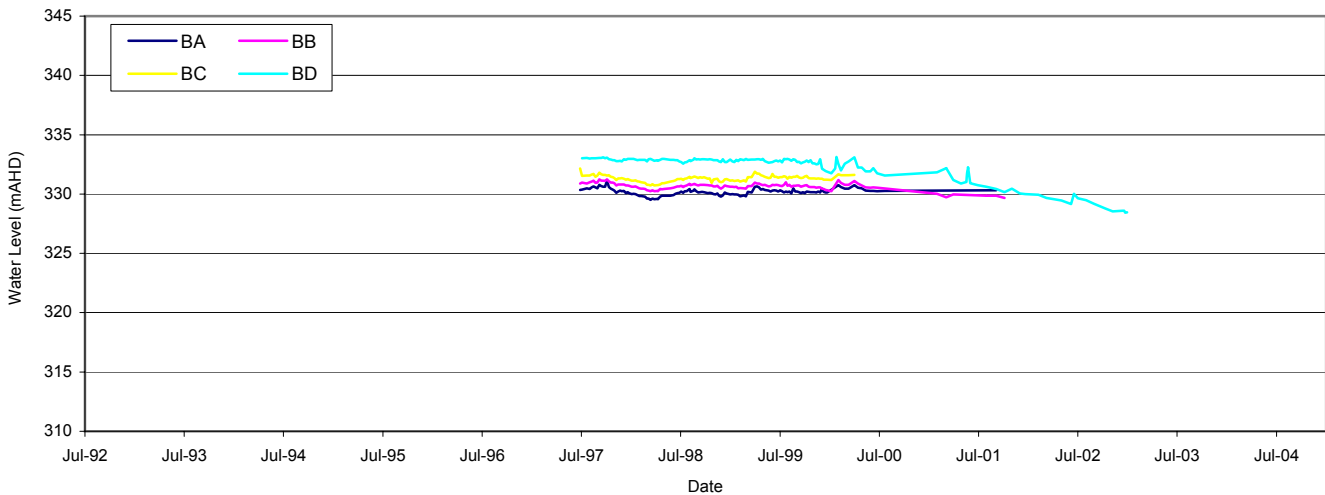
Water levels generally exceeded the target water levels from 1994 through 2000, declining from 1999 onwards in response to cessation of tailings disposal – the driver of seepage to the aquifers, and to ongoing groundwater recovery. By 2002 all target water levels in the designated monitor bores had been achieved and in some areas such as the north wall exceeded by 5 m or more. A slight rebound in the water levels is noted when recovery was reduced or stopped but was not of sufficient magnitude to exceed the target levels.

The Coffey report of 2004 extended the period of water level records to September 2004 and indicated that since use of the Kaltails TSF was discontinued in 1999 water table levels had fallen significantly in response to continued use of groundwater recovery bores. Along the eastern wall the water table levels fell by 1.2 to 9.2 m, northern wall by 0.7 to 7.3 m, western wall by 0.2 to 4.0 m, and southern wall by 0.7 to 6.2 m. In terms of the target

water table levels agreed in 1999 and reported by Aquaterra (1999) this corresponded to water table levels in September 2004 being between 0.8 m and 6.5 m below the target levels.

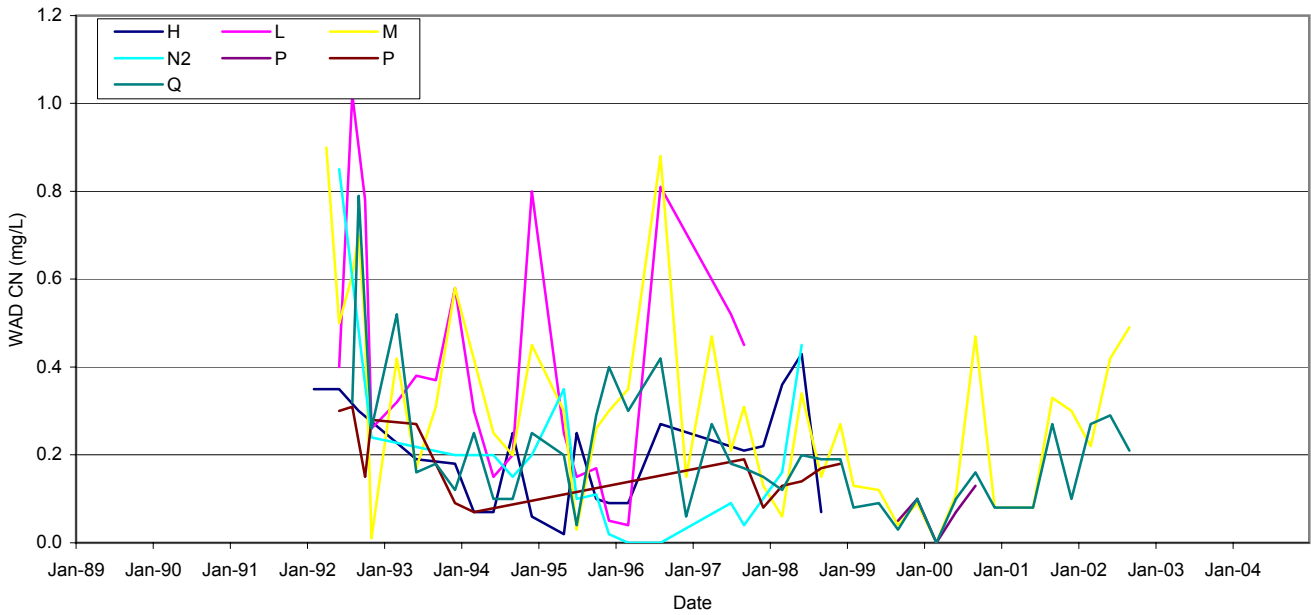
South Wall Bores

The agreed upper concentration level for WAD CN is 0.5 mg/L. During operation of the TSF the WAD CN concentration peaked on several occasions at about 60 mg/L and this was reflected in WAD CN concentrations as high as 1.0 mg/L however in general the concentrations in all monitor bores was generally less than 0.5 mg/L. By 2002 the WAD CN concentrations had stabilised at approximately 0.4 mg/L along sections of the south and west walls and about 0.2 mg/L along the north, east and outer perimeter bores.
