**ECOSYSTEM FUNCTION ANALYSIS
MONITORING REPORT 2009
PAD 19, OLD TRAFLAGAR DUMP
& RADIO HILL**

Final Report

Prepared For:
Kalgoorlie Consolidated Gold Mines
Private Mail Bag 27
Kalgoorlie WA 6433

Prepared by:
Botanica Consulting
PO Box 2027
Boulder WA 6432
90930024

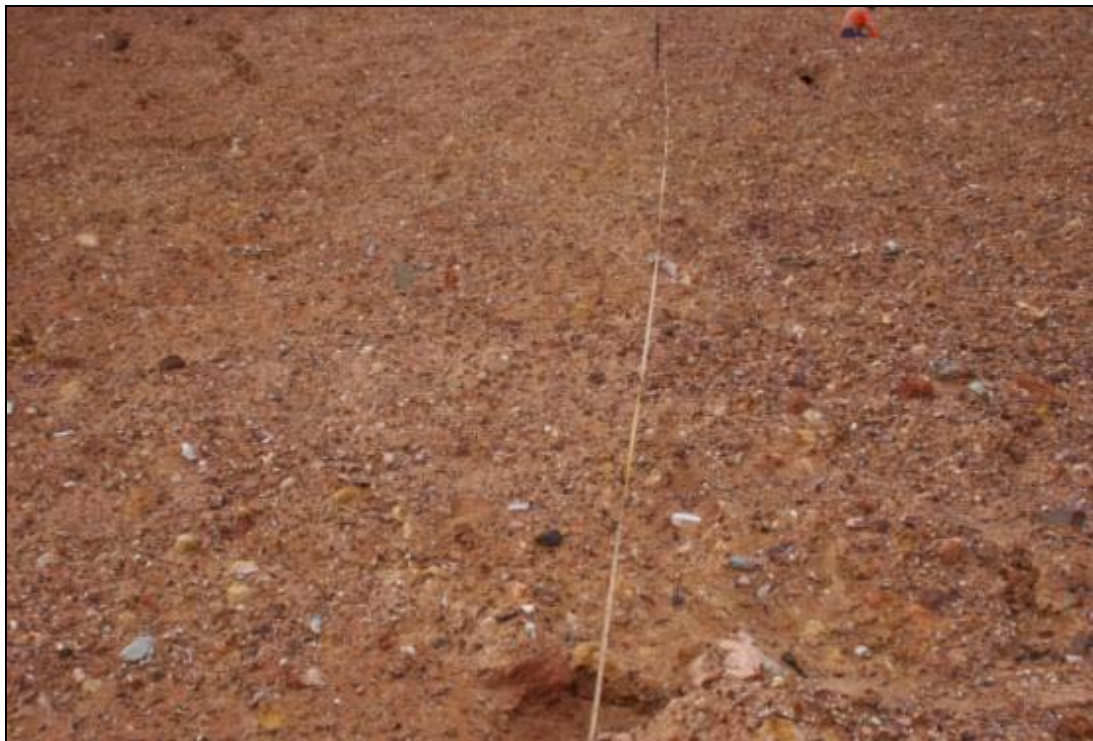
Figure 11: OTD Area Transect 2 View from Bottom 2009.

Transect 2, located approximately 200m east of transect 1 occurs on very poor soils, containing high levels of oxide and consisting of a soft yellow-grey material. Despite the poor soil condition and evidence of tunnelling within the transect, stability increased in 2009. Infiltration and nutrient cycling both decreased as did species density and diversity with no vegetation growing in 2009.

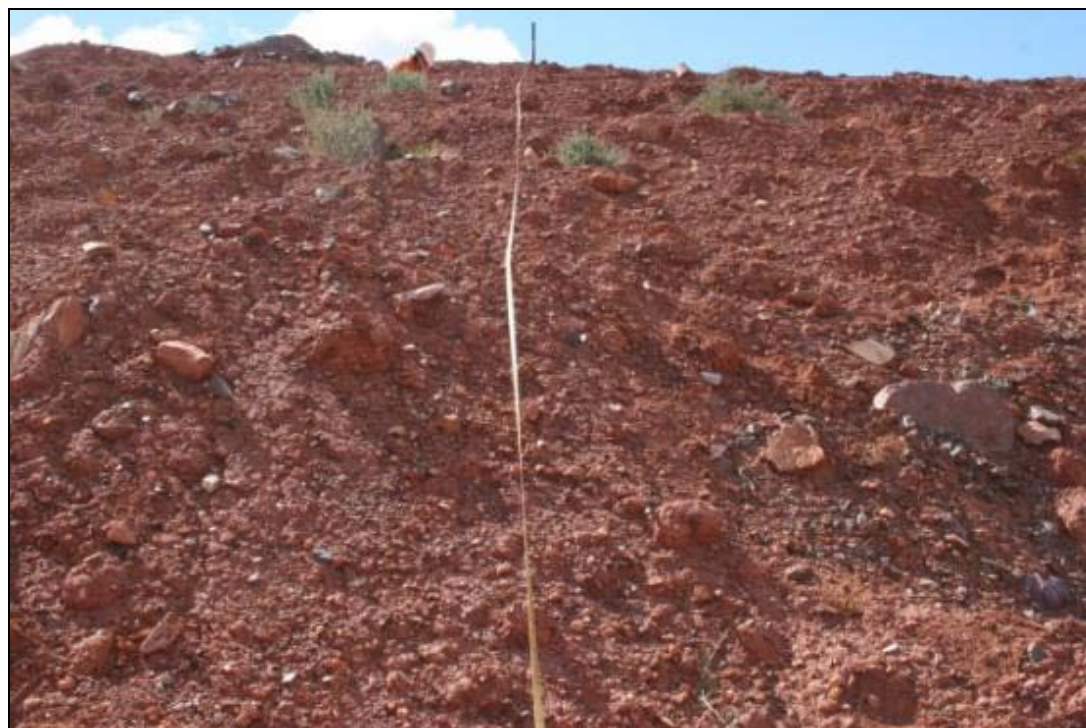
Figure 15: Pad 19 Transect 2 View from Bottom 2009.

Transect 2, located on the south-westerly aspect had an increase in stability from 2007 however nutrient cycling and infiltration levels both decreased. 2009 was the first year of monitoring that vegetation was present and species density was quite high, recording a similar level to the analogue site. Species diversity was also high, exceeding diversity levels of the analogue site. Leaf litter cover was low and ants were seen within the area.

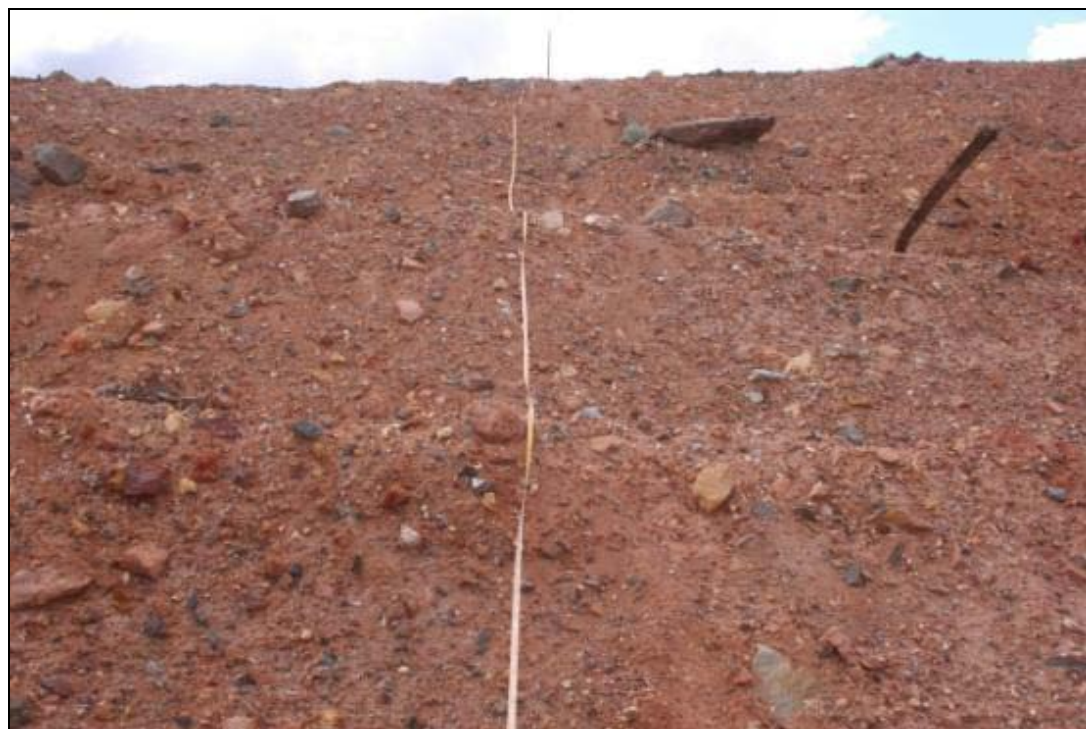
Figure 17: Pad 19 Transect 3 View from Bottom 2009.

The soils of Transect 3 (closest transect to the road tunnel, south-westerly aspect) appeared to contain more oxide than the other two transects. In 2009 stability increased however both infiltration and nutrient cycling decreased. Species density was good and species diversity was very high, recording a greater number of species than the analogue site. Leaf litter cover was low and ants were seen within the area.

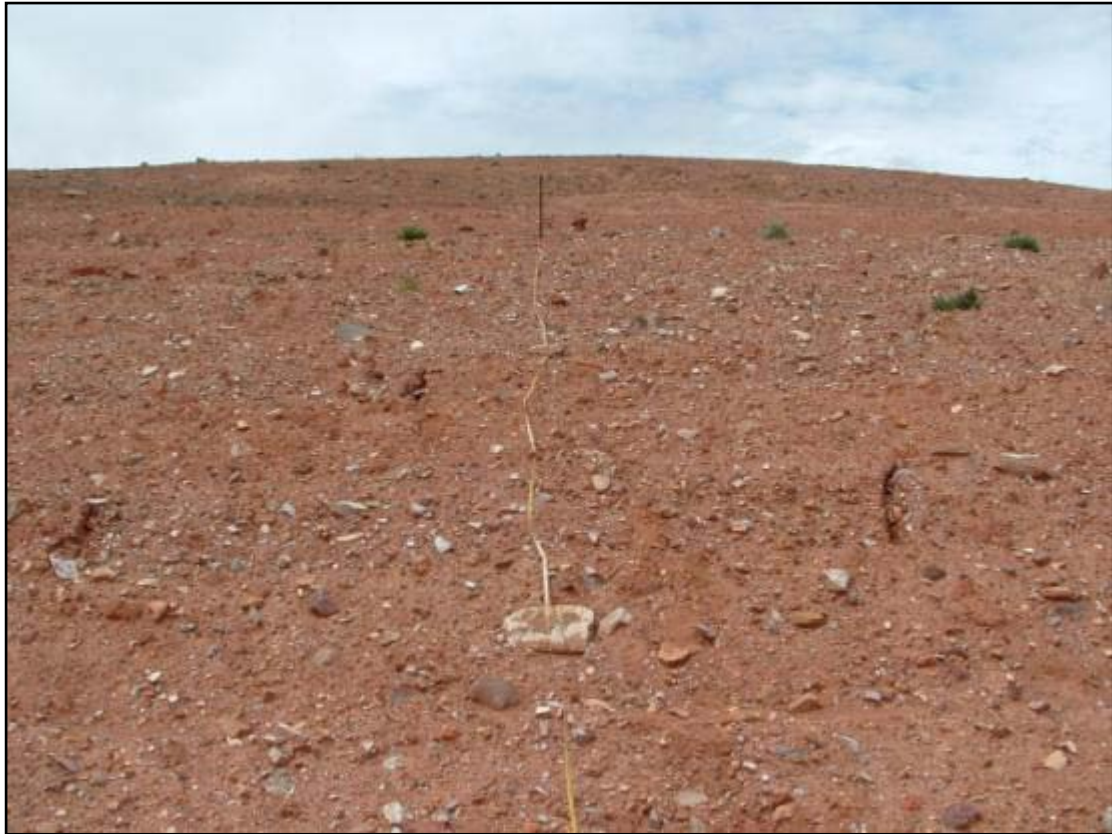
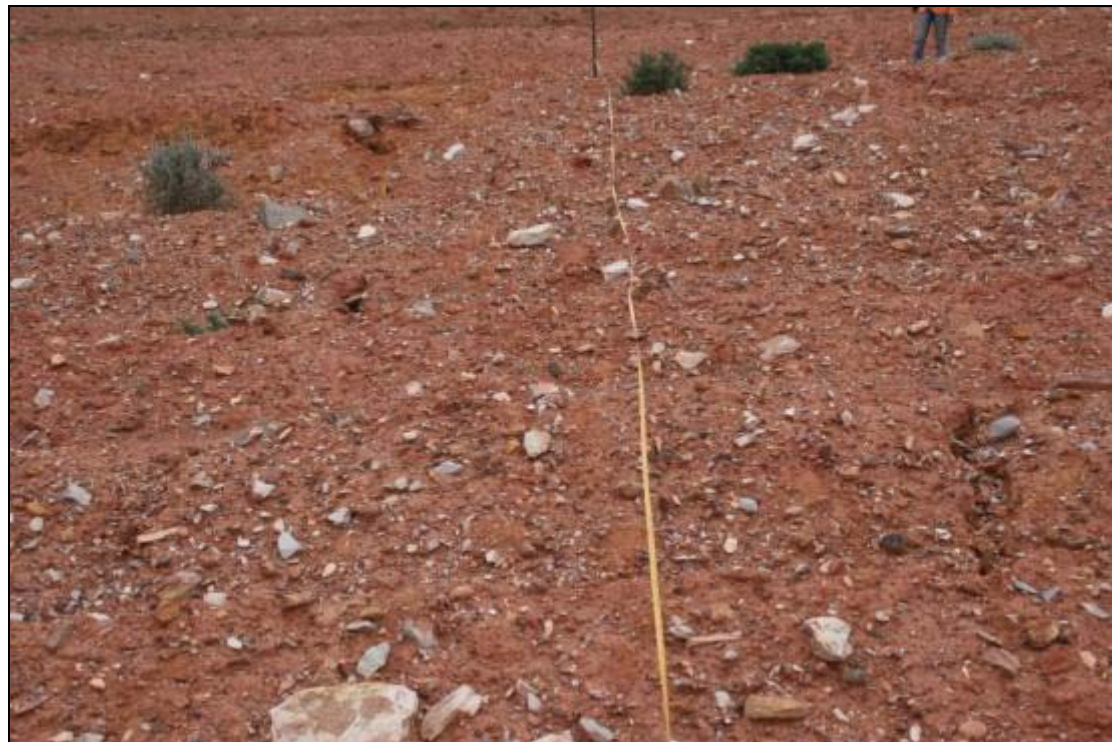
Figure 22: Radio Hill Transect 3 View from Bottom 2007.

Figure 23: Radio Hill Transect 3 View from Bottom 2009.

Transect 3, located on the western aspect had an increase in stability from 2007 despite major signs of erosion (Figure 38 & 39). There is a break in the berm on the second lift causing tunnelling down the slope which has resulted in a break in the berm of the first lift (right of the transect). This is leading to a high level of run off with water flowing with greater force onto the road below. Remedial work will need to be conducted to fix the berms to prevent further erosion and loss of top soil. Infiltration and nutrient cycling levels both decreased which may be due to the high run off caused by the broken berms. Despite the decrease in nutrient cycling and infiltration species density and diversity levels increased yet did not exceed levels of the analogue site.

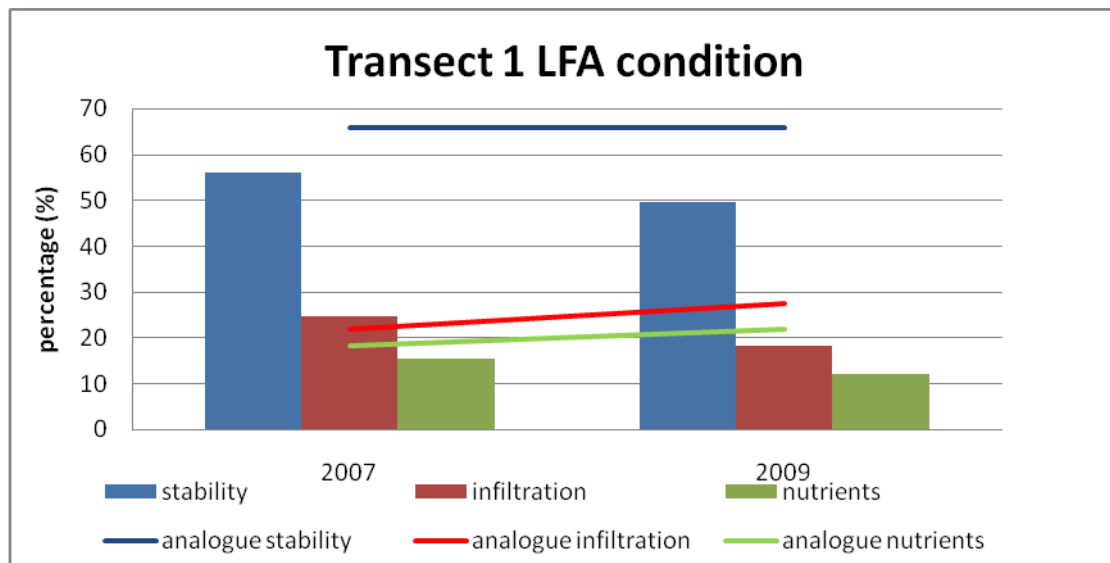
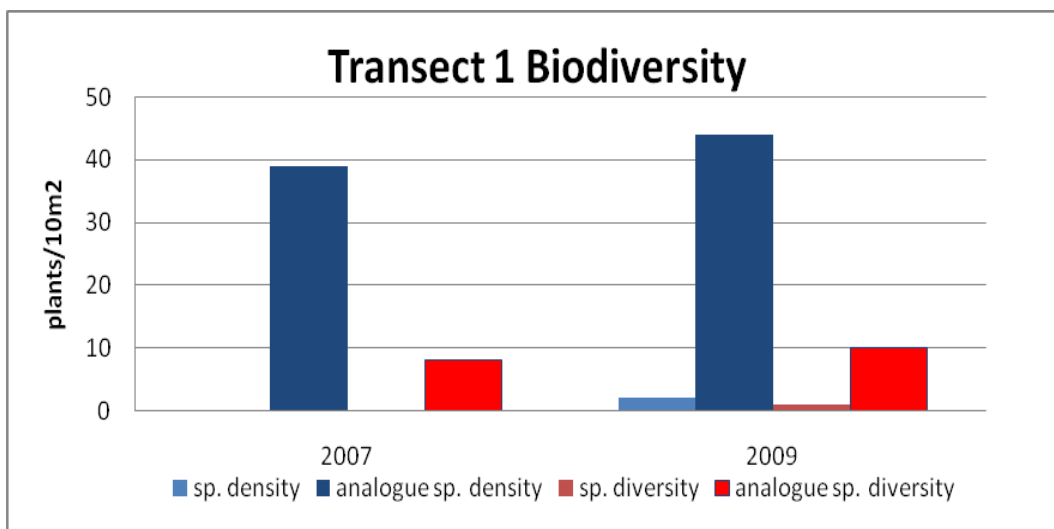
Figure 26: LFA Data Pad 19 Transect 1

Figure 27: Biodiversity Data Pad 19 Transect 1. (No vegetation present in T1 2007)

Pad 19 was seeded with a secondary oxide seed mix in 2008. Transect 1 is located on the south-west corner of the Pad 19 waste rock landform and has high blue rock cover. All three LFA indices decreased and there has been little to no vegetation growth since 2007 with only one species present in 2009. This lack of vegetation growth may be due to the additional rehabilitation work conducted in the area to correct the positioning of rip lines after they were initially developed down the slope rather than across the slope face. Leaf litter cover was low and ants were seen within the area.

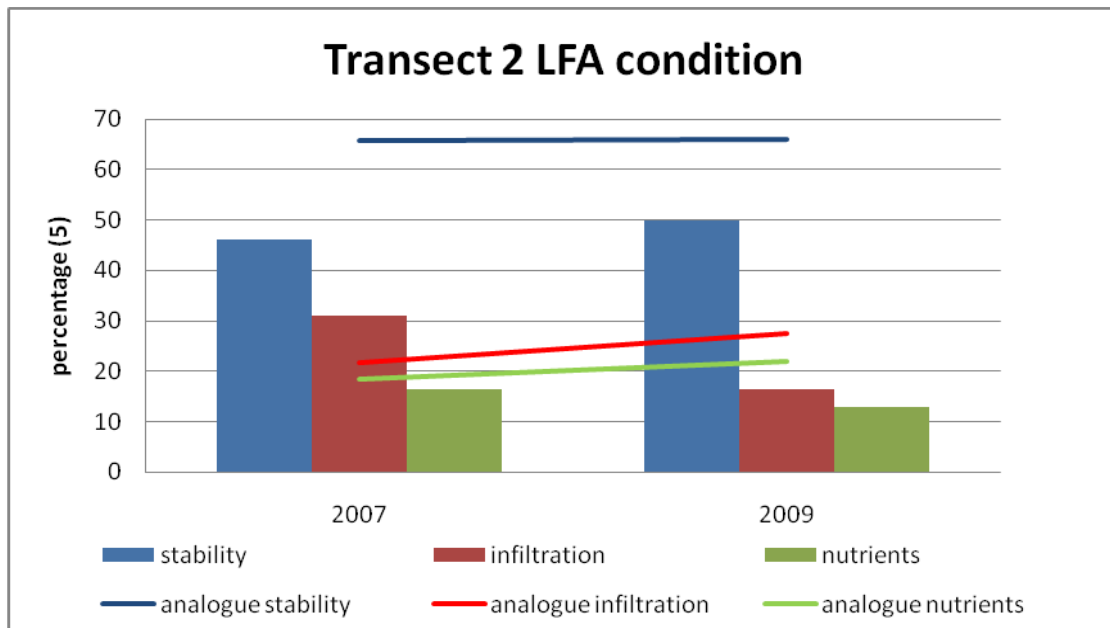
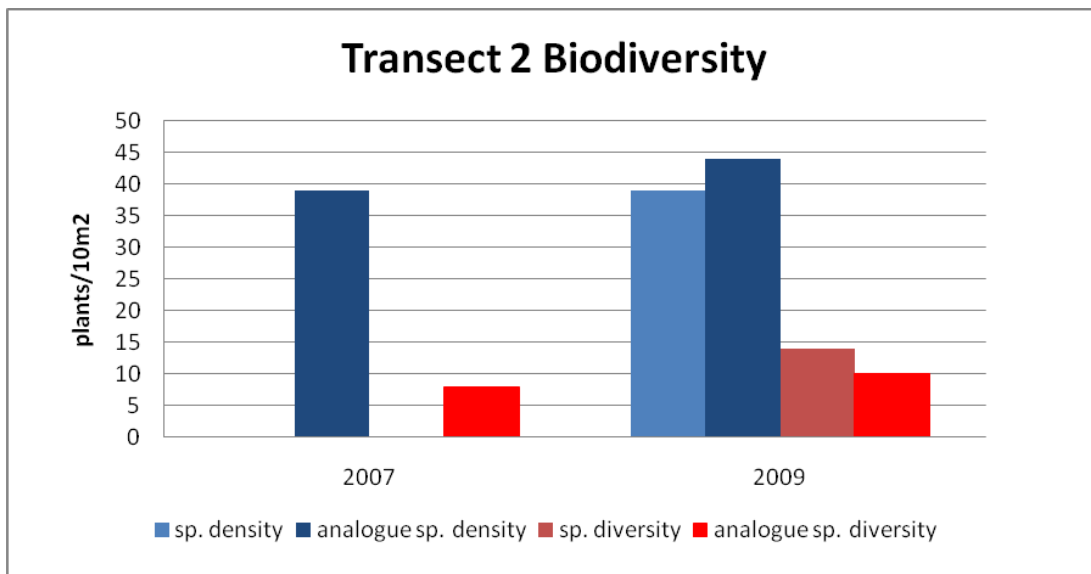
Figure 28: LFA Data Pad 19 Transect 2

Figure 29: Biodiversity Data Pad 19 Transect 2. (No vegetation present in T2 2007).

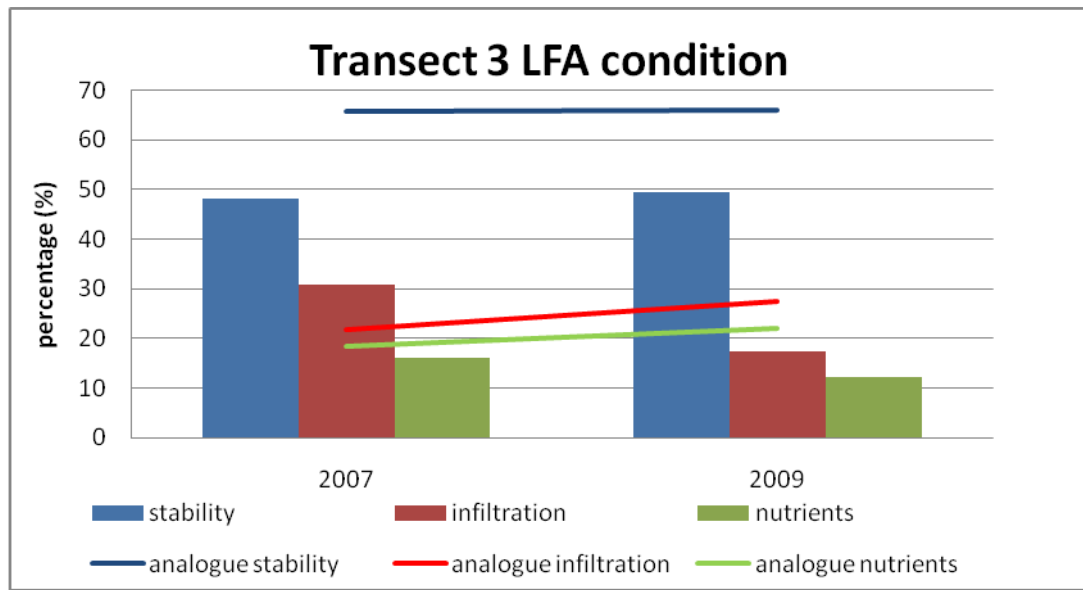
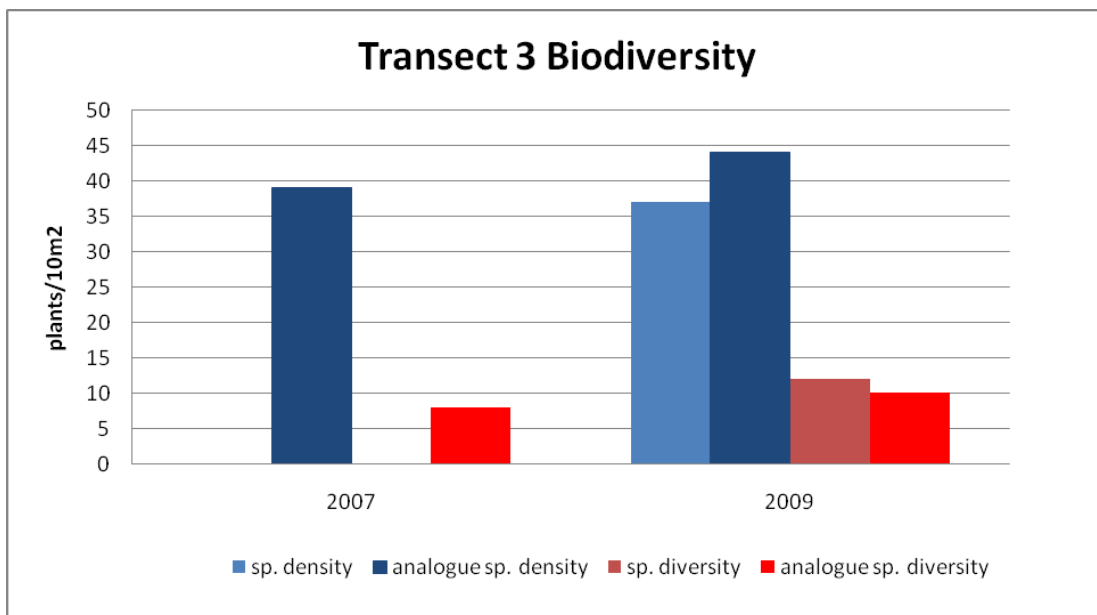
Figure 30: LFA Data Pad 19 Transect 3

Figure 31: Biodiversity Data Pad 19 Transect 3. (No vegetation present in T3 2007).

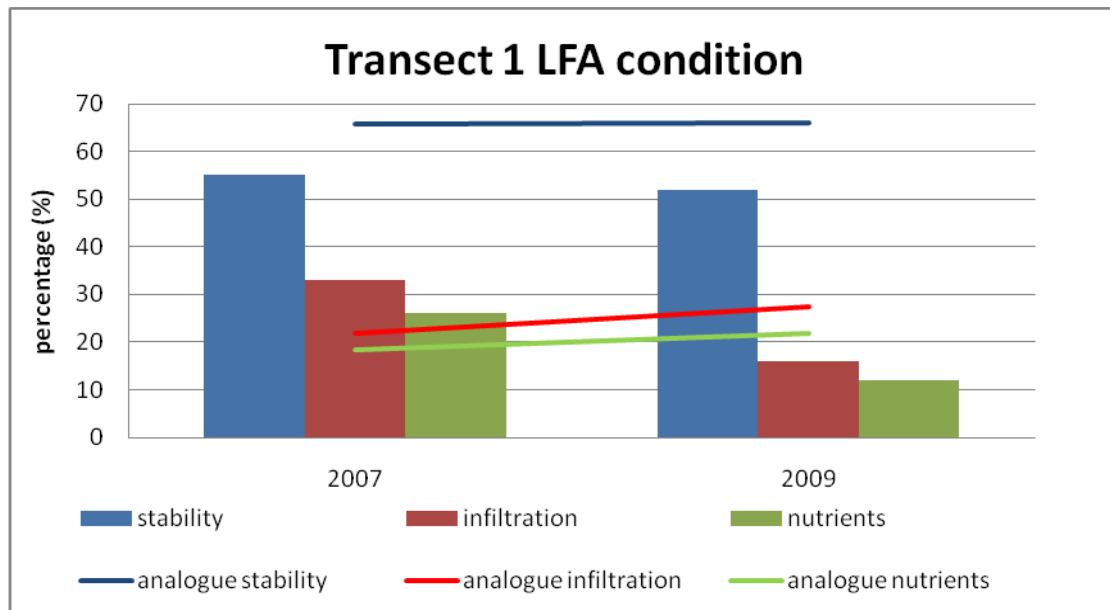
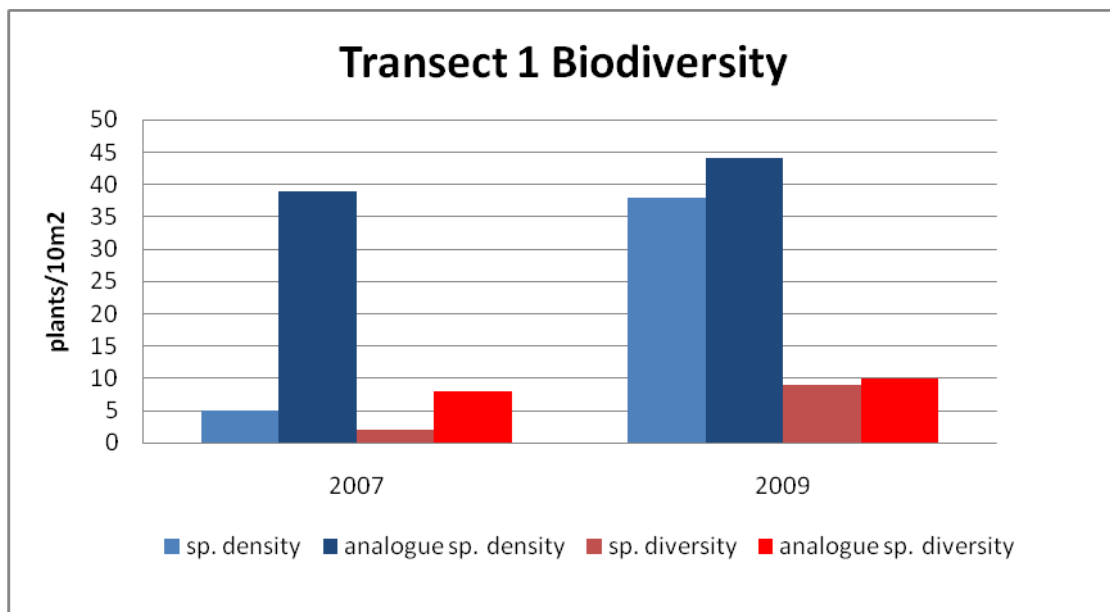
Figure 32: LFA Data OTD Transect 1

Figure 33: Biodiversity Data OTD Transect 1

Transect 1 is located on the western face overlooking the Fimiston open pit. The area has high exposure to wind. All three LFA indices decreased in 2009 however both species density and diversity increased. There was evidence of riling and tunnelling within the transect.

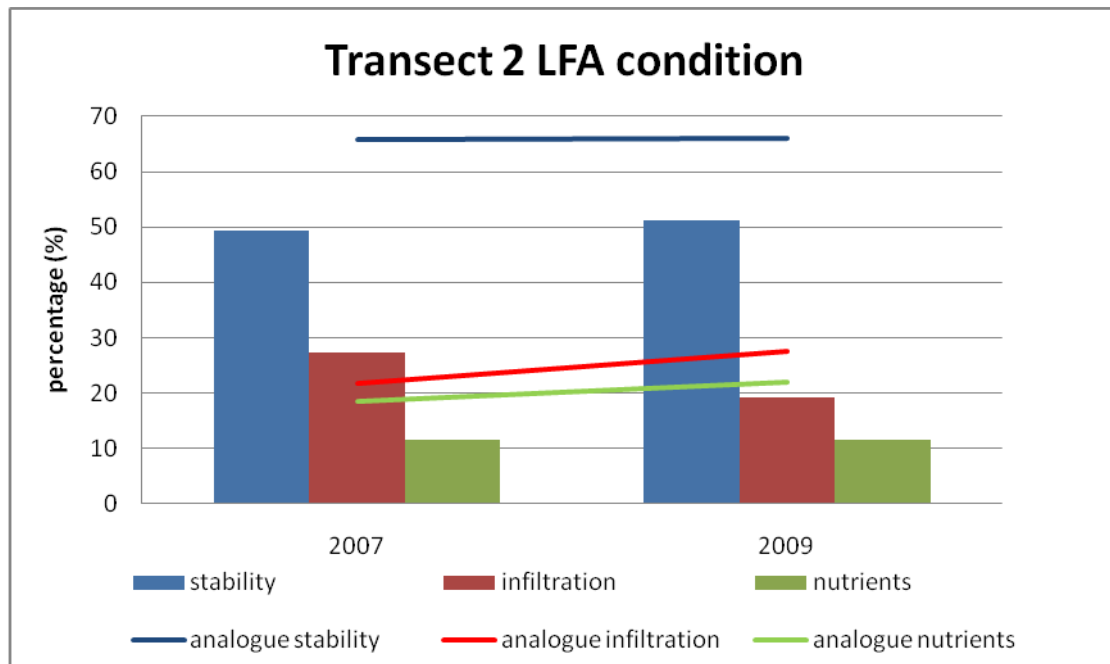
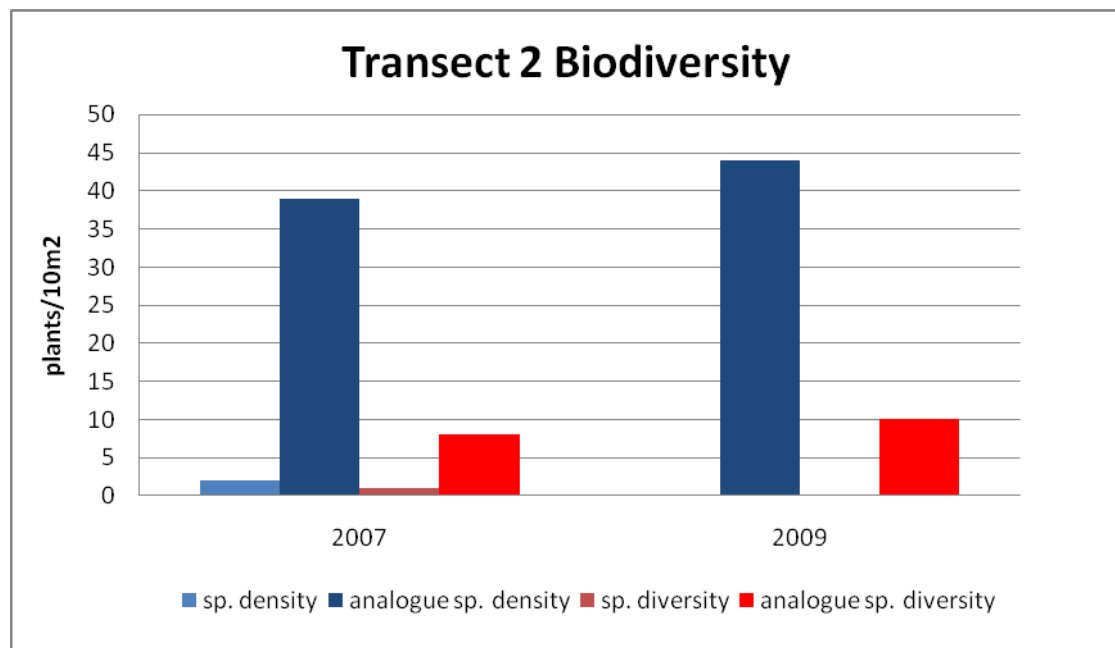
Figure 34: LFA Data OTD Transect 2

Figure 35: Biodiversity Data OTD Transect 2

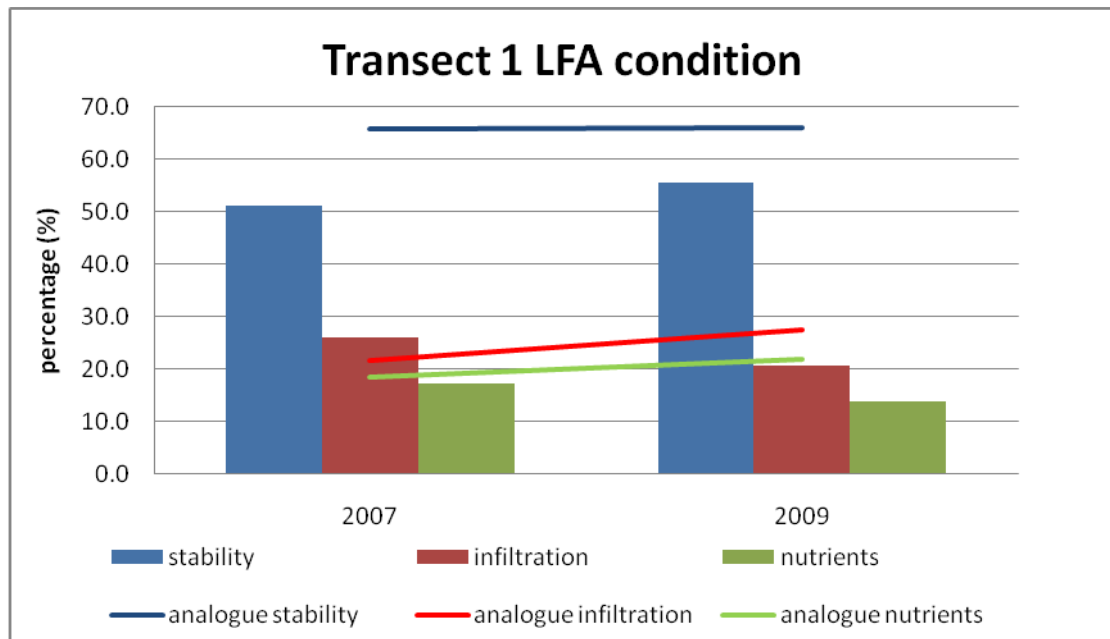
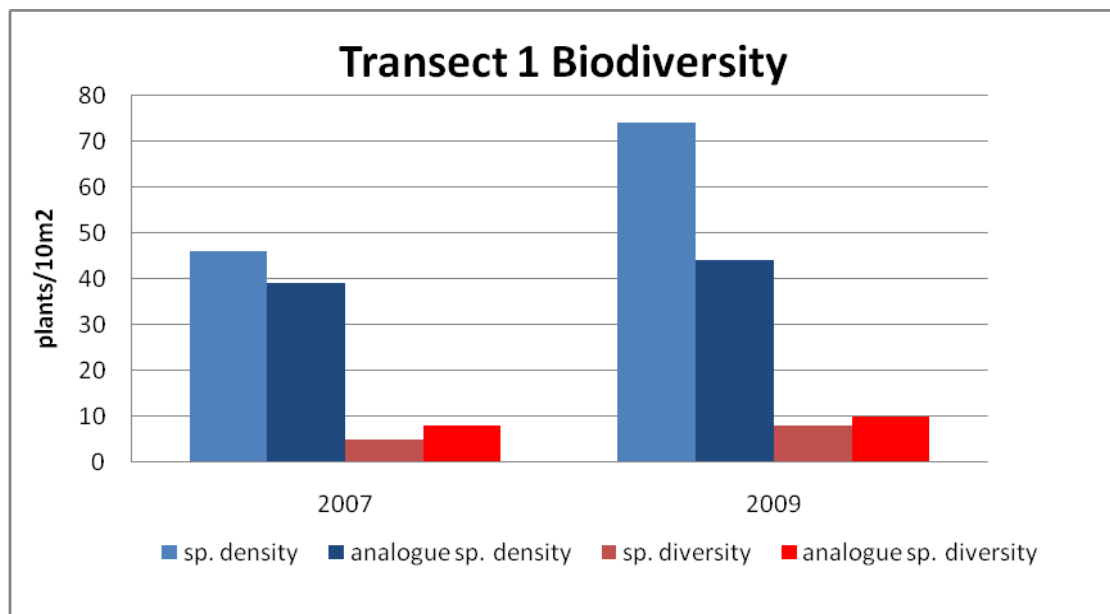
Figure 36: LFA Data Radio Hill Transect 1

Figure 37: Biodiversity Data Radio Hill Transect 1

Transect 1 is located on the southern face of the Radio Hill waste rock landform. Stability levels increased in 2009 despite evidence of minor riling and erosion within the transect. Infiltration and nutrient cycling both decreased. Transect 1 has recorded high levels of density in both 2007 and 2009 with levels exceeding that of the analogue site. Despite the decrease in LFA condition, in 2009 species density reached significantly high levels, greater than that of the analogue site.

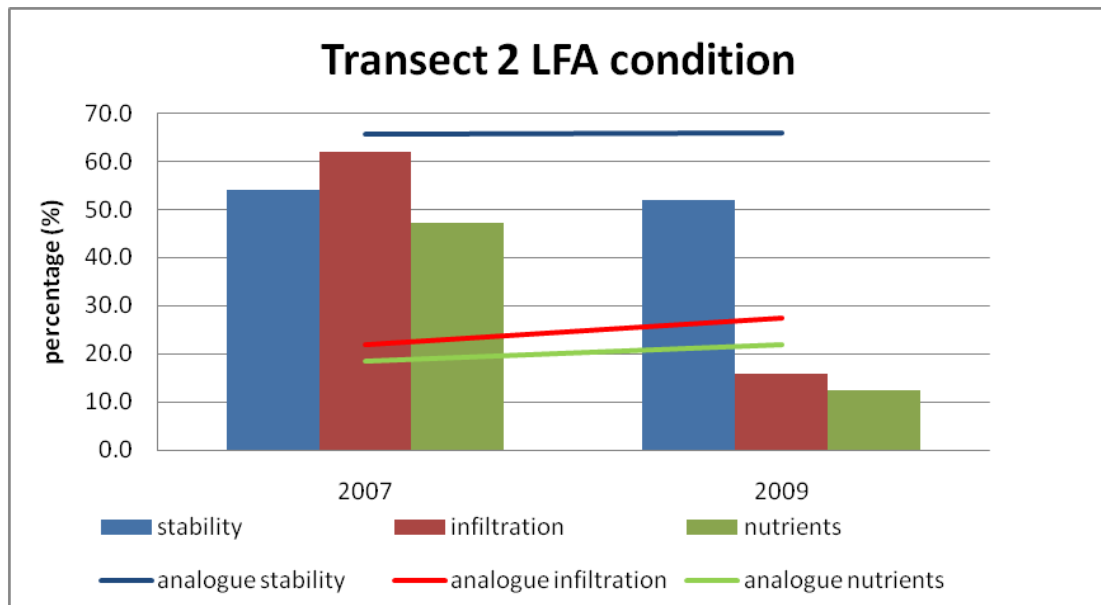
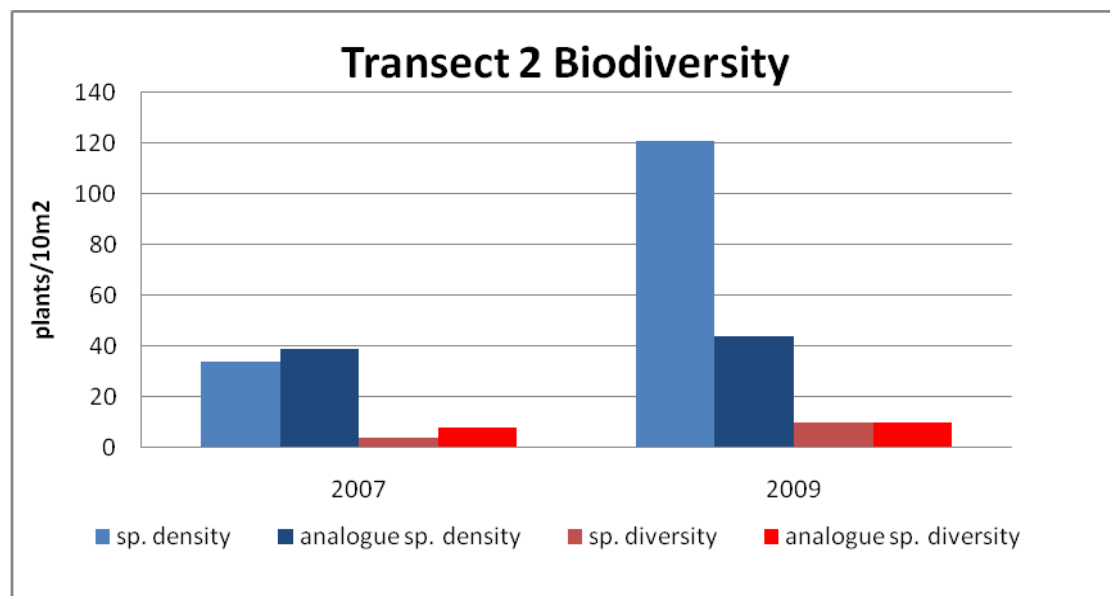
Figure 38: LFA Data Radio Hill Transect 2

Figure 39: Biodiversity Data Radio Hill Transect 2

Transect 2, located on the southern aspect had an increase in stability from 2007 however nutrient cycling and infiltration levels both decreased significantly. This substantial decrease from 2007 appears to be due to a decrease in leaf litter accumulation within the system. Despite the significant drop in nutrient cycling and infiltration, species density increased and currently exceeds density levels of the analogue site. Species diversity also increased to a level equal to the analogue site.

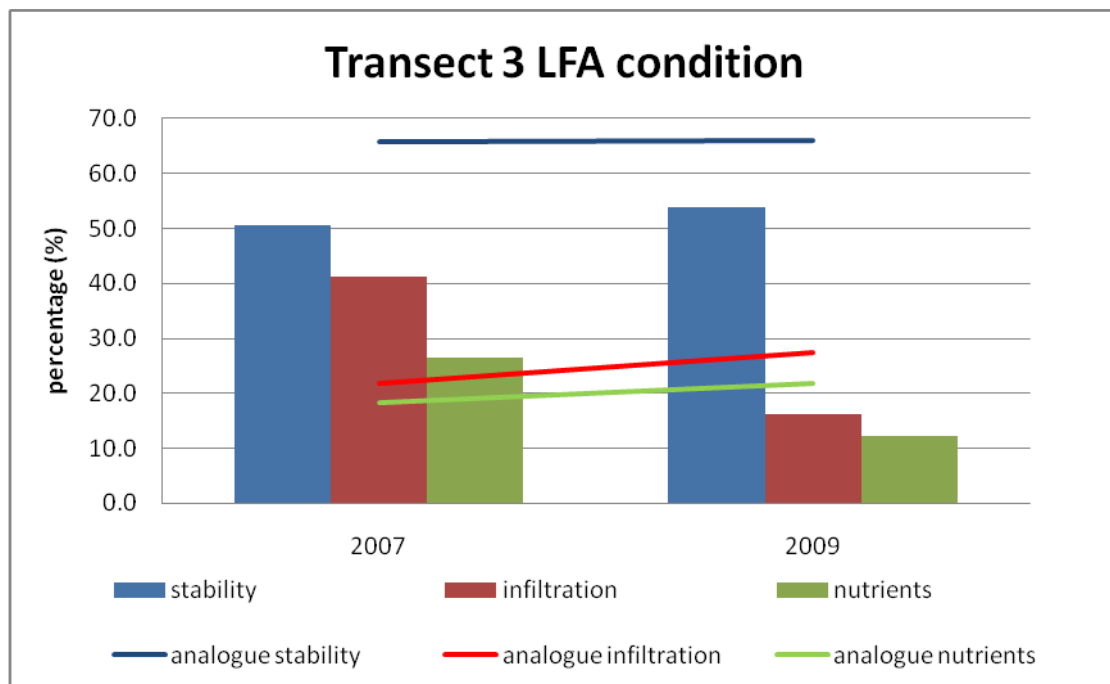
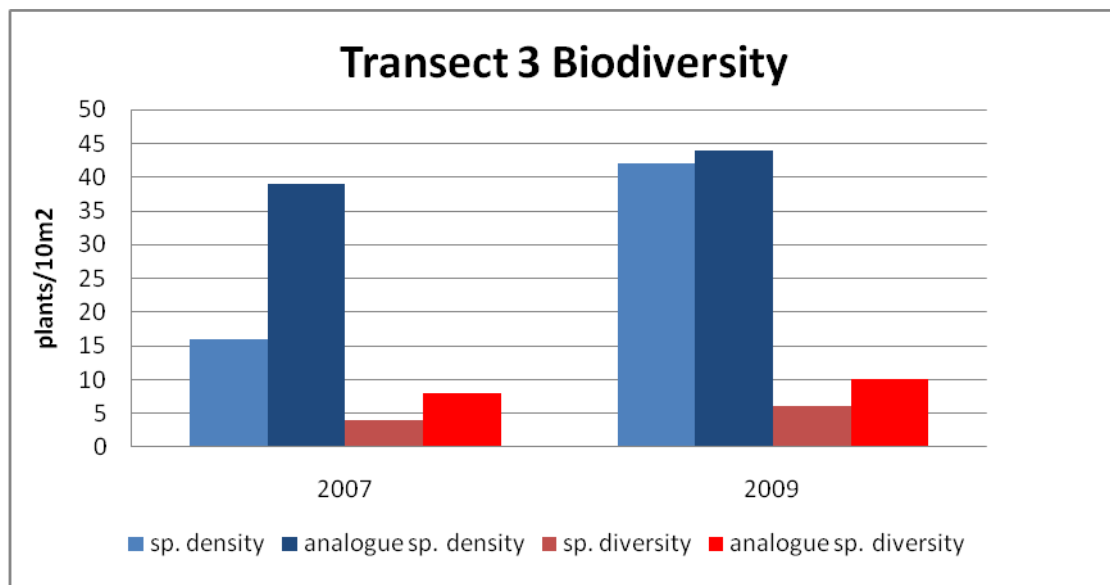
Figure 40: LFA Data Radio Hill Transect 3

Figure 41: Biodiversity Data Radio Hill Transect 3

The break in the berm above transect 3 has caused a high level of run off in the area resulting in decreasing levels of infiltration and nutrient cycling. Despite the high level of erosion occurring near the transect, the transect itself recorded increased stability. This may be due to the increase in species density from 2007 to 2009, which increases soil stability. Once again low vegetation cover and leaf litter production also explains the decreasing levels of infiltration and nutrient cycling within the transect.
