**REQUIREMENTS OF PIT ABANDONMENT
AND DESIGN CHANGE ASSOCIATED
WITH THE GOLDEN PIKE CUTBACK

KCGM**

Dr P M Dight

DATE: JULY 2005
JOB NO.: 1803128

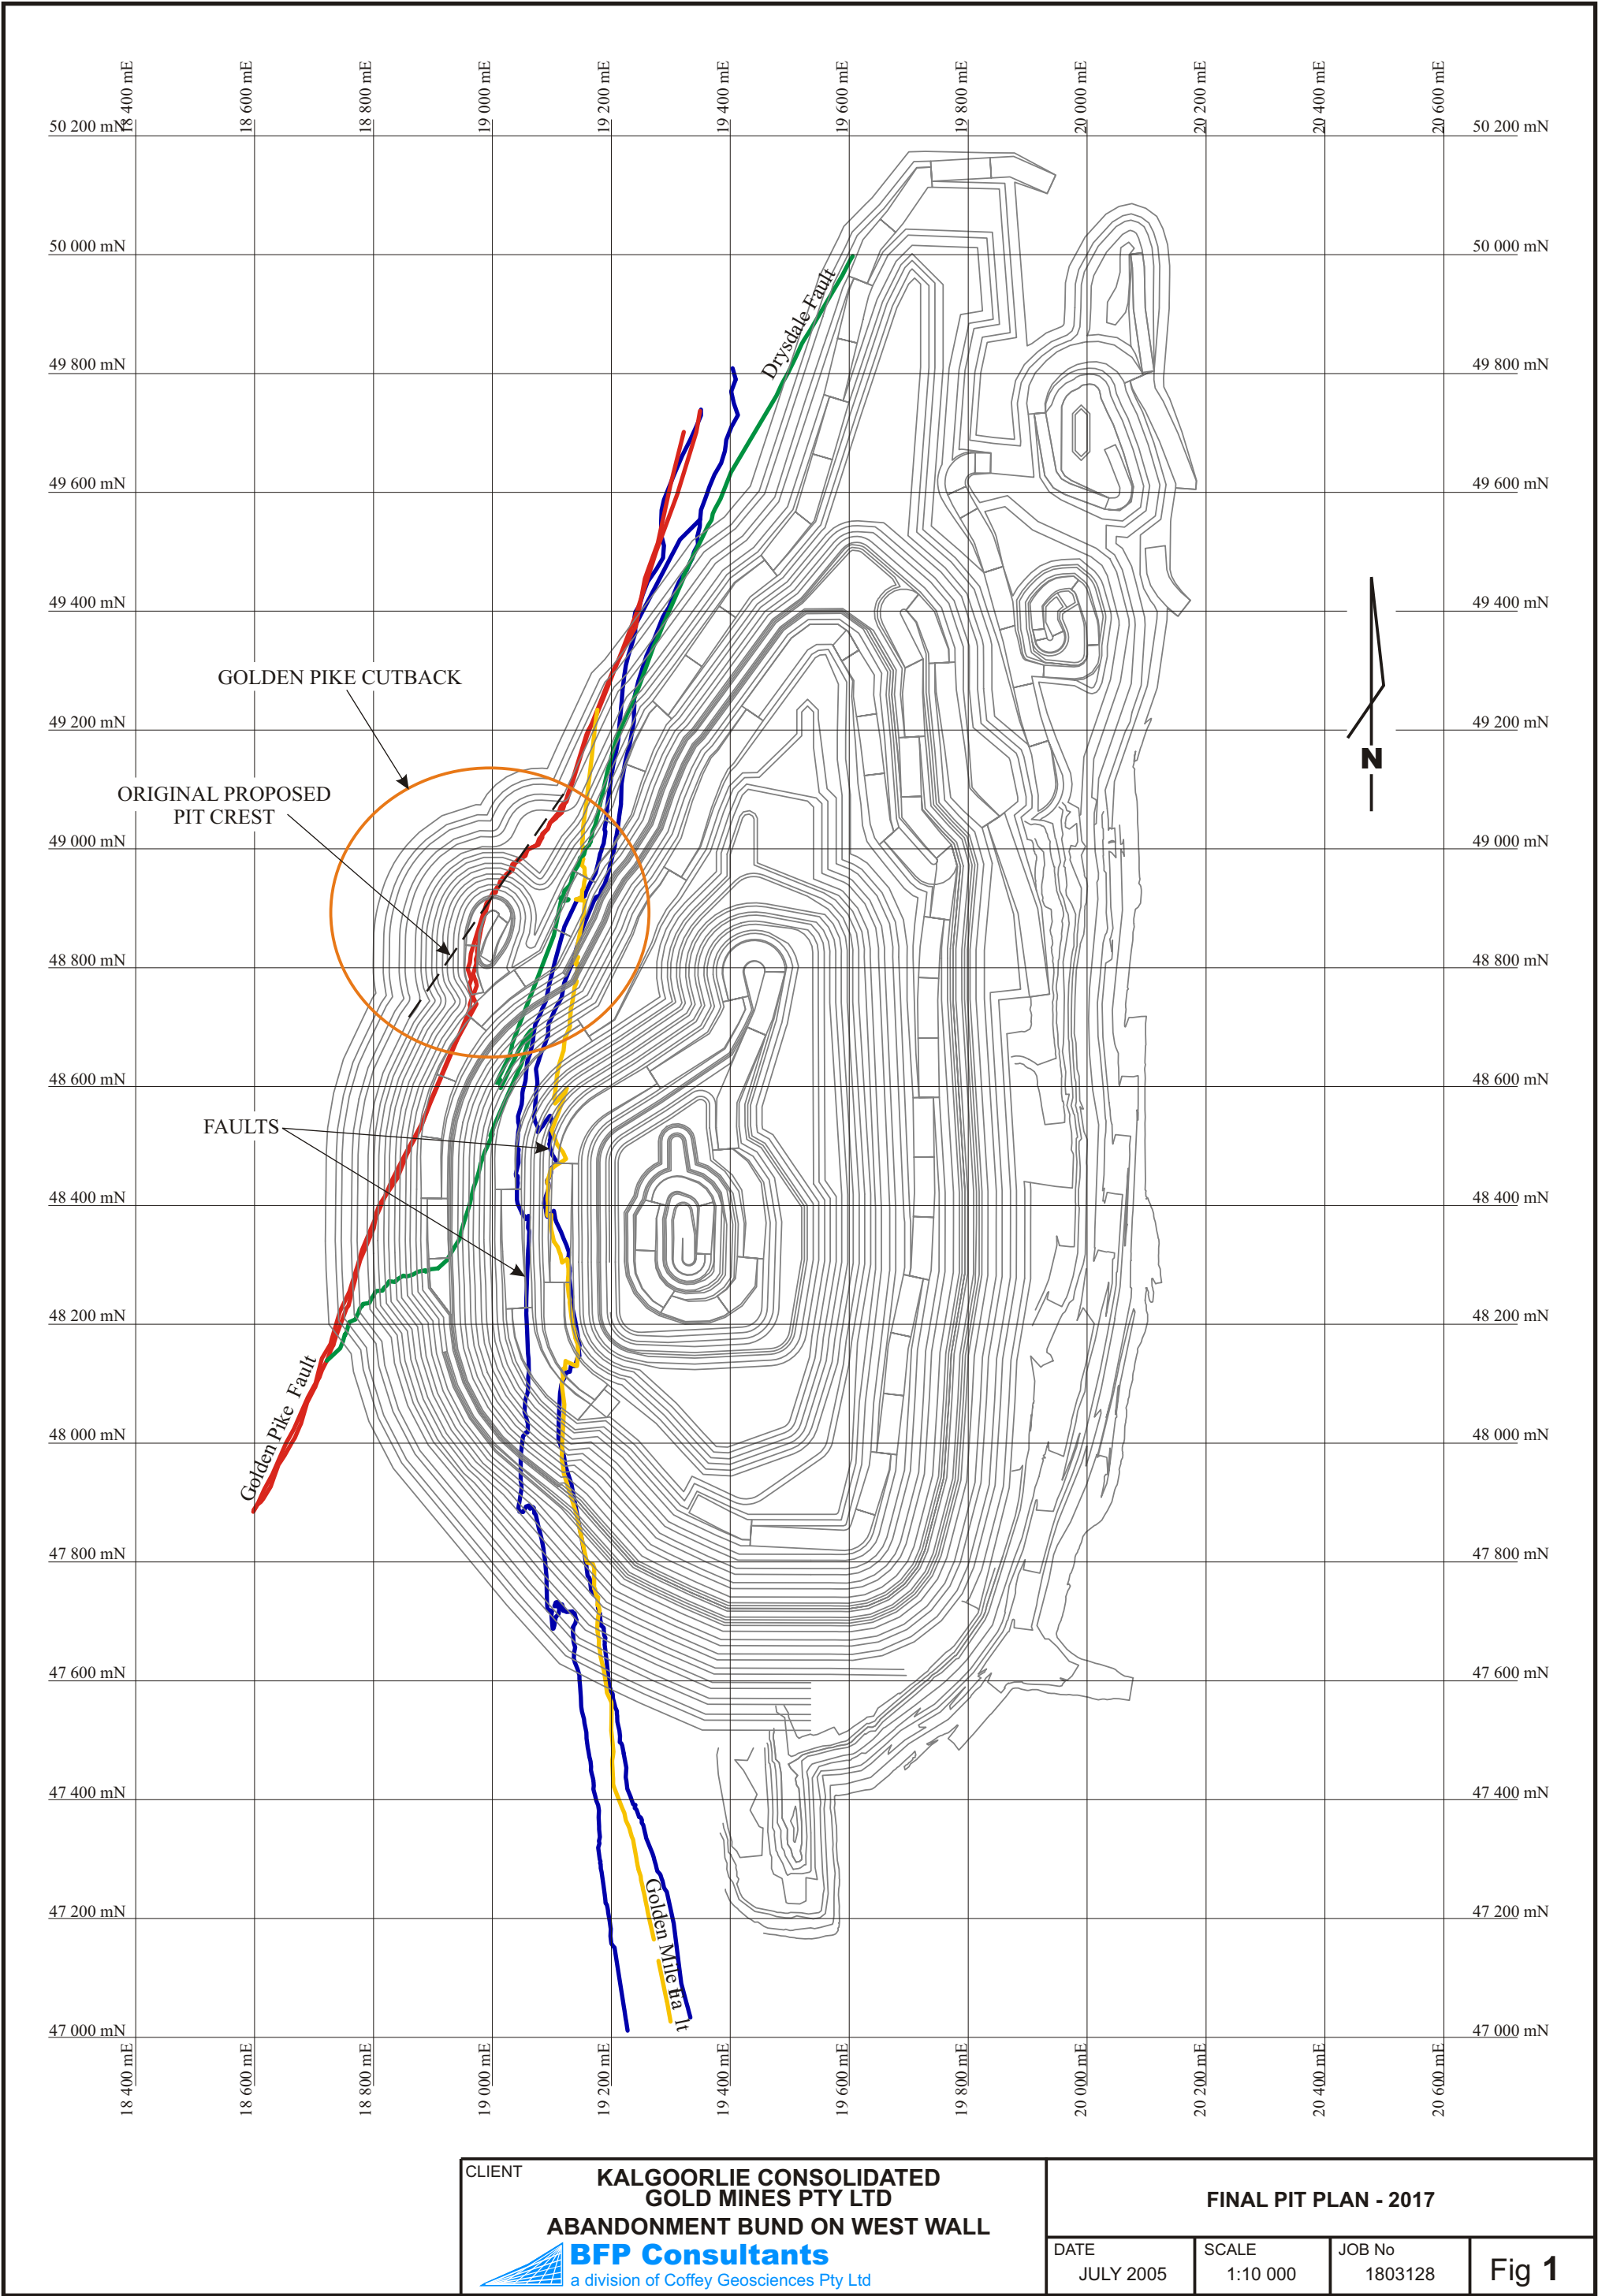
BFP has undertaken a geotechnical assessment for the proposed Golden Pike Cutback (Reference 3). The proposed cutback, shown in Figure 1, will impact on the location of any abandonment plans developed prior to this new design consideration.

- There are faults and shears which define the mineralisation at KCGM. It is possible that a fault could be present in the final wall; however the faults and shears within the west wall of KCGM are generally re-healed (Reference 3), (Figure 1).

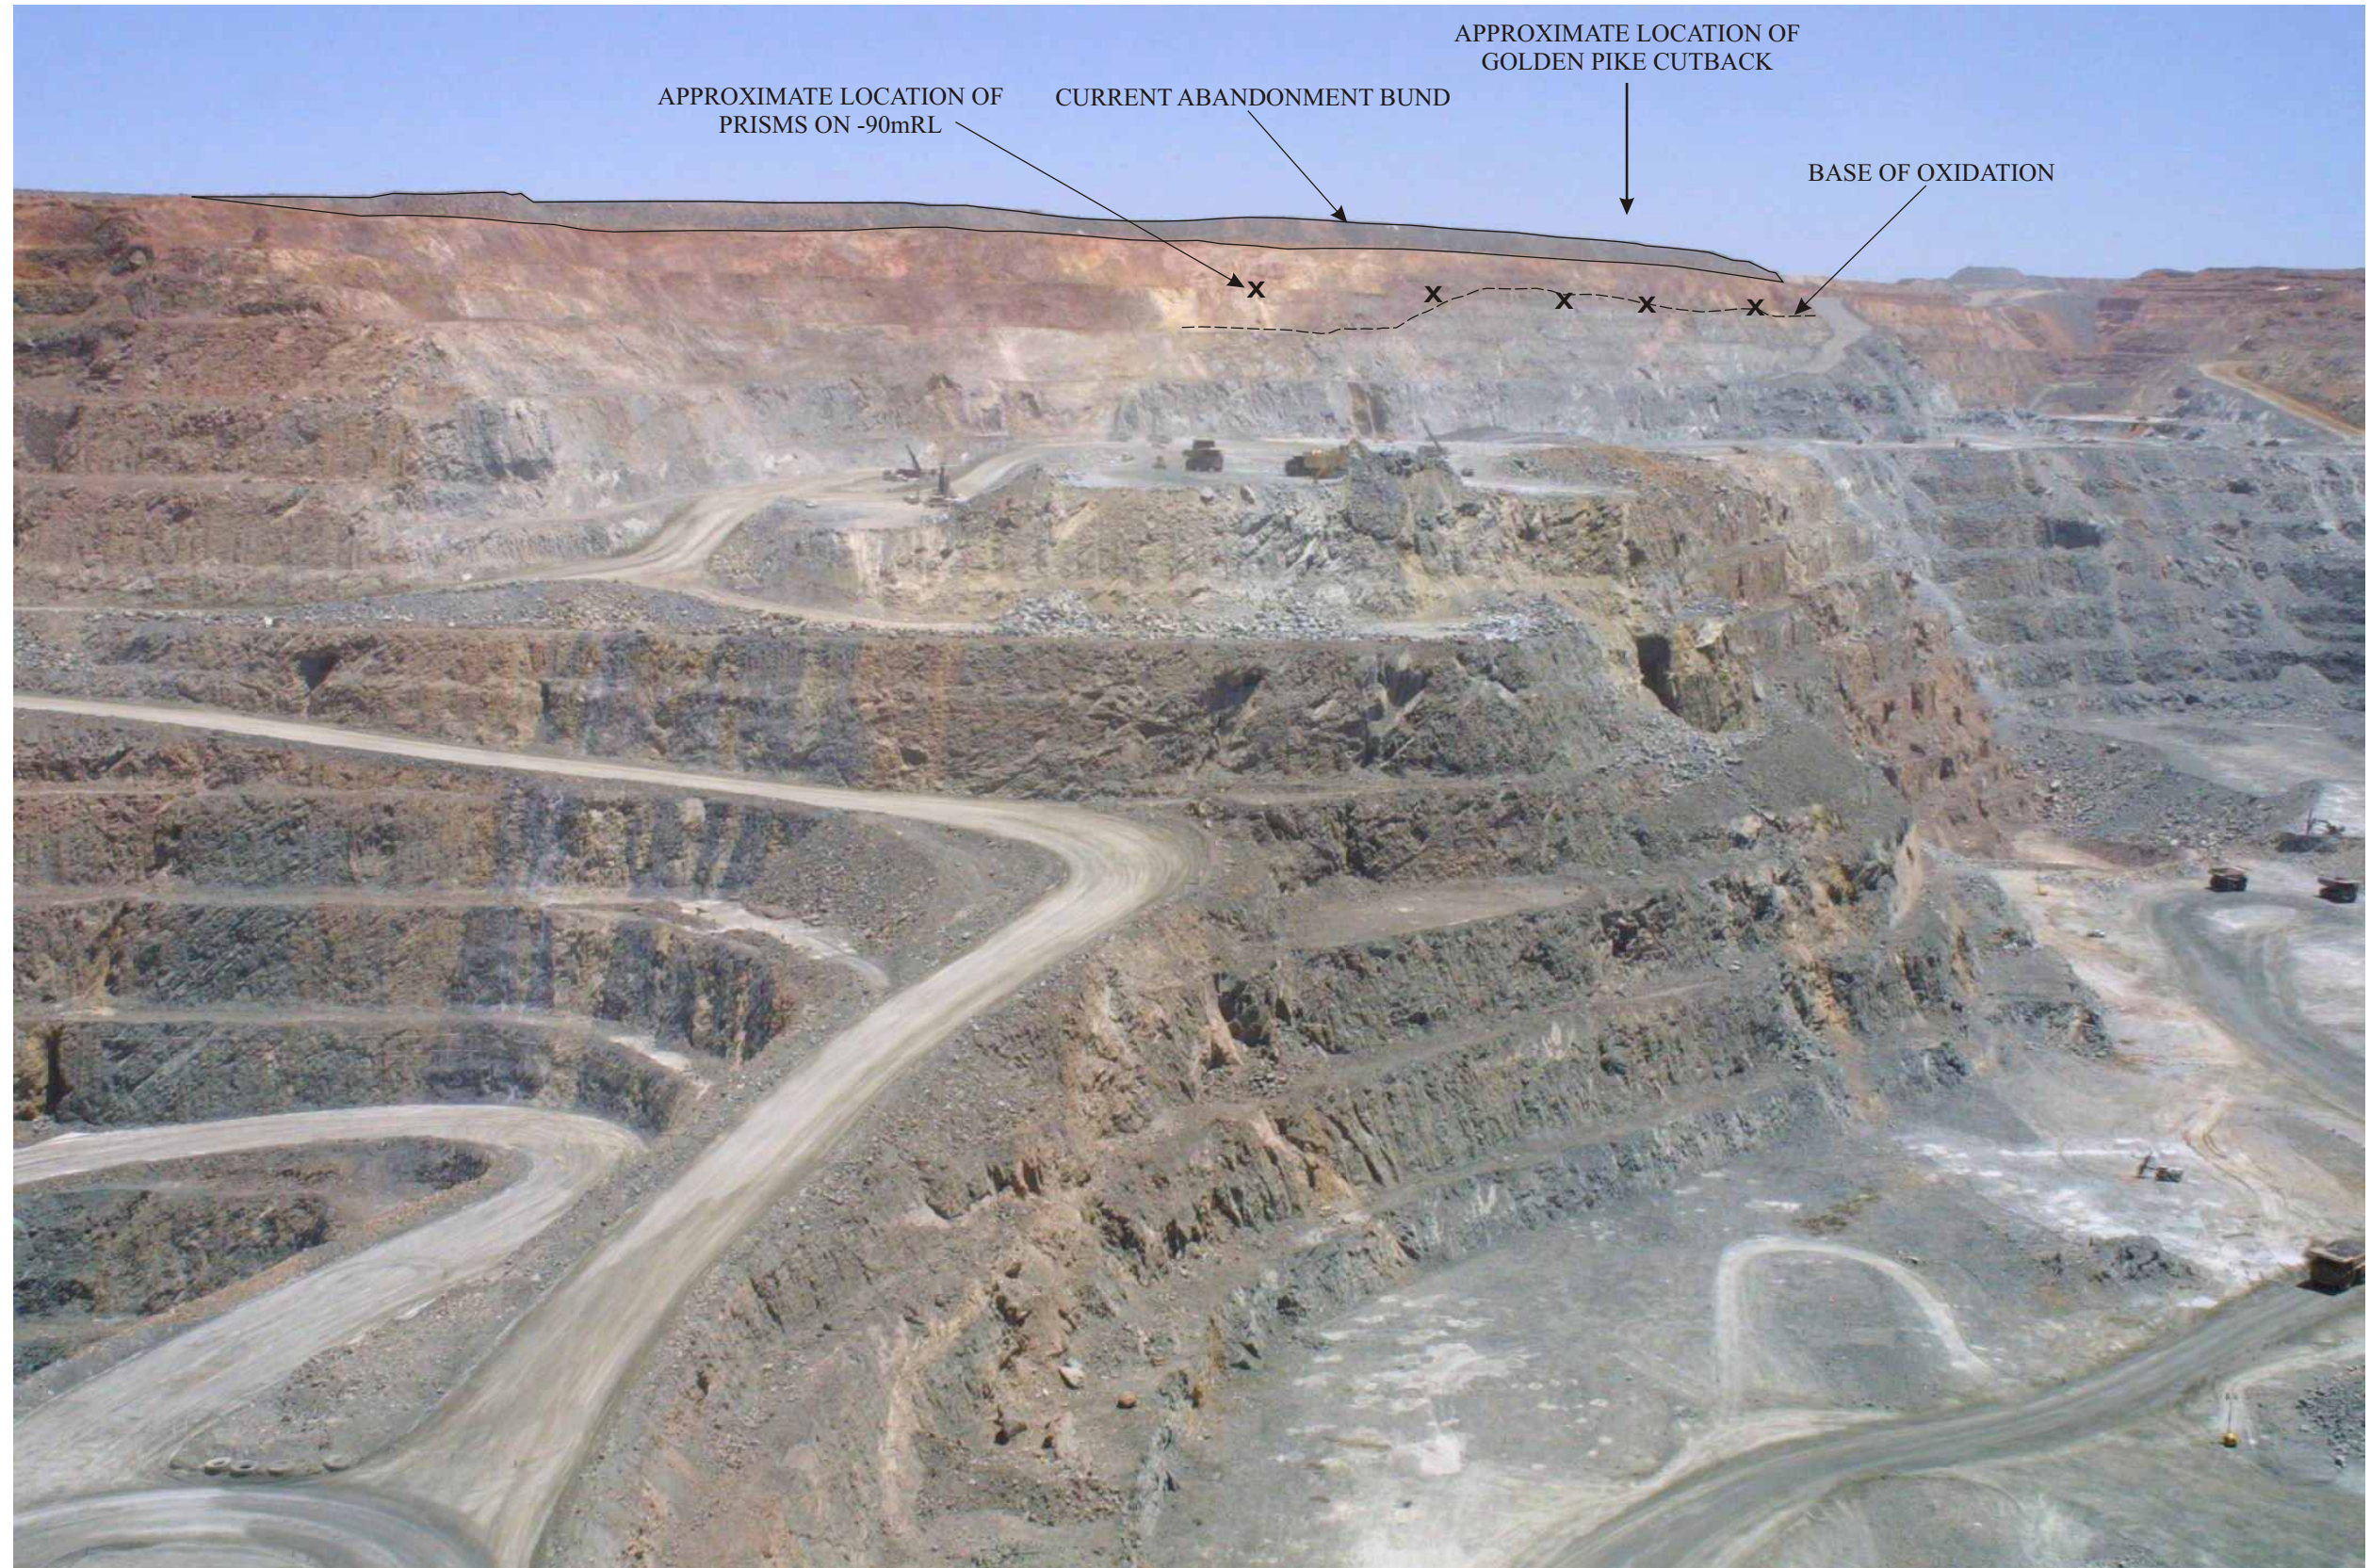
BFP Consultants a division of Coffey Geosciences Pty Ltd				JOB No 1803128	Fig 2

KCGM plan to relocate the Environmental Noise-Bund (ENB) along the western side of the pit which is shown in Figure 2. This is a view of the pit looking north with the present ENB highlighted. The bund is approximately 20 m high, with a base width of approximately 100 m. A picture of the present ENB is shown in Figure 3. This is a substantial bund and significantly exceeds the requirements outlined in the DoIR Guidelines (Reference 2) which requires, as a minimum, a bund with:

CLIENT	KALGOORLIE CONSOLIDATED GOLD MINES PTY LTD			VIEW OF WEST WALL STORES CUTBACK BEING UNDERTAKEN IN FOREGROUND	
	ABANDONMENT BUND ON WEST WALL			DATE JULY 2005	SCALE NTS

- The prism data presented in Figure 6 corresponds to prisms located at -90 mRL in the Stores Cutback (shown in Figure 2). The displacements show a trend of dilation of approximately 30 mm/year. This response is linear and therefore considered to be within the elastic range for calibration purposes. The stress regime used in the analyses has been measured at the Croesus waste dump and in the Chaffers shaft confirming the general trends previously established at Mt Charlotte (Reference 6). The results indicate that the stress ratio is as follows:

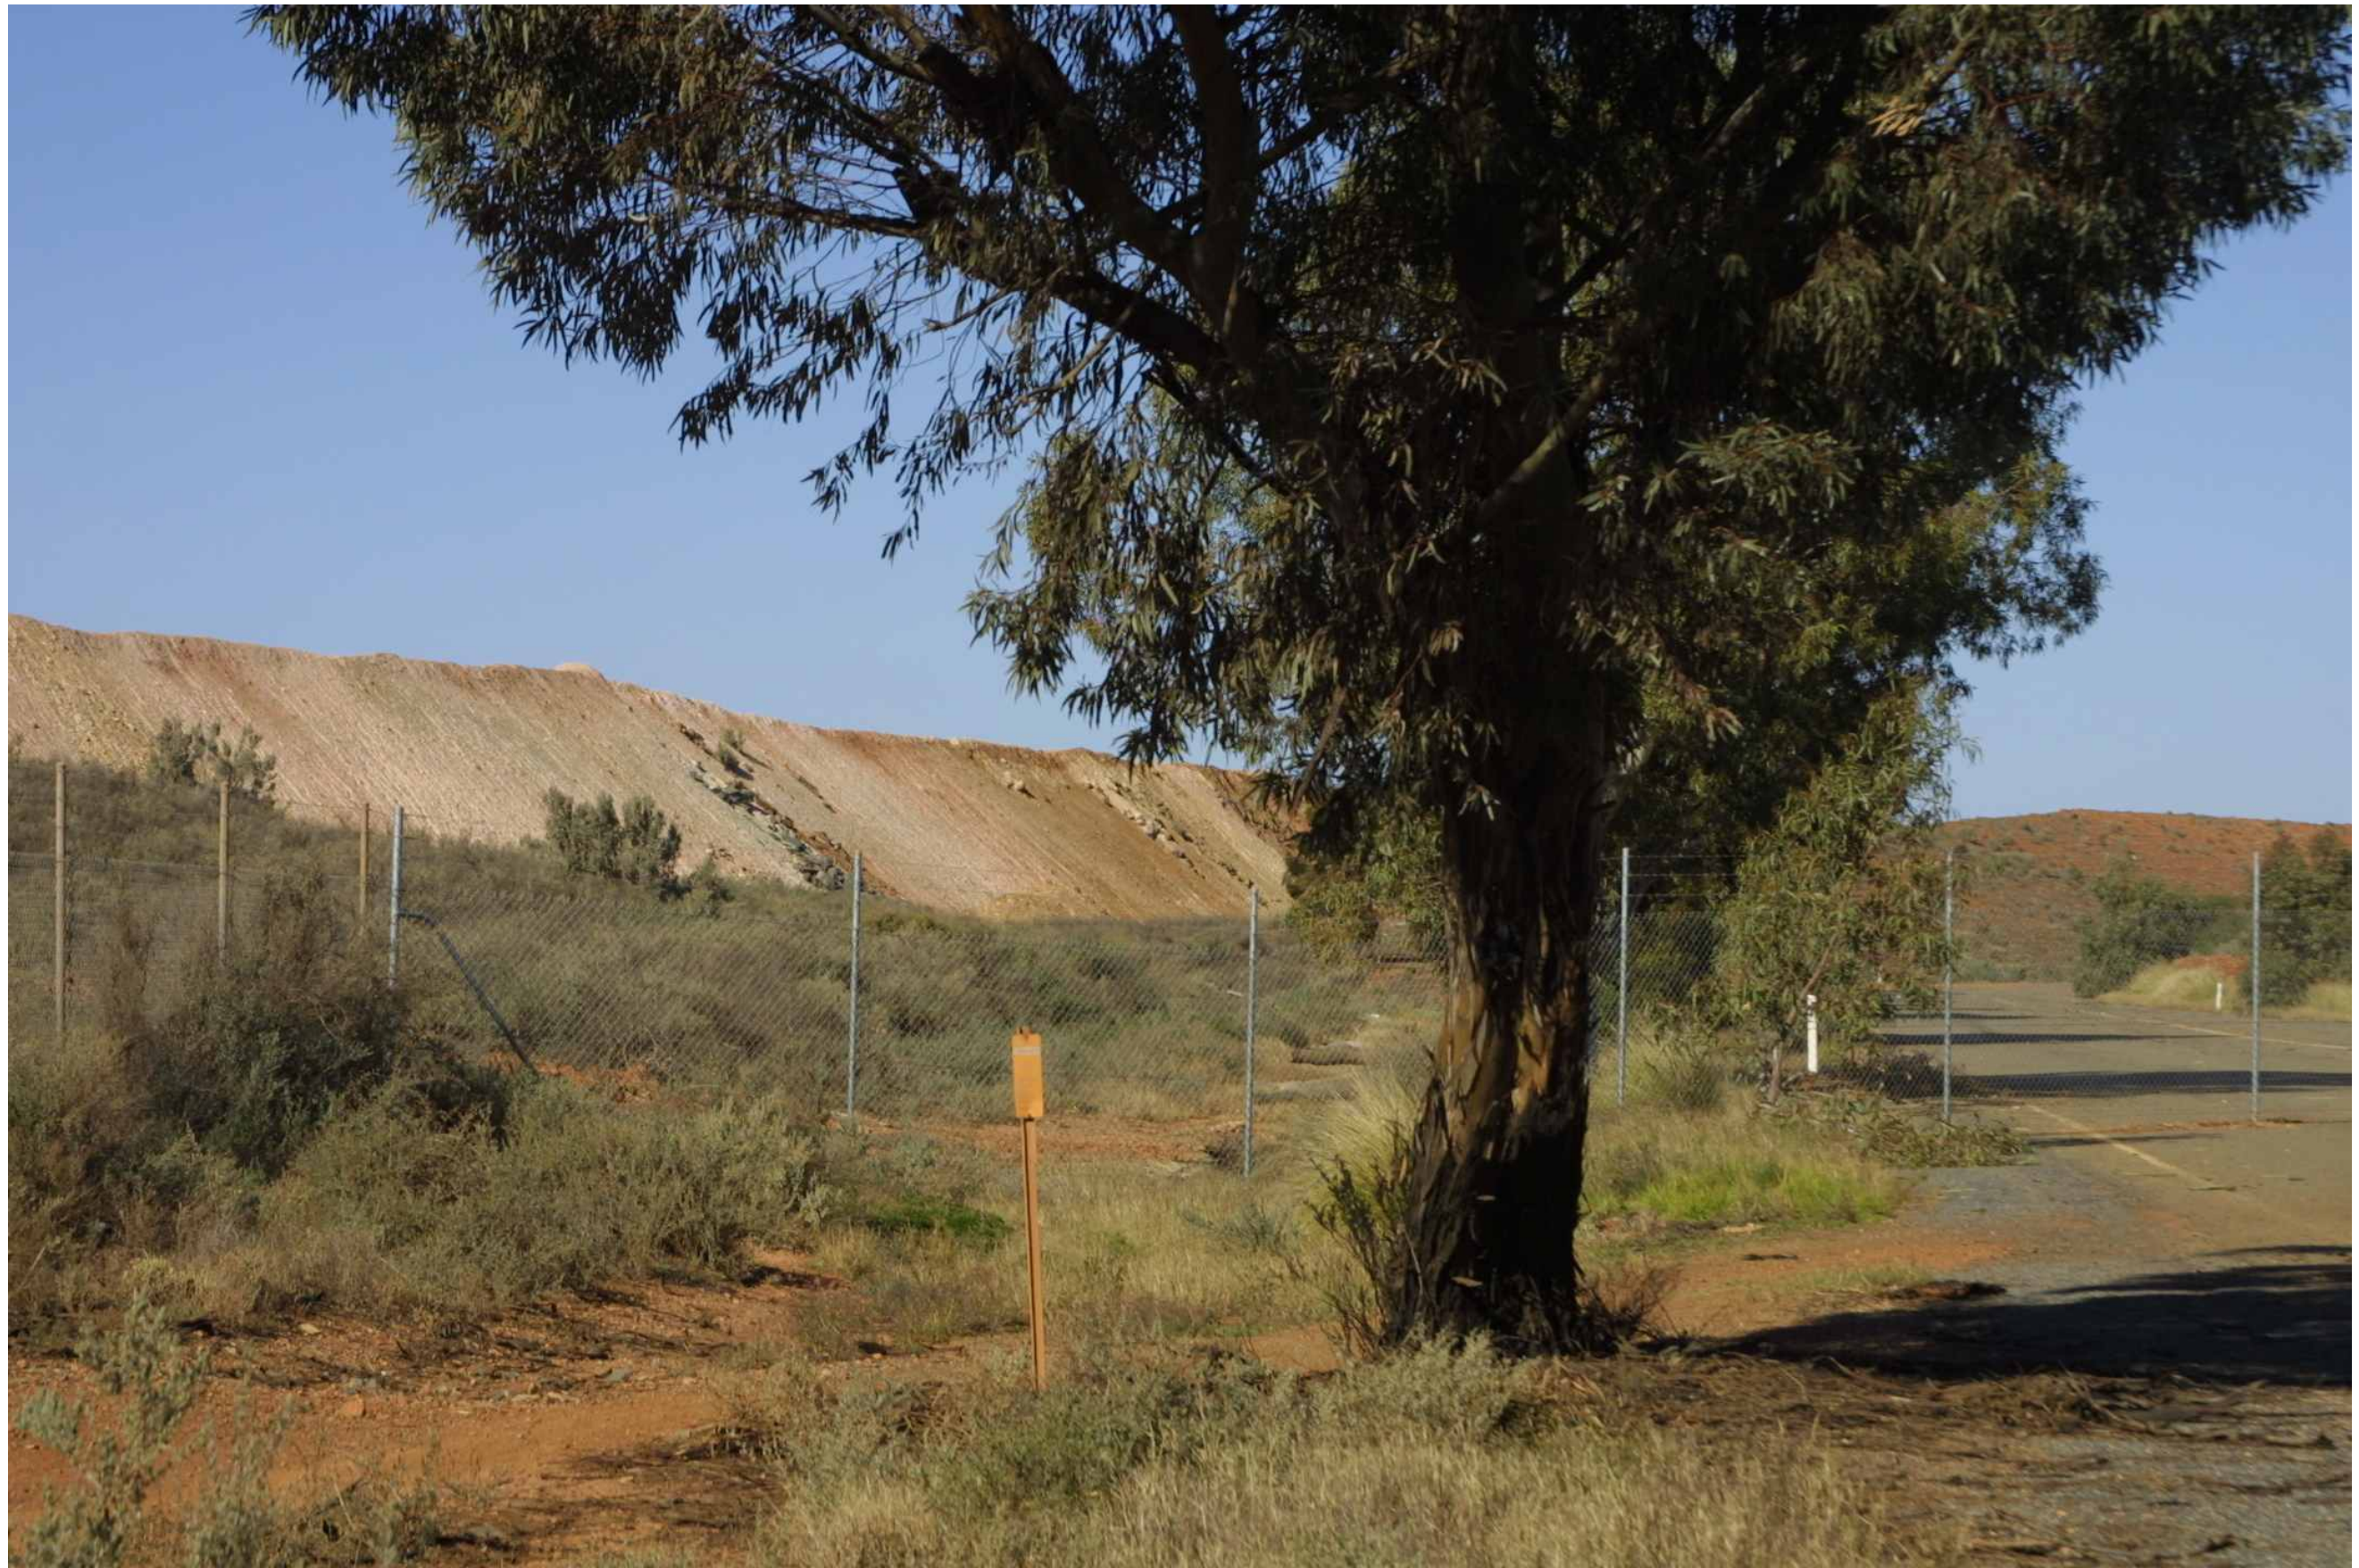
Fig 3

VIEW OF ENVIRONMENTAL NOISE BUND (ENB)

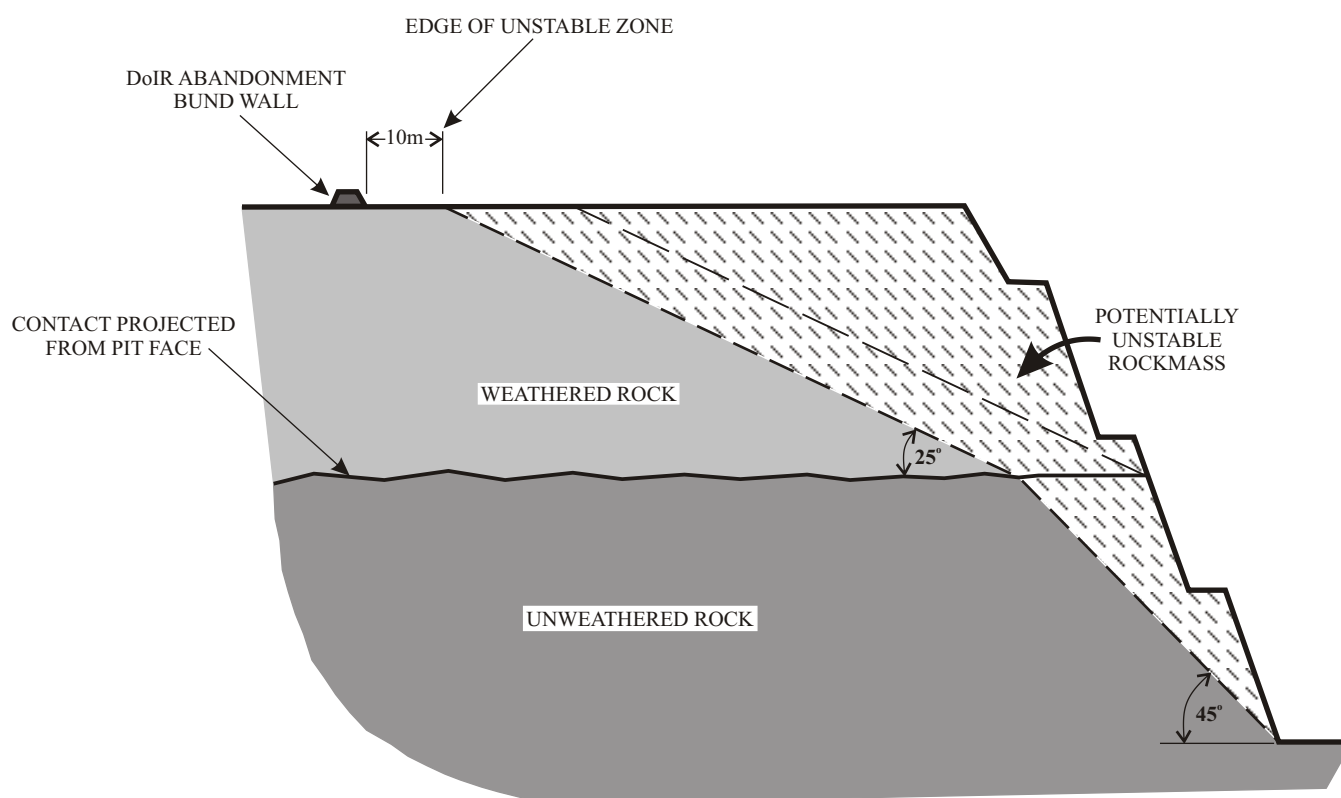
Fig 5

In the absence of any geotechnical investigations, the guideline establishes the location of the bund based on WA experience with abandoned pits. The guideline has established that a pit slope constructed in unweathered (fresh and slightly weathered) rock would be 45° from the toe of the slope to the top of the fresh rock. In weathered (distinctly to extremely weathered) rock, the slope angle would be 25° angle from the bottom of the weathered (oxidised) material to the ground surface. In the guidelines un-oxidised and oxidised rocks are defined as equivalent to unweathered and weathered rocks respectively. In compound slopes comprising both materials then the bottom of the weathered zone would coincide with the point at which the 45° line intersected this horizon. The guideline, as proposed by DoIR, is summarised in Figure 5.

BFP Consultants a division of Coffey Geosciences Pty Ltd	EXAMPLE OF ABANDONMENT BUND LOCATION		
	DATE JULY 2005	SCALE 1:1000	JOB No 1803128

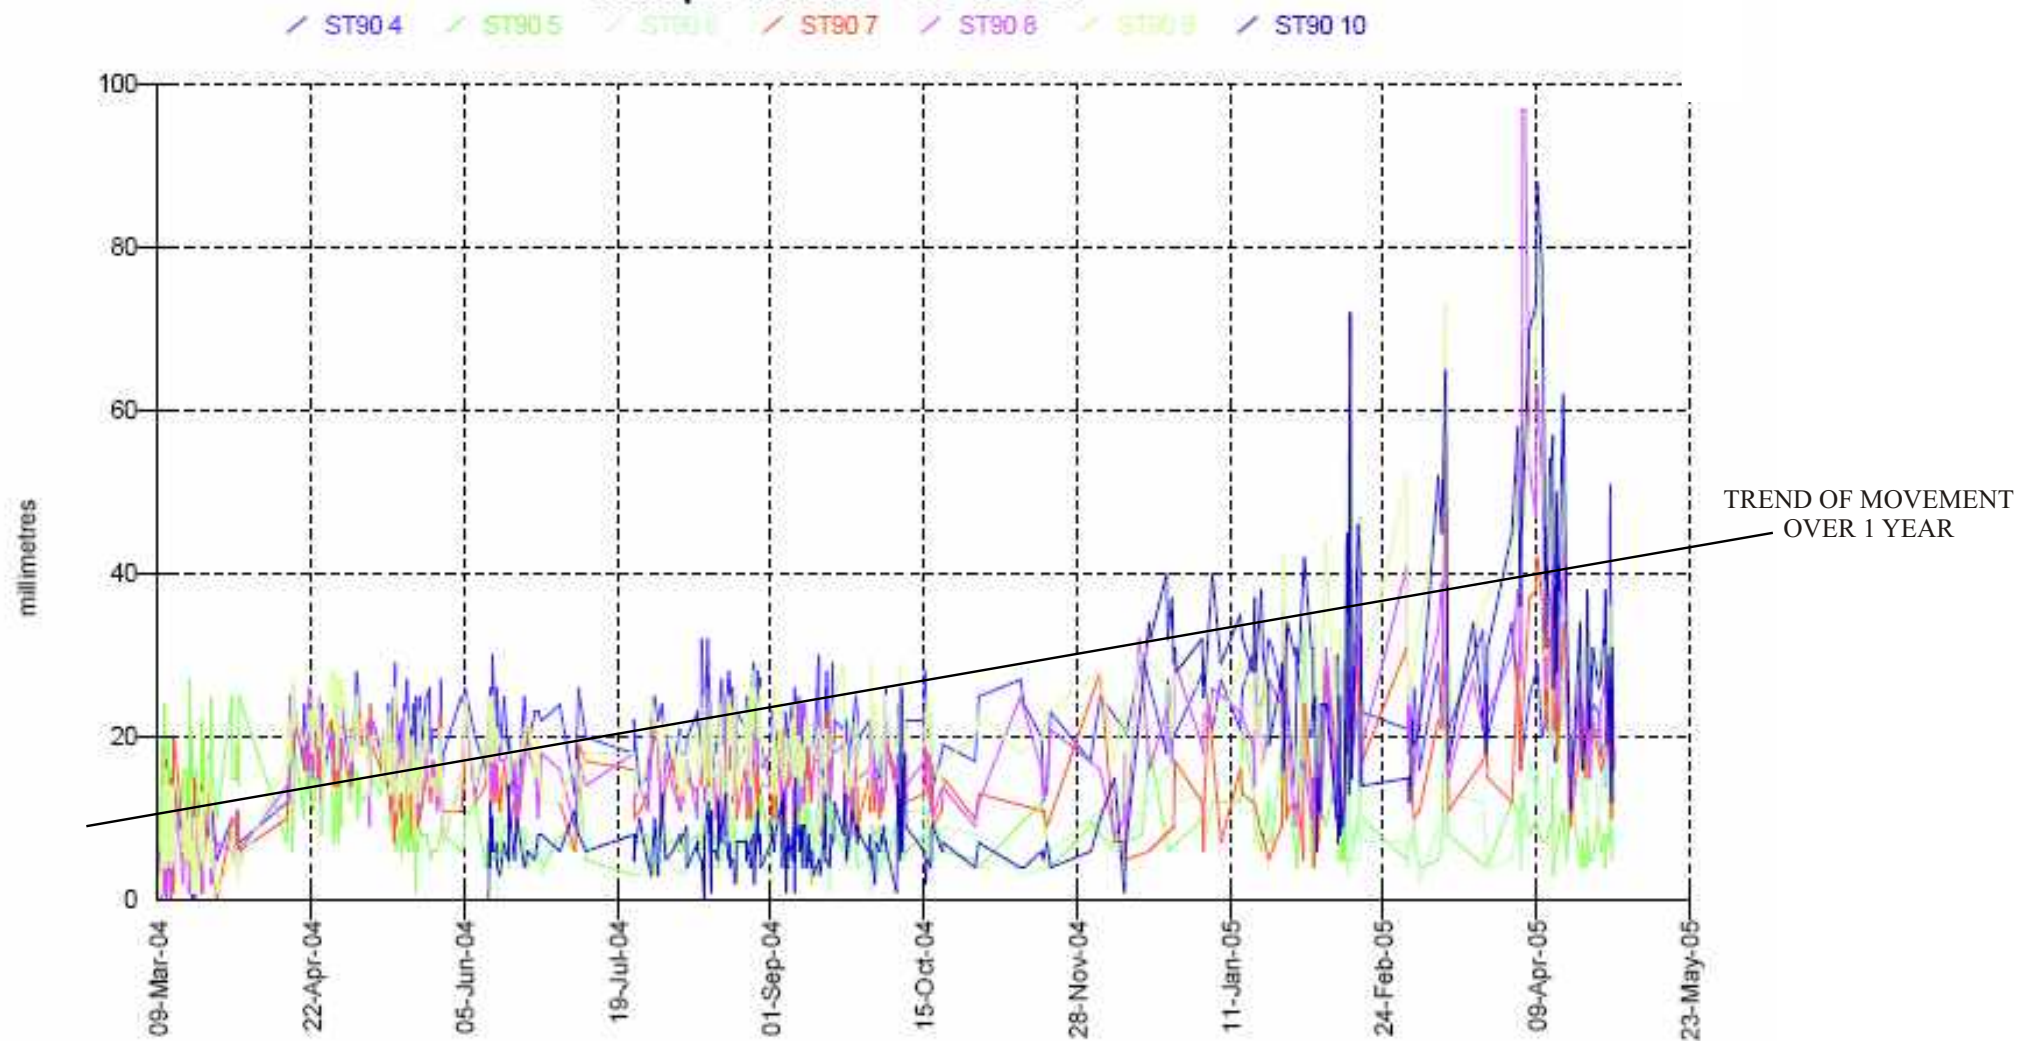
Multiple Prisms - 3D vector

CLIENT		KALGOORLIE CONSOLIDATED GOLD MINES PTY LTD		PRISM MOVEMENT -90 mRL STORES CUTBACK, WEST WALL	
ABANDONMENT BUND ON WEST WALL		BFP Consultants		DATE	JULY 2005
a division of Coffey Geosciences Pty Ltd		SCALE		AS SHOWN	JOB No
					1803128
				Fig 6

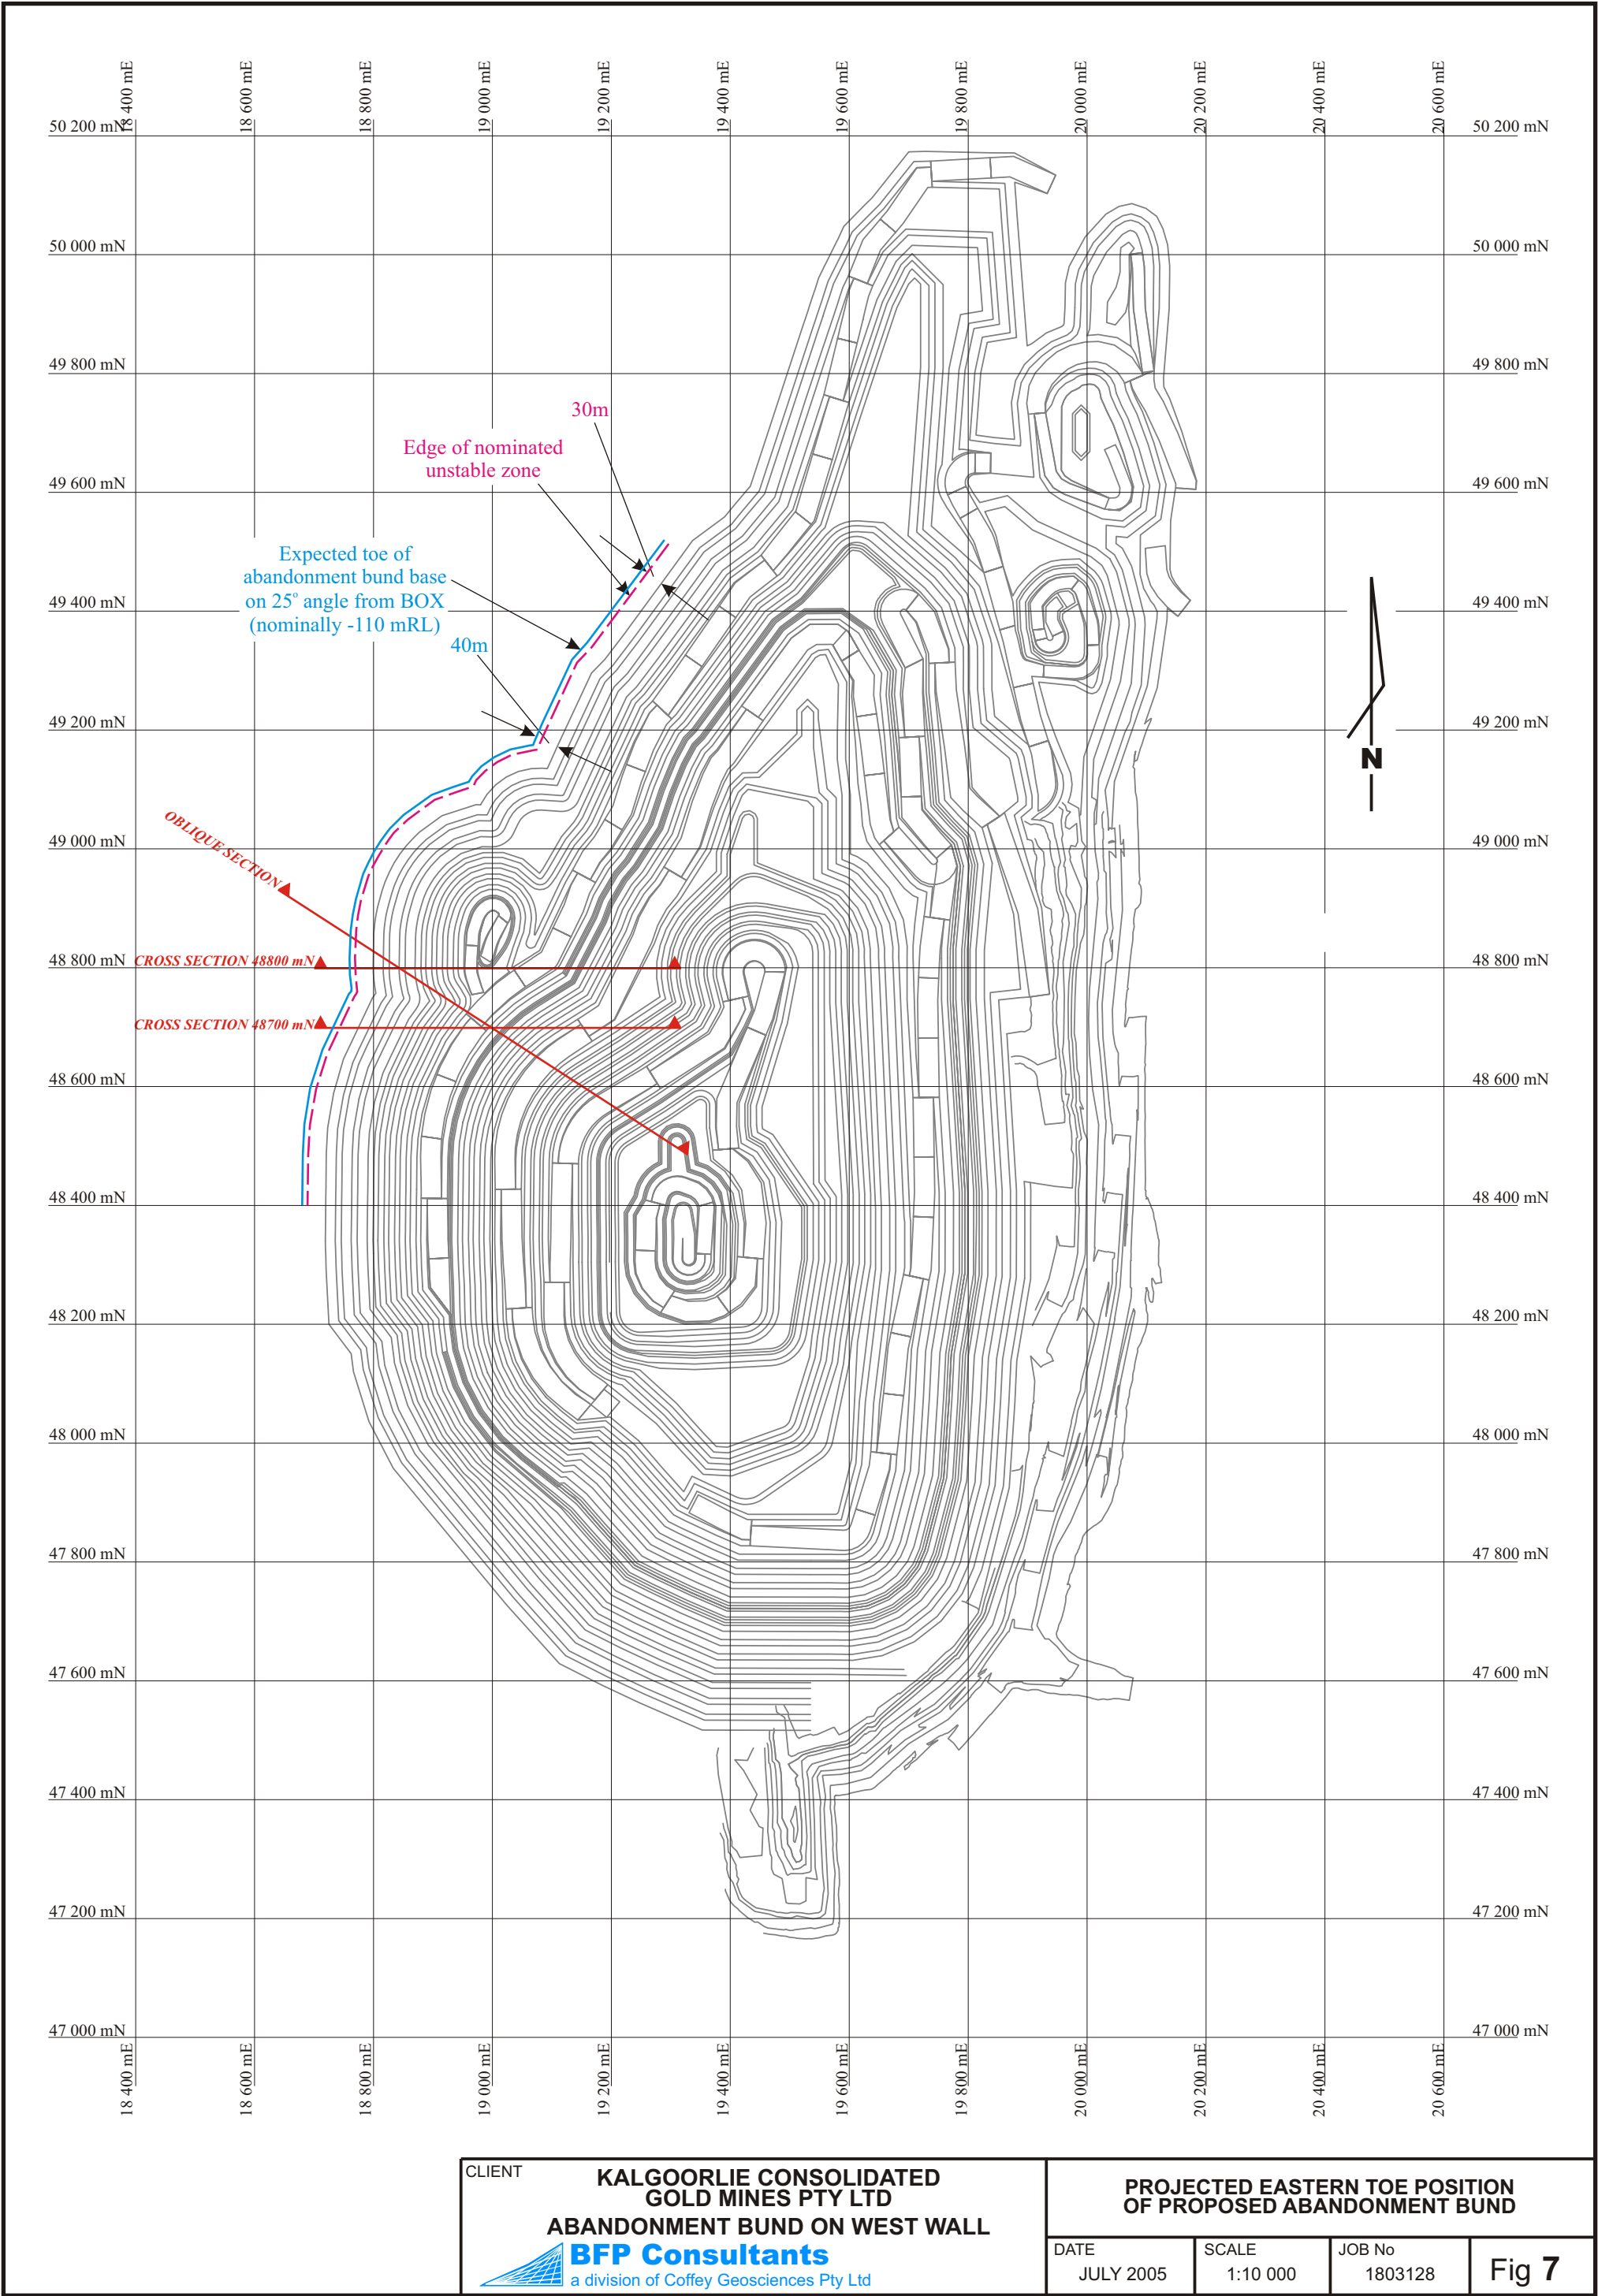
Fig 7

**PROJECTED EASTERN TOE POSITION
OF PROPOSED ABANDONMENT BUND**

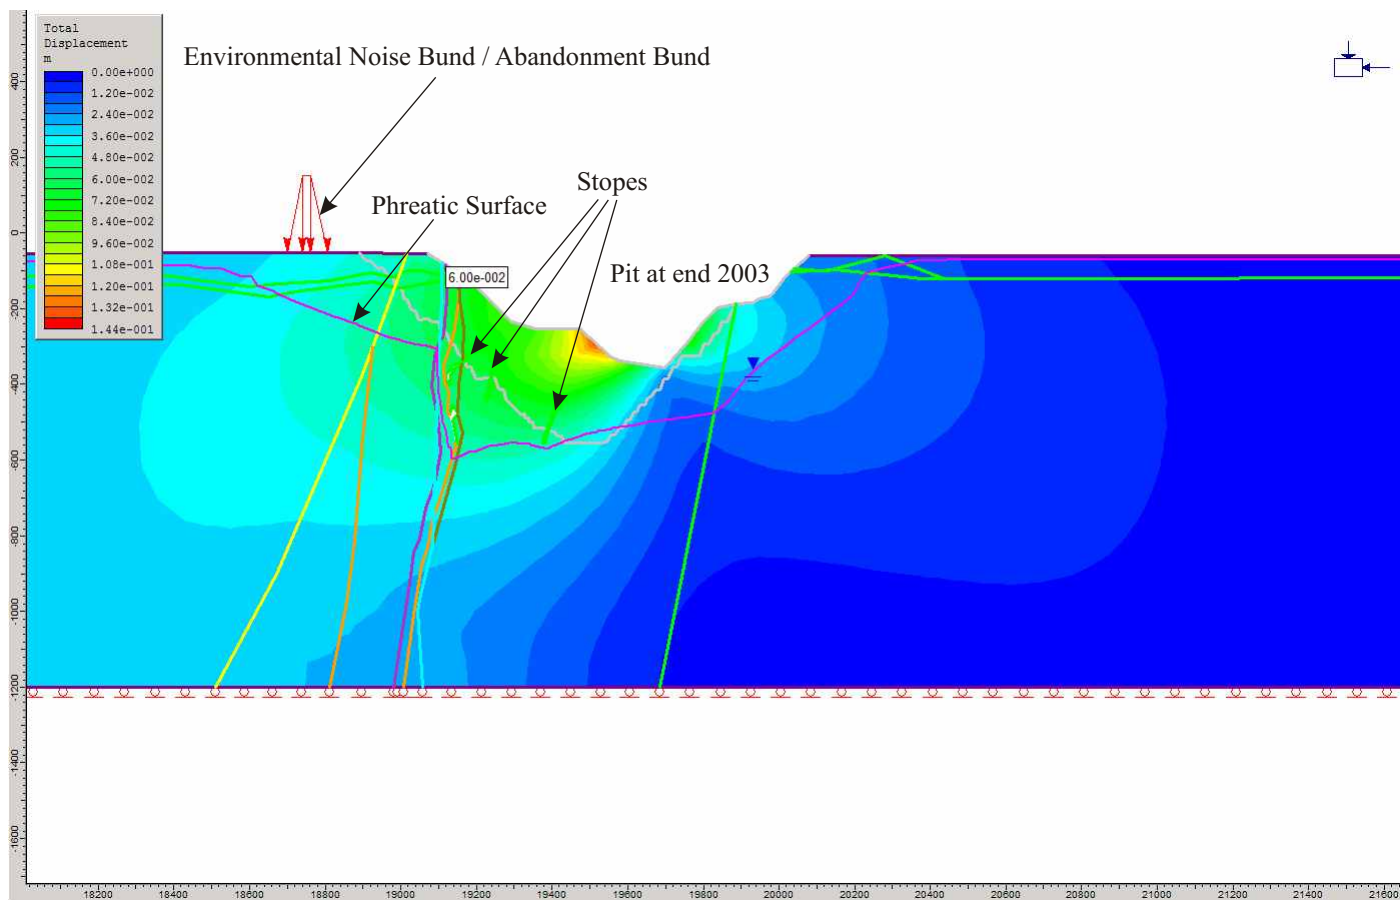
Critical SRF = 4.54

SRF = Strength Reduction Factor
SRF = Effective Factor of Safety

- The numerical analyses were then used to examine the rock mass behaviour with time and determine the effective factor of safety. The results of the analyses are presented in Figures 15 to 20. Three sections were examined 48700N, 48800N and an oblique section constructed normal to the wall. The location of these design sections are shown in Figure 1. The effective factor of safety (the term used in the stress analyses is Strength Reduction Factor (SRF)), has been calculated by progressively increasing or reducing the material parameters until plastic yield occurs within the model. It can be seen that, at the final pit shape, the factor of safety at 48700 mN, 48800 mN and the oblique section will be 4.54, 5.94 and 2.0 respectively. The oblique section has a much steeper overall slope than sections 48900 N and 4800 N contributing to the lower SRF calculated. These safety factors compare very favourably when compared to the DoIR guidelines of acceptable factors of safety in the range of 1.2 to 1.5 for commensurate pit wall designs.

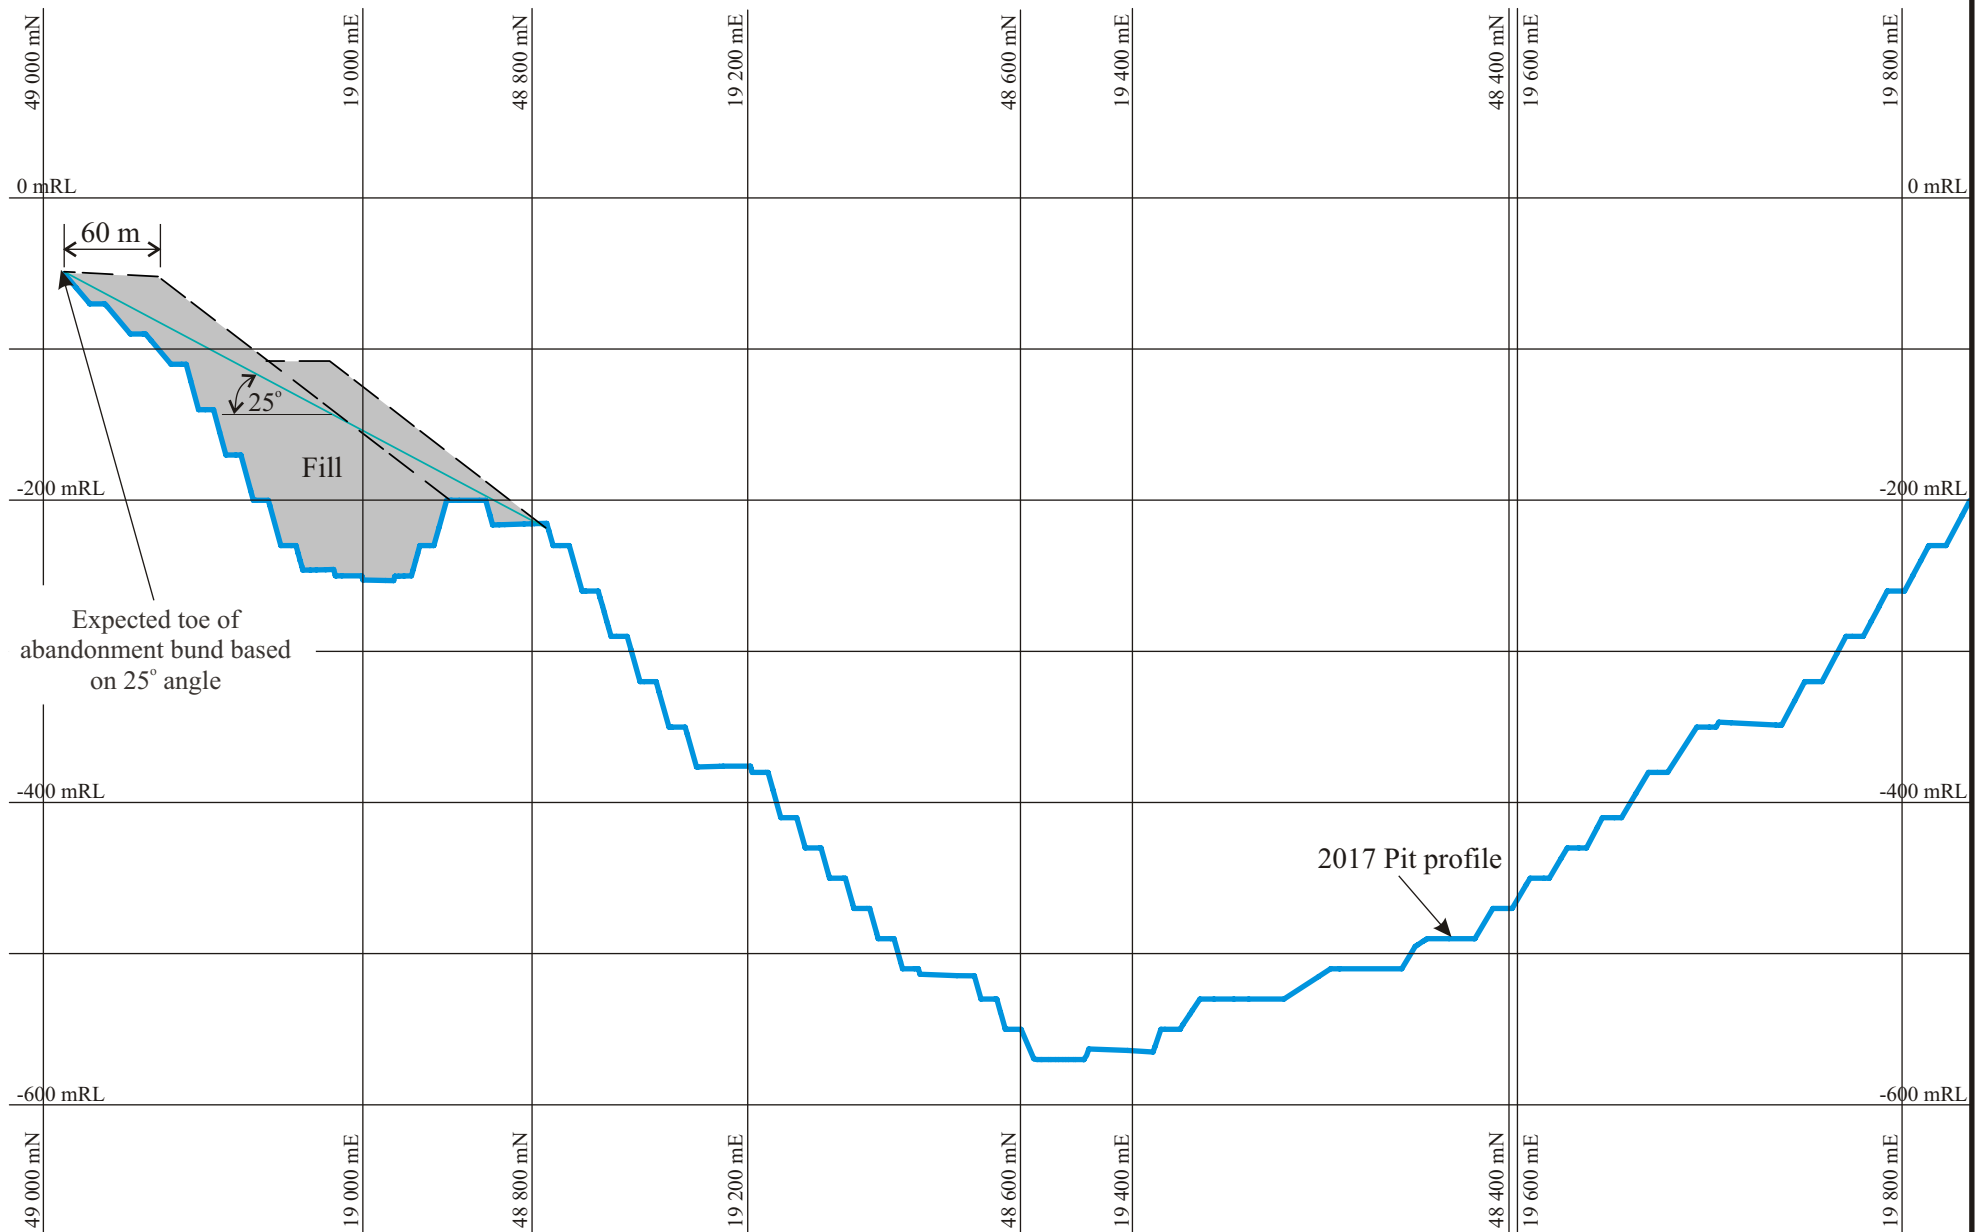
CLIENT		KALGOORLIE CONSOLIDATED GOLD MINES PTY LTD		GOLDEN PIKE BACKFILL	
		ABANDONMENT BUND ON WEST WALL

To reduce the impact of weathering in the Golden Pike Cutback, it is proposed to backfill over the pit crest with fresh waste rock to minimise further deterioration by the eventual flooding of the pit and any subsequent wave action. The benefits of this approach can be seen in Figure 32 where the abandonment guideline would then be effectively located at the (former) pit crest.
