**REQUIREMENTS OF PIT ABANDONMENT
AND DESIGN CHANGE ASSOCIATED
WITH THE GOLDEN PIKE CUTBACK

KCGM**

Dr P M Dight

DATE: JULY 2005
JOB NO.: 1803128

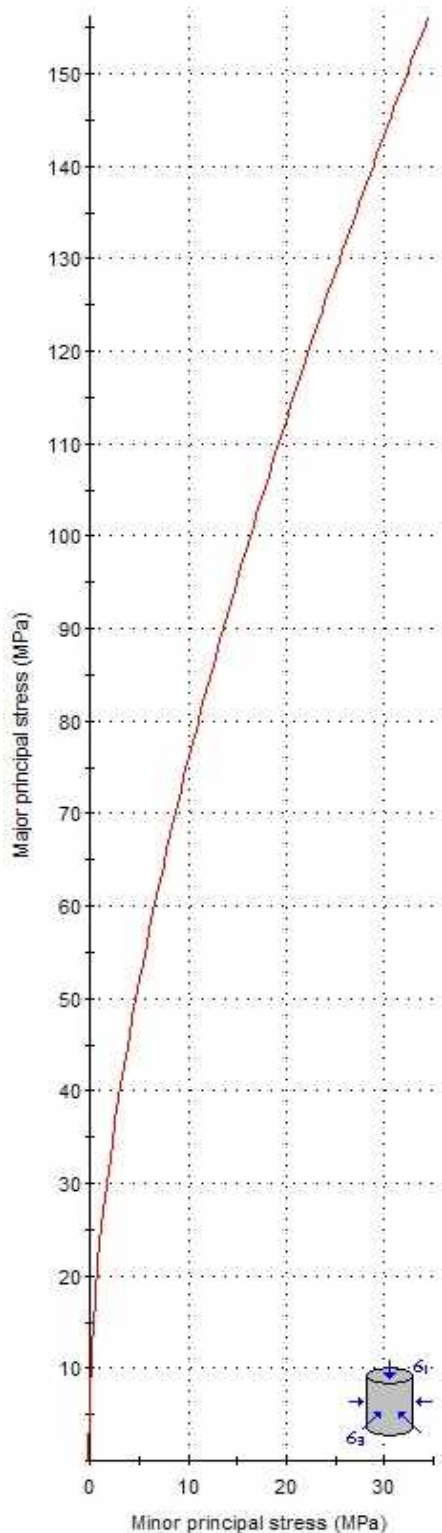
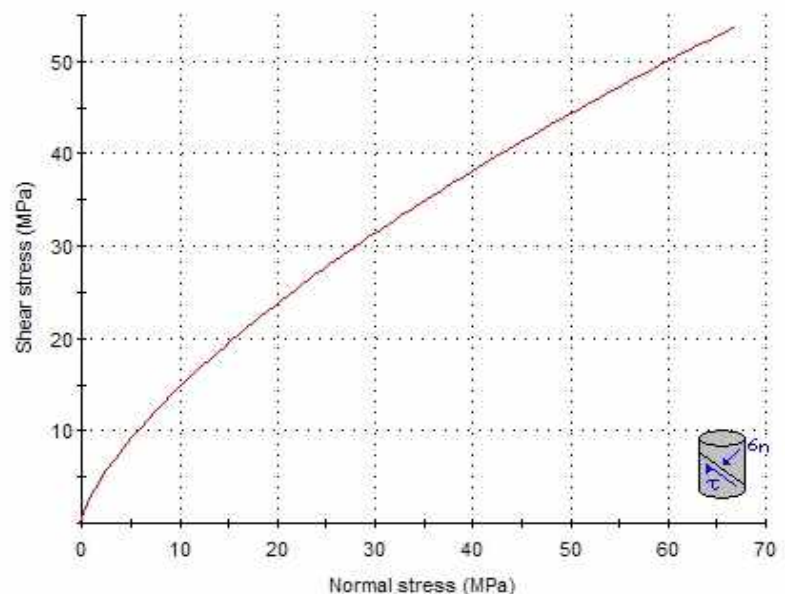
Fig A1

Golden Mile Dolertite (GMD) - West

tensile strength = -0.269 MPa
uniaxial compressive strength = 10.480 MPa
global strength = 32.786 MPa
modulus of deformation = 12589.25 MPa

- The rockmass properties have been determined using RocLab from RocScience. The results are presented in Table 2, with the calculation sheets presented in the Appendix.

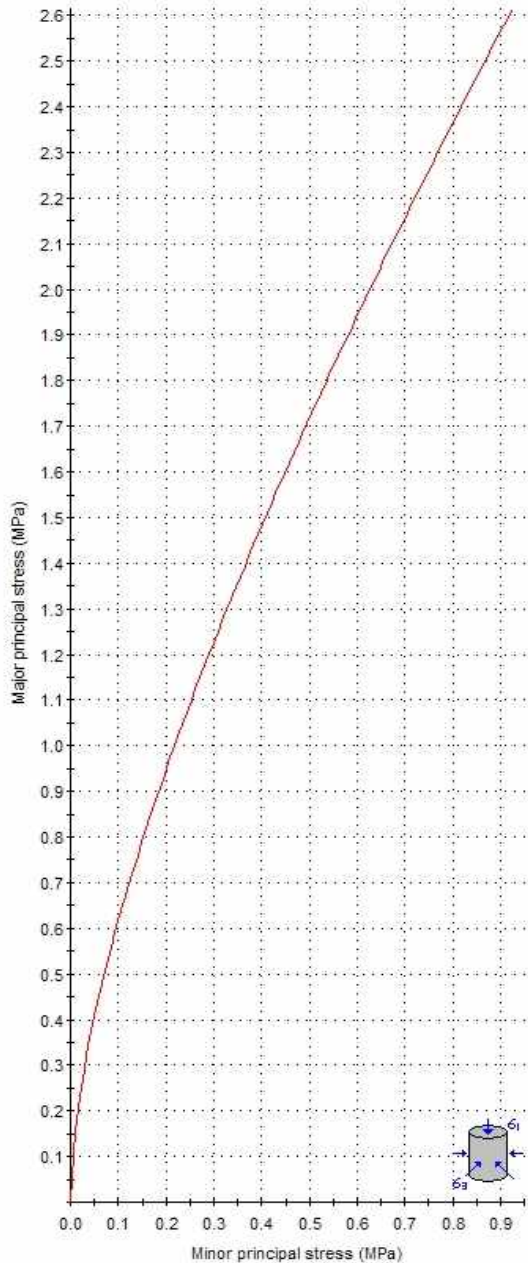
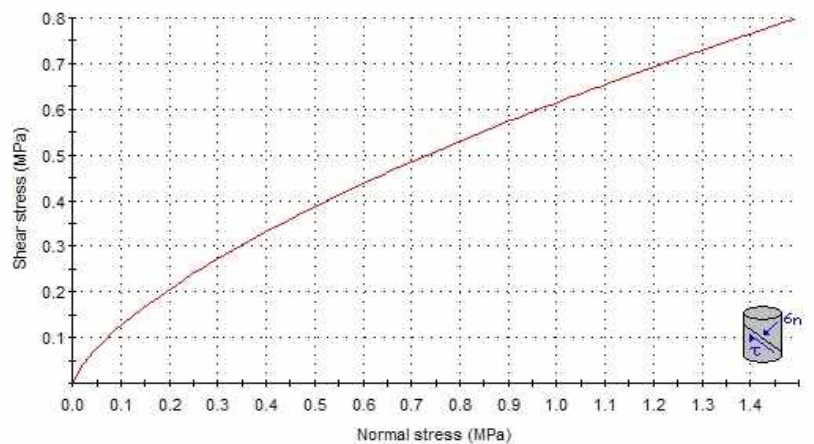
Fig A2

Distinctly Weathered Williamstown Dolerite

intact uniaxial compressive strength = 3 MPa
GSI = 25 m_i = 16 Disturbance factor = 0

tensile strength = -0.001 MPa
uniaxial compressive strength = 0.036 MPa
global strength = 0.366 MPa
modulus of deformation = 410.73 MPa

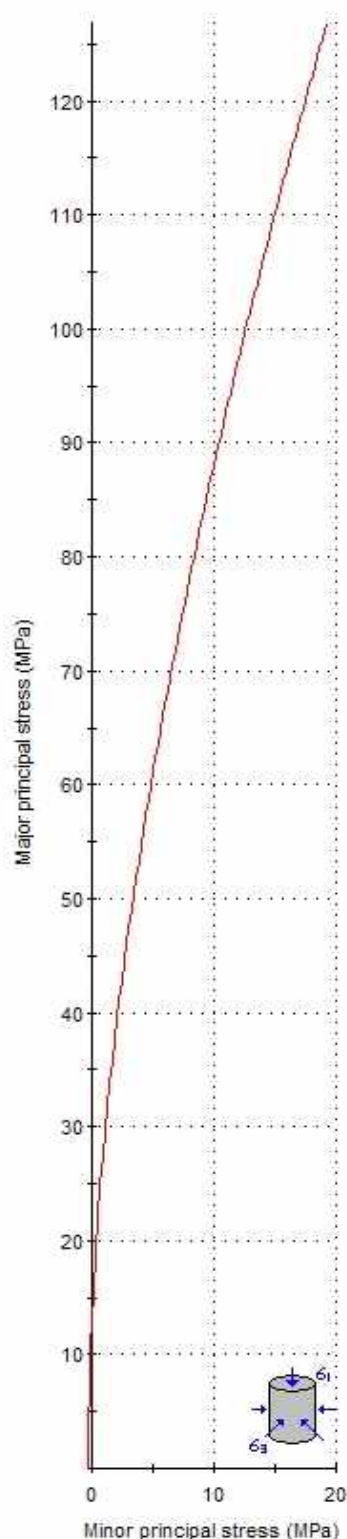
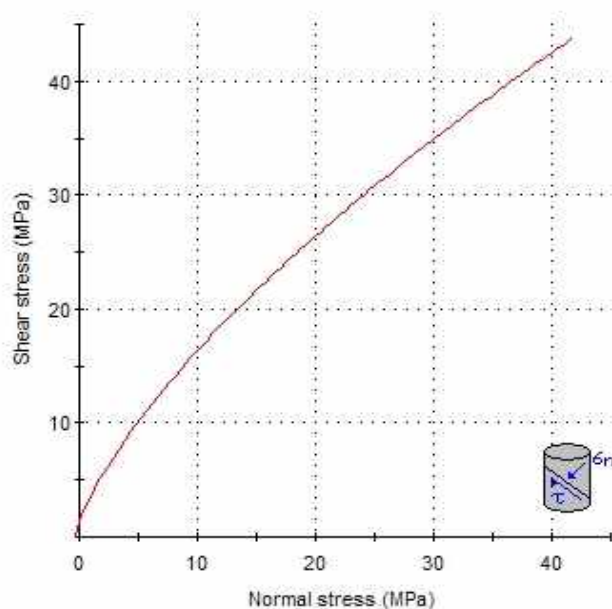
Paringa Basalt

intact uniaxial compressive strength = 77 MPa
GSI = 67 m_i = 25 Disturbance factor = 0

tensile strength = -0.256 MPa
uniaxial compressive strength = 12.234 MPa
global strength = 29.678 MPa
modulus of deformation = 23347.77 MPa
