KCGM

Kaltails TSF Hydrogeological Review

June 2006

Reference: 0051522

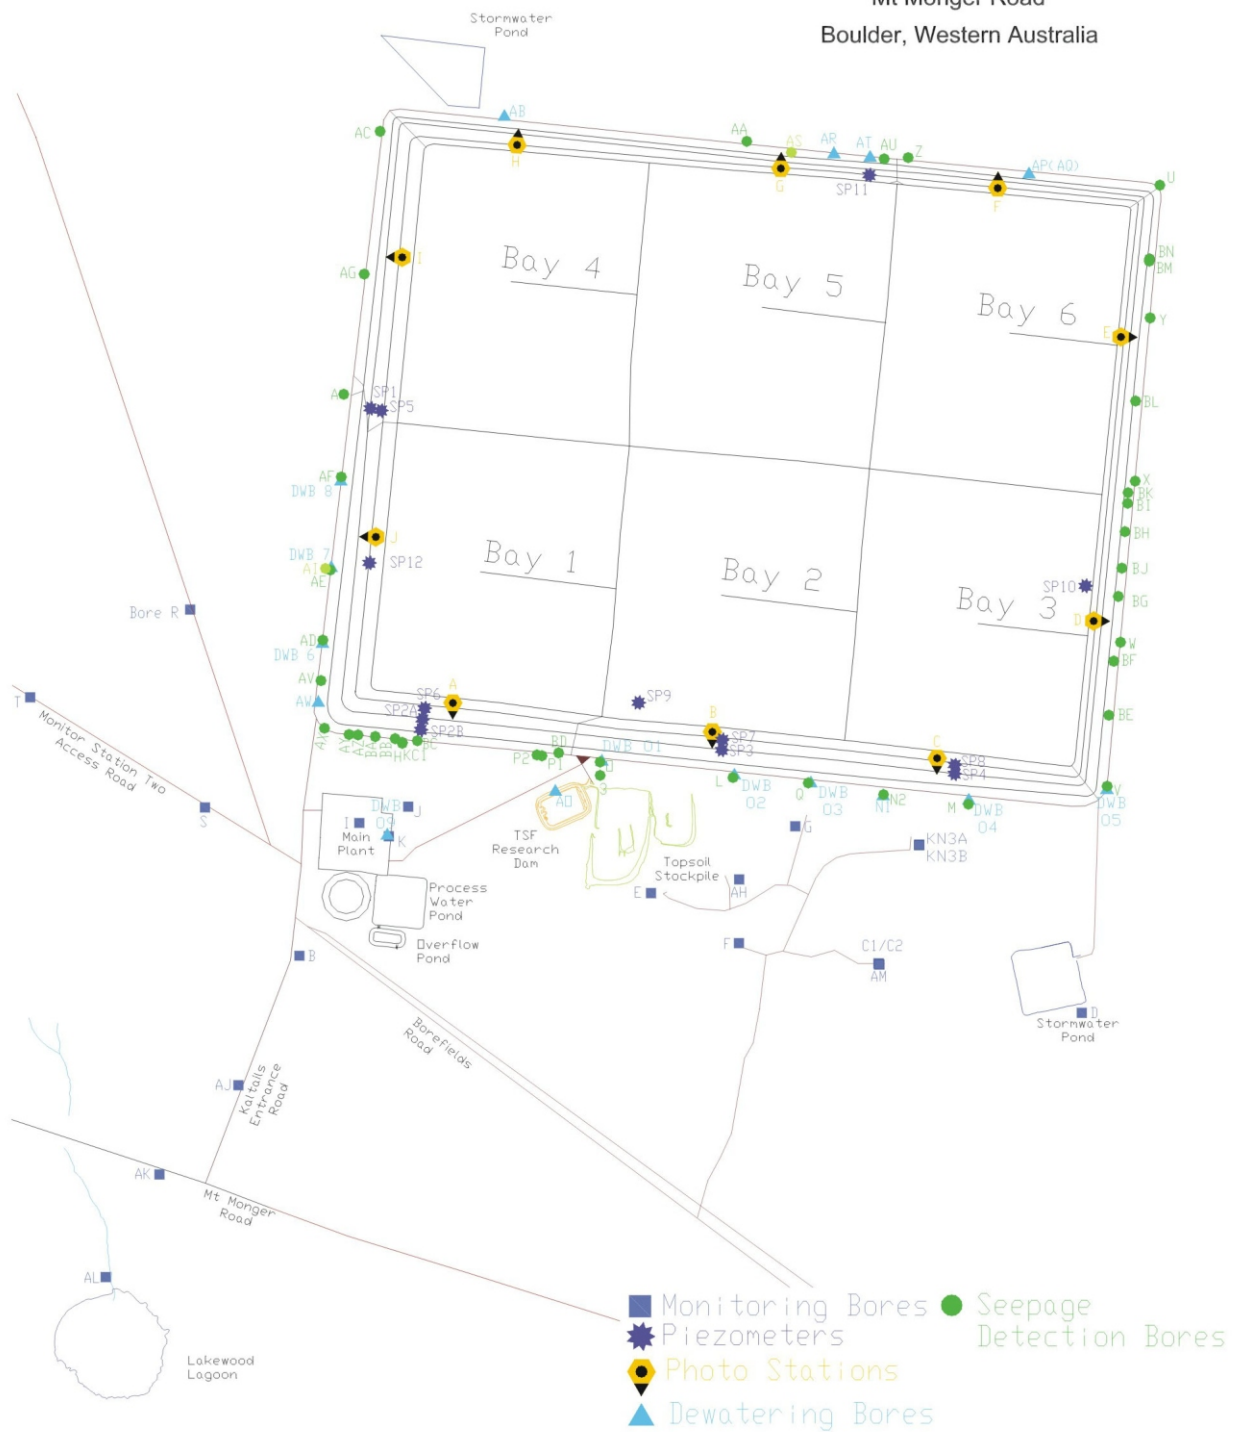
Figure 1

It should be noted that the numbering and designation of dewatering bores and monitor bores has changed over the years. The revised numbering of several significant dewatering bores is indicated in *Table 3* to facilitate comparison of recovery/water level graphs presented as Annexes A and B with bore nomenclature shown in *Figure 1*.

Kaltils TSF
Bores and Piezometers Location Plan

Model predictions also indicated that groundwater levels were expected to be above ground surface in an area south of the TSF and north of Mt Monger Road (note that this is the area shown to be degraded on *Figure 3*). The area immediately south of Bay 1 of the TSF and north of the plant site (refer *Figure 1*) was predicted to have a water table within one metre of the ground surface. The final predicted recovered water levels were consistent with the inferred levels believed to exist prior to commissioning of the TSF in 1989.

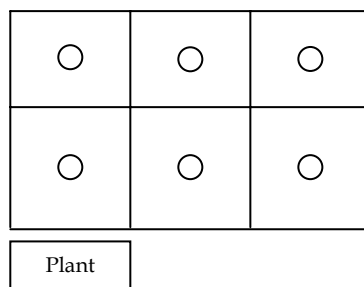
Former Layout

- the new decant point would be a pumped unit operating from a concrete sump configured similar to but larger than that used at the Gidji TSF;
- the current six gravity decants (one for each paddock) would be grout sealed; and
- the six paddocks would be amalgamated to a single paddock with only one single decant point as indicated in the sketch below. This would give a slightly longer seepage path from the decant to the toe.

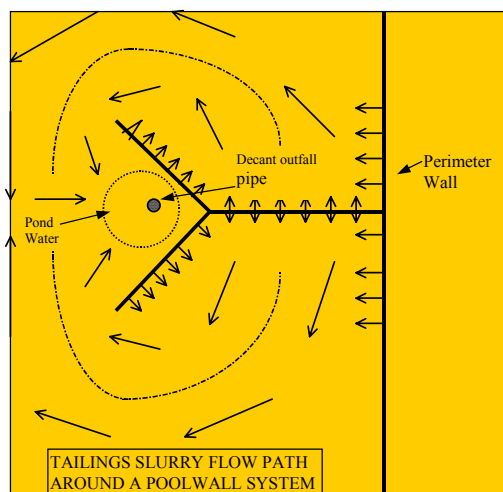
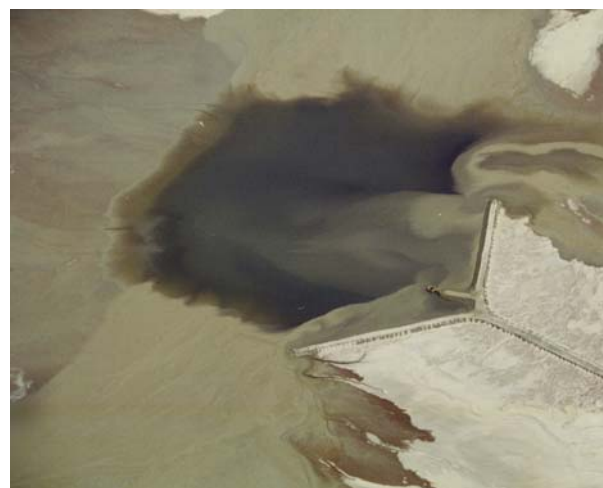
- the single paddock would have wing walls constructed each side of the decant with associated tailings deposition pipe work running along the back of these walls similar to the system used at the Fimiston TSFs for the past ten years. Wing walls give several advantages with respect to construction and water management. Construction is aided because the tailings are deposited sub aerially at the back of the wall and thus drying is more efficient than if deposited sub aqueously as they usually are near the decant. The material also contains a coarse fraction which aids drainage. Deposition along the back of the wing is via small diameter (50mm) spigots compared to the perimeter discharge from large diameter outlets (200mm). This generates a steeper beach due to the low energy contained in the resultant slurry flow which in turn generates a deeper and smaller area supernatant pond at the decant compared to a typical pond. In addition the wings form a glove like feature and this combined with an increased pond depth maintains the pond close to the decant point as indicated in the photographs below.
