KCGM

KCGM Mine Closure Plan 2025 (v1) Volume 1 of 3

J102 Golden Mile/KCGM (S0236564, S0236565, S0236563), J177 Kaltails

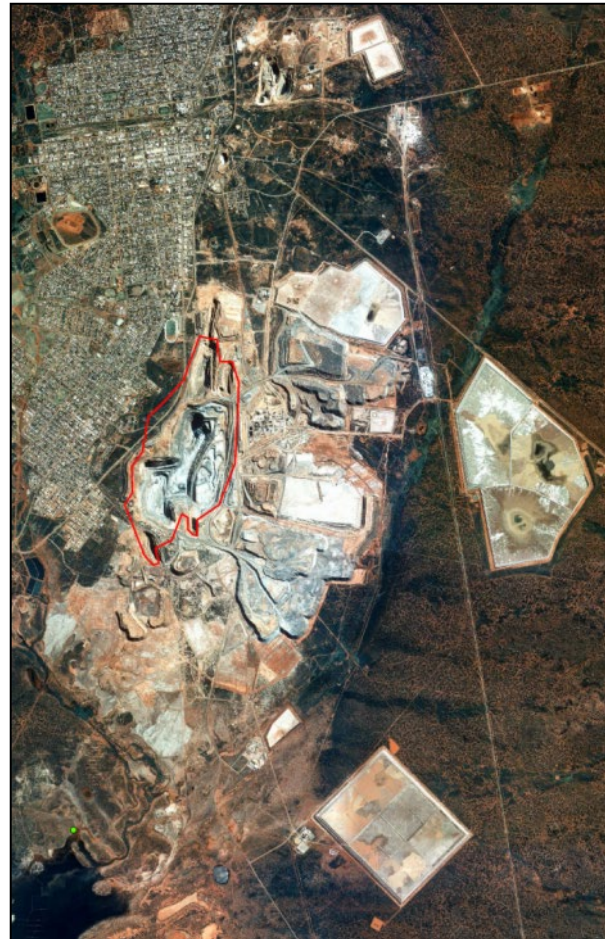
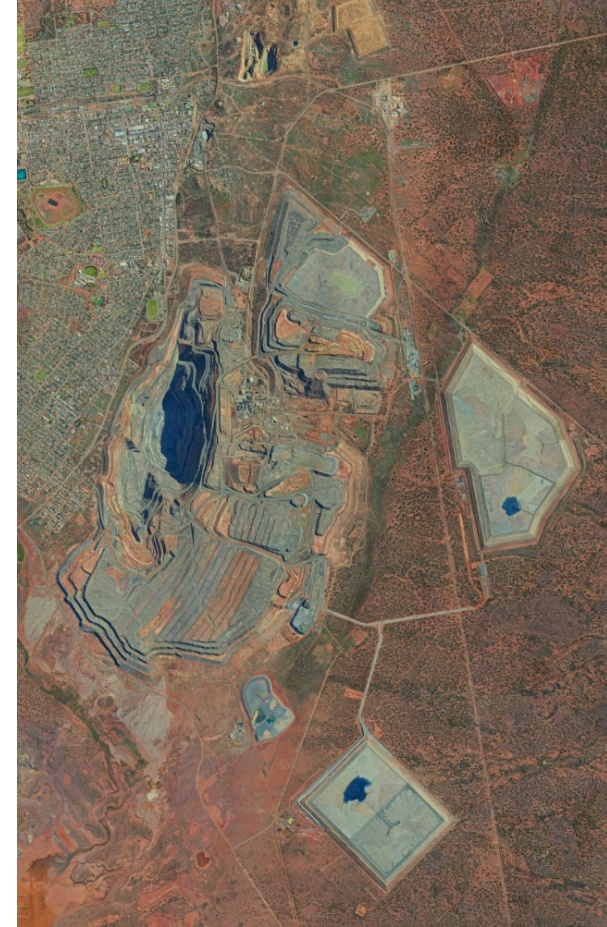
(Highly disturbed nature of the Fimiston, Mt Charlotte, and Mt Percy Operational Areas – 2019 extent of Fimiston Open Pit outline shown in red)

Figure 5-7: KCGM Operations 1983, 1999, and 2019

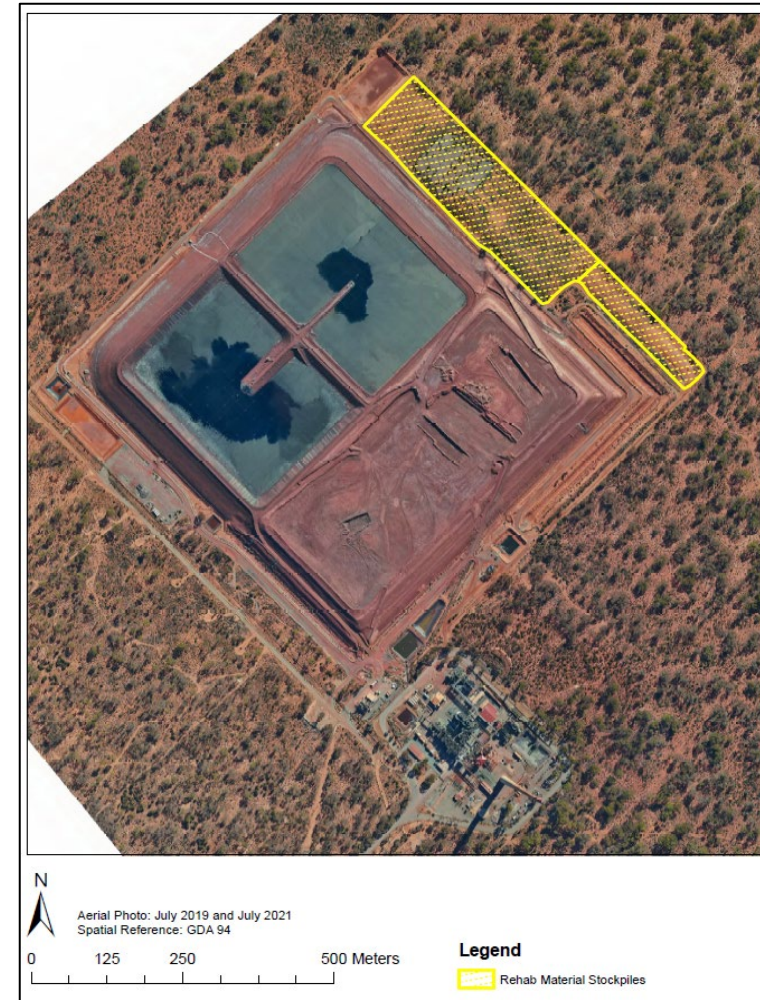
Figure 5-9: Gidji Rehabilitation Material Stockpiles (2025)

Topsoil stockpiles are located at Fimiston (Figure 5-8) and Gidji (Figure 5-9) Operational Areas. Rehabilitation at Mt Percy has already been completed (before 2001), with all available topsoil utilised. Mt Charlotte does not have any topsoil stockpiles due to the age of the operation. The Regional Operational Area will likely utilise topsoil pushed up to form windrows or stockpiled during construction of service corridors.

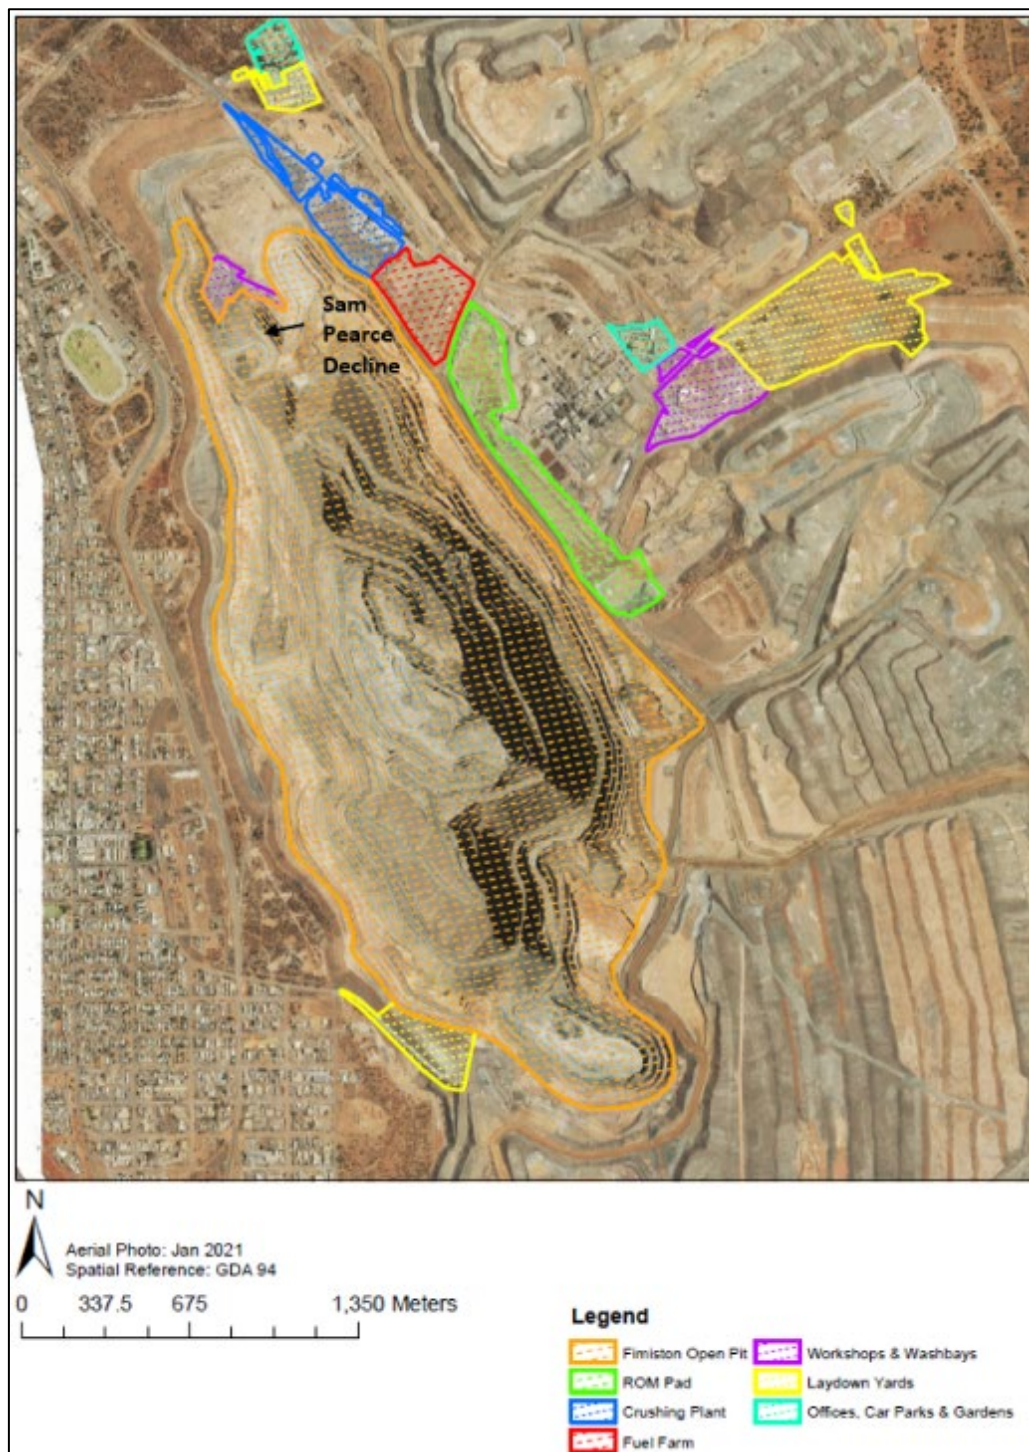
Infrastructure specifically related to mining activities at Fimiston has been grouped within this Domain (Figure 5-18).

Figure 5-18: Fimiston Mining Infrastructure including Fimiston Open Pit and Sam Pearce Decline (current)

Mining laydown areas (Figure 5-18) include a laydown area associated with the open pits mining maintenance contractor workshops, laydowns associated with Sam Pearce support facilities and the open pits haul truck hard stand area. Smaller laydown areas are located around the Fimiston Operational Area, which are actively used for storage of equipment that may be used or required in the future.

Mineral Processing laydown areas (Figure 5-18) include a laydown area associated with the maintenance workshops and are actively used for storage of equipment.

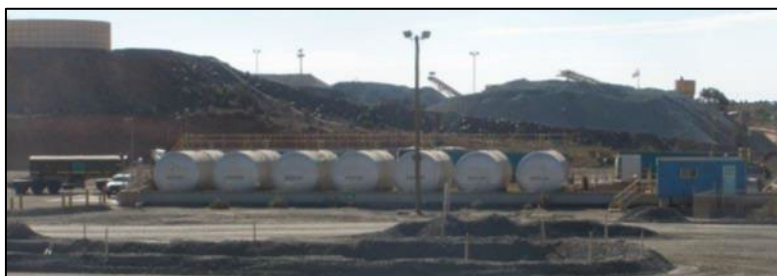
The Fimiston Mining Fuel Farm (Figure 5-21) consists of seven 110,000 litre tanks in a bunded area with a concrete apron for the refuelling of light vehicles, trucks, and ancillary equipment. The area is located north of the Fimiston Plant, adjacent to Black Street.

Figure 5-21: Fimiston Mining Fuel Farm

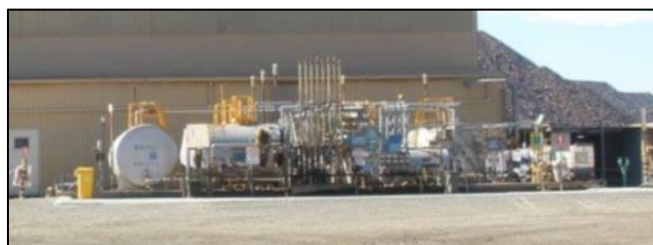
The Mining Maintenance Workshops includes all contractor workshops at the Fimiston Operational Area (Figure 5-18), the majority of which are located to the southeast of the Fimiston Plant. Other small workshops are located at the Sam Pearce Decline, CSI crushing services and bulk explosives storage. The workshop areas are currently in active use and contain several hydrocarbon storage areas (Figure 5-22). The open pits contractor workshop area (AOC58) and the Sam Pearce support facilities area (AOC69) have been reported to the DWER as potentially contaminated sites.

Figure 5-22: Fimiston Mining Maintenance Workshops Main Hydrocarbon Area

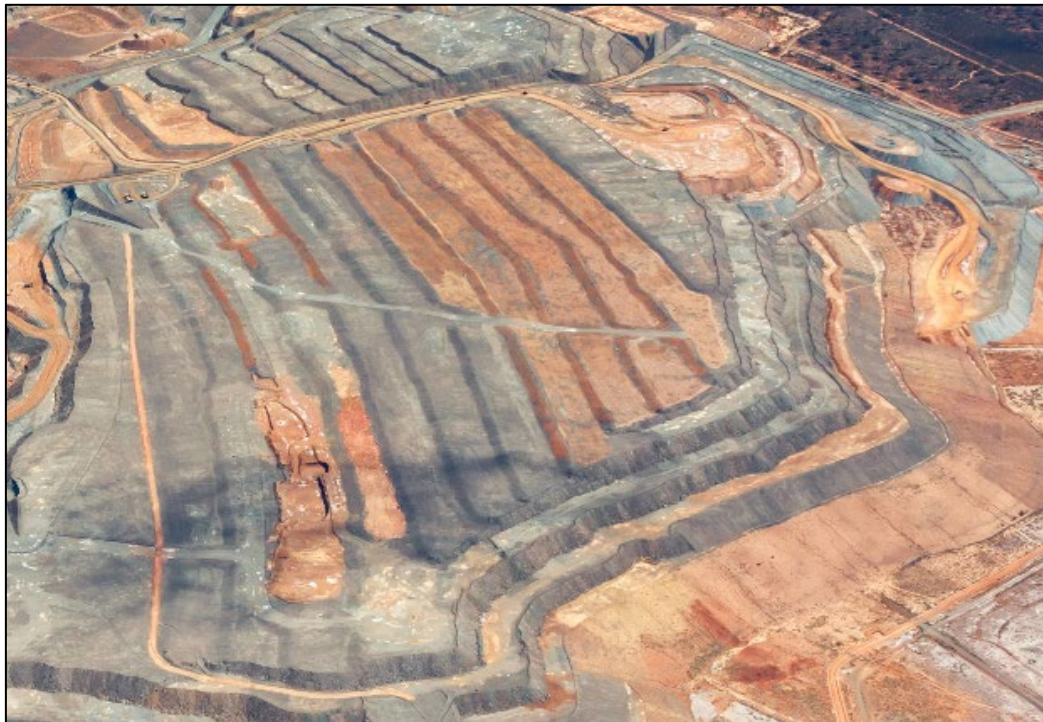
Rehabilitation of the Trafalgar 5 m lifts commenced in 2015 with rocky, shallow batters and very wide benches in alignment with the ‘erosion resistant’ design (Figure 5-28). Material placement has been guided by the Visual Amenity rating of the location, with better rehabilitation materials used on the western facing “highly visual” slopes. Oxide has been used on the “non visible” benches (flat areas). As this material is saline it will take time to leach to become a

Figure 5-28: 5 m Lift Rehabilitation (2021)

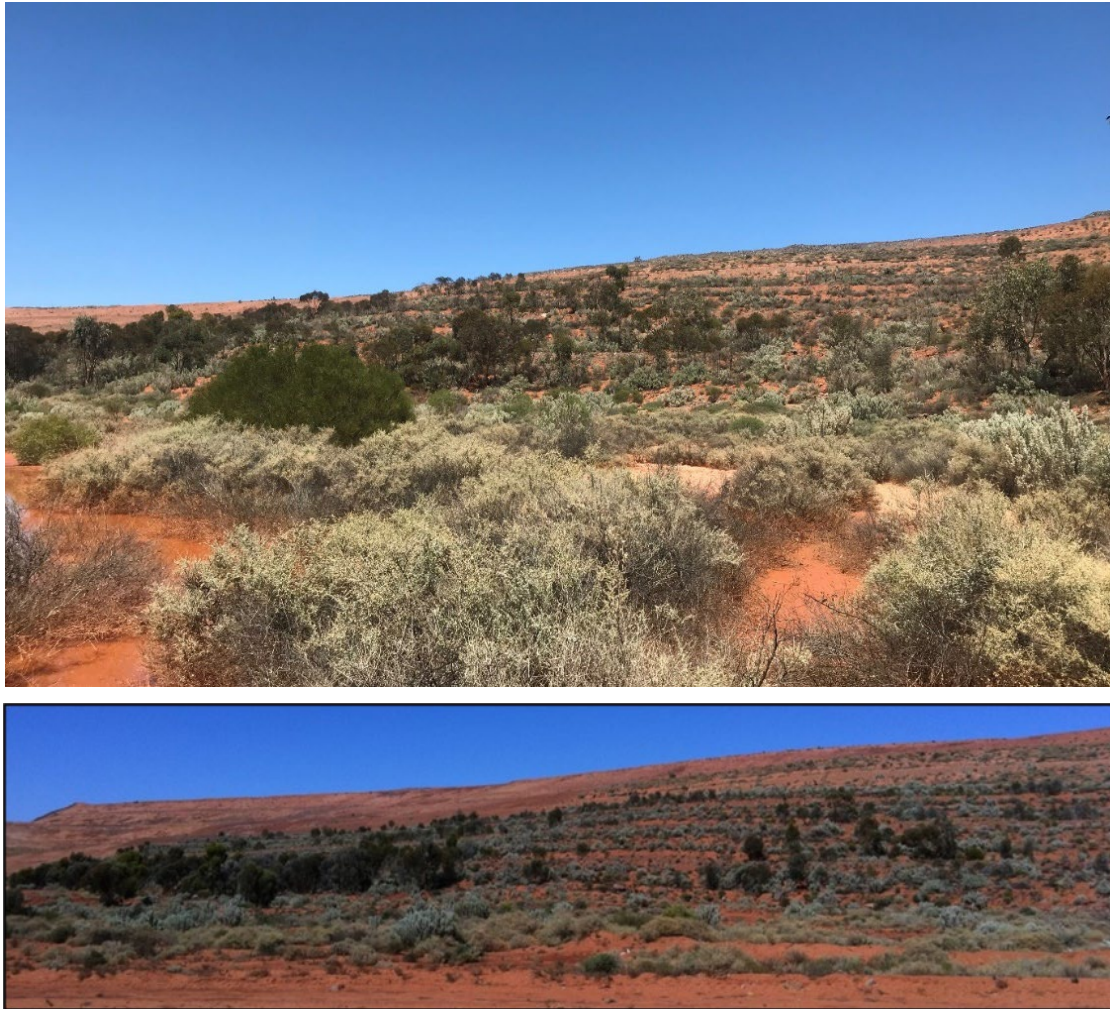
A section of the bottom lift of the eastern batters of the Oroya WRD (Figure 5-32) was rehabilitated in 1998 by pushing the slopes down to 14°, sheeting with growth medium, deep ripping and cutting in narrow back sloping contour berms. Seeding was undertaken at 10 kg/ha with application of Agras 1 fertiliser at 100 kg/ha, with different seed mixes applied to the lower, middle and upper parts of all slopes. In recent years, vegetation in this area is showing stress due to high average annual temperatures and several years of low annual rainfall (as discussed in Section 5.1.1).

Figure 5-32: 1998 Rehabilitation – southern lower lift (2013 below and 2021 above)

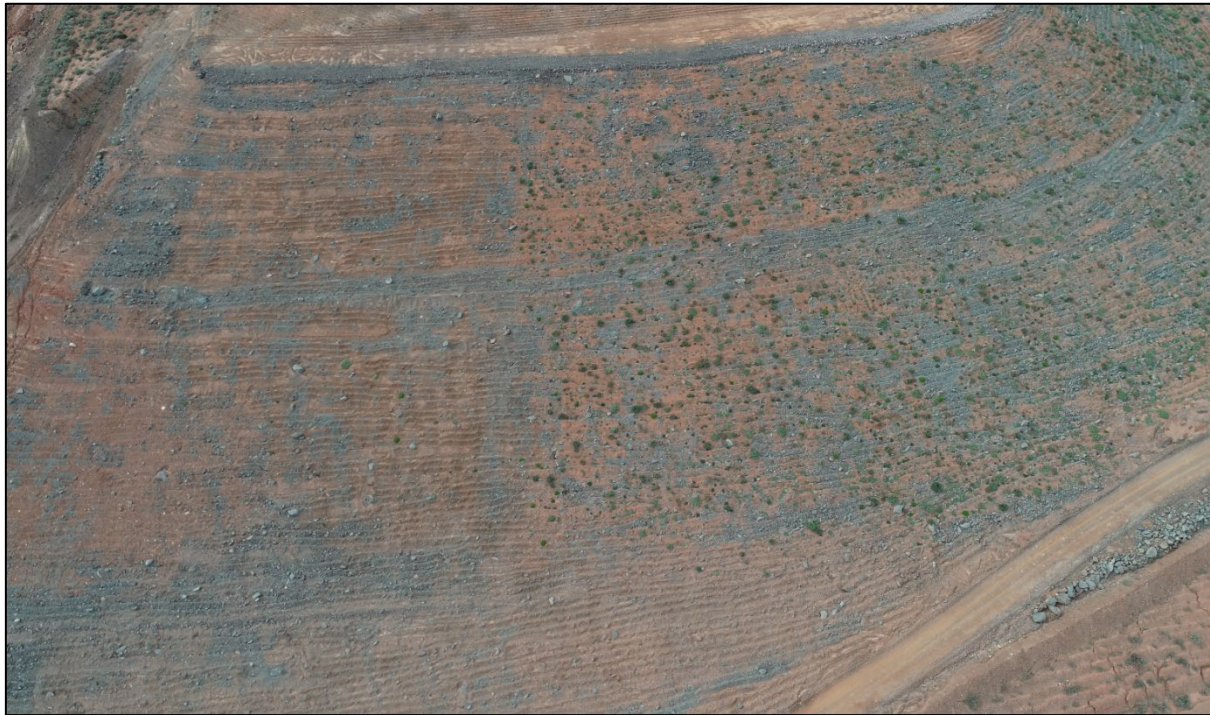
Figure 5-35: Radio Hill (2019) after remedial works
 (note vegetation difference between Class D (left) and Class A (right) soils)

Due to the medium visual amenity rating of the area, and potential relocation of the Public Lookout, remedial works were implemented on the WRD in 2017/8 (Figure 5-34). The WRD has been recontoured, sheeted with a layer of waste rock, and had growth media reapplied. A robust rocky crest bund and back sloping rock crest area, to prevent tunnel erosion through the upper oxides, also forms part of the design. The area was rehabilitated again in 2017/8, with a rock capping placed over the oxide waste and subsequent replacement of original Class D topsoil. Additional Class A topsoil was brought in to supplement the works. Significantly improved regrowth has occurred on the Class A soils compared to the Class D soils, highlighting the difference in soil properties (Figure 5-35).

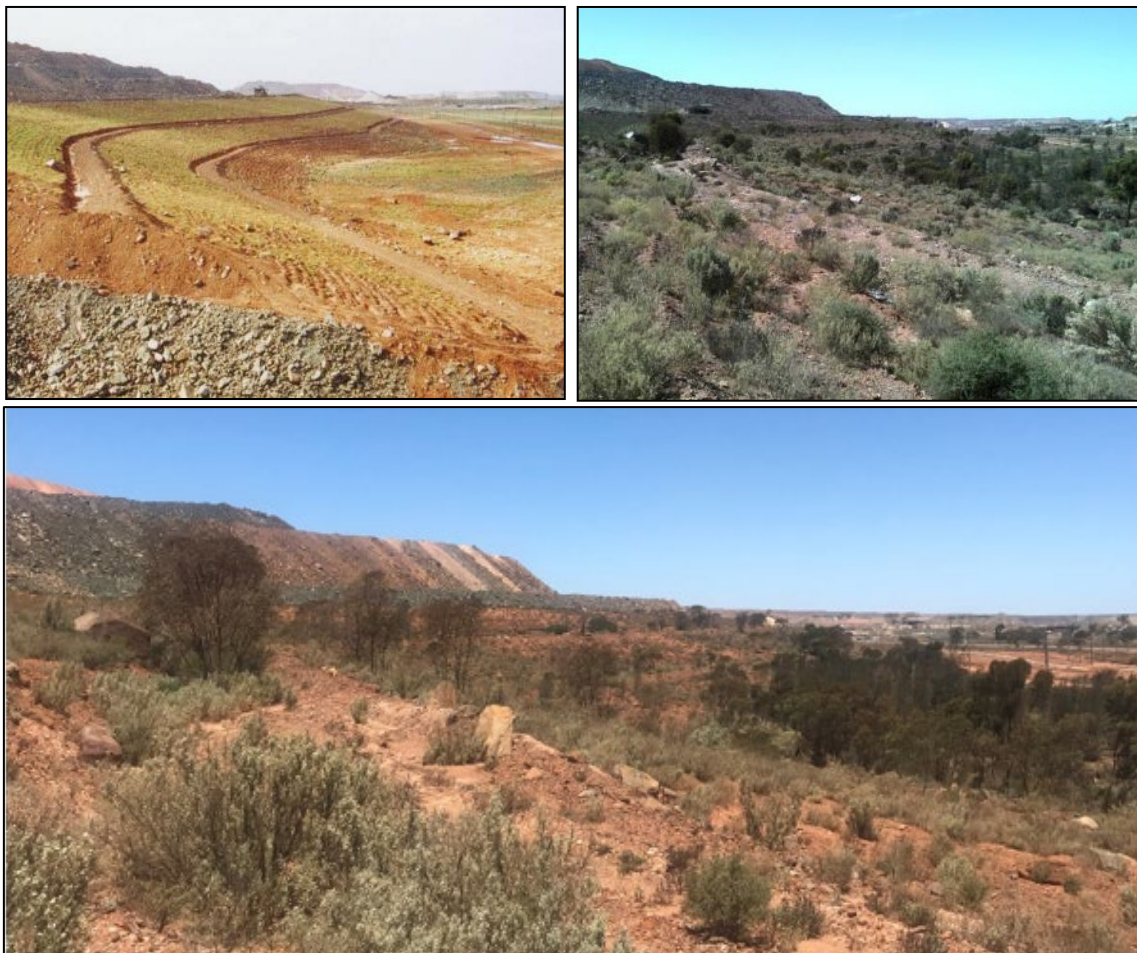
The north western slopes, located immediately north of the Black Street trials, were rehabilitated in 1998 (**Error! Reference source not found.**). Visual observations indicate that this area appears to be performing well vegetatively, with minor erosion present. Overall, KCGM does not consider this area to be a high risk in terms of poor rehabilitation performance.

Figure 5-39: North Eastern WRD Black Street Rehab 1998 (left), 2013 (right), and 2021 (below)

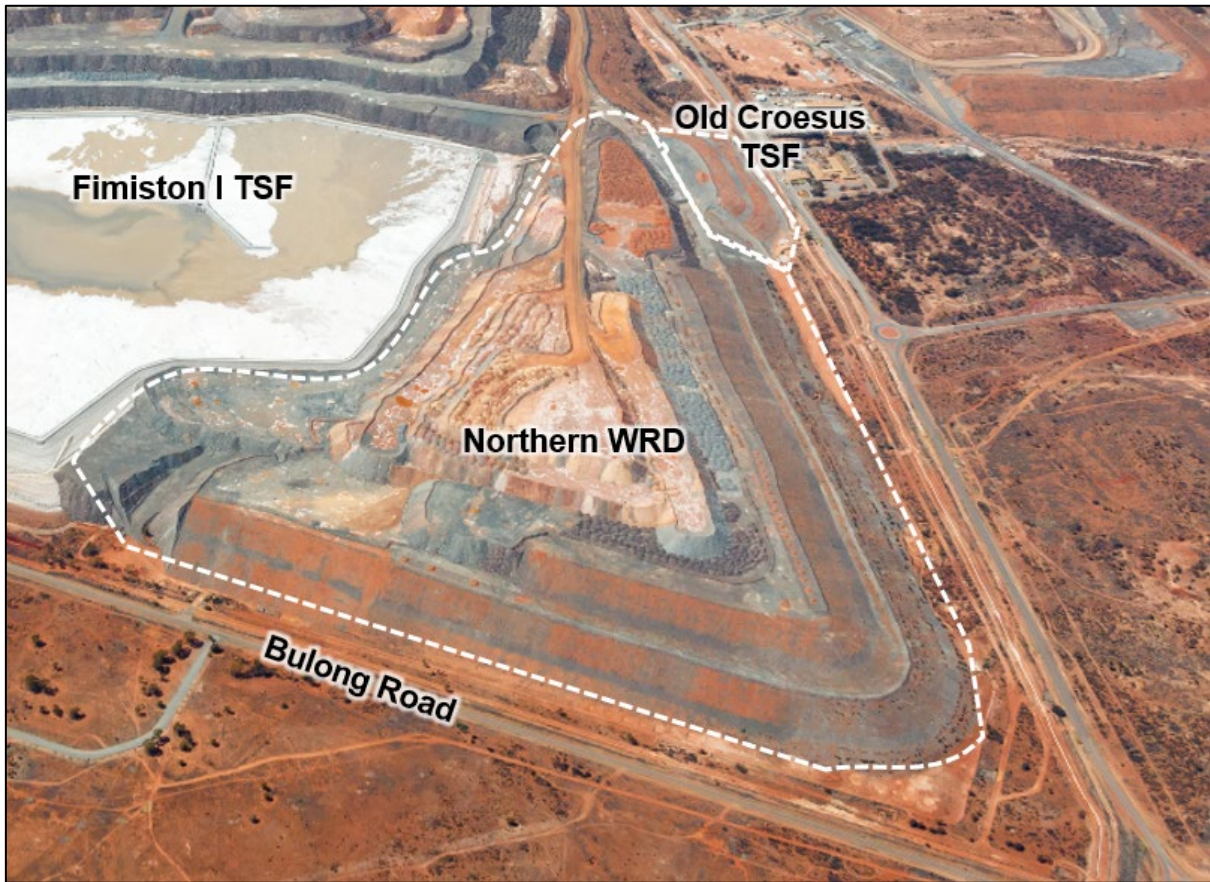
Figure 5-42: Northern WRD Viewed from the North (2021)

The erosion resistant design was successfully trialled on this WRD. The design consists of 16° -17° slopes with 10-15 m wide berms, and a high percentage rock cover. Extensive technical work supports this design.

BF shale waste material is co-disposed with waste rock within the Northern WRD, with a buffer of 40 m for high ANC dolerite/basalt on the external faces of the dump and capping of 5 m of benign material on the final upper surfaces of the dump.

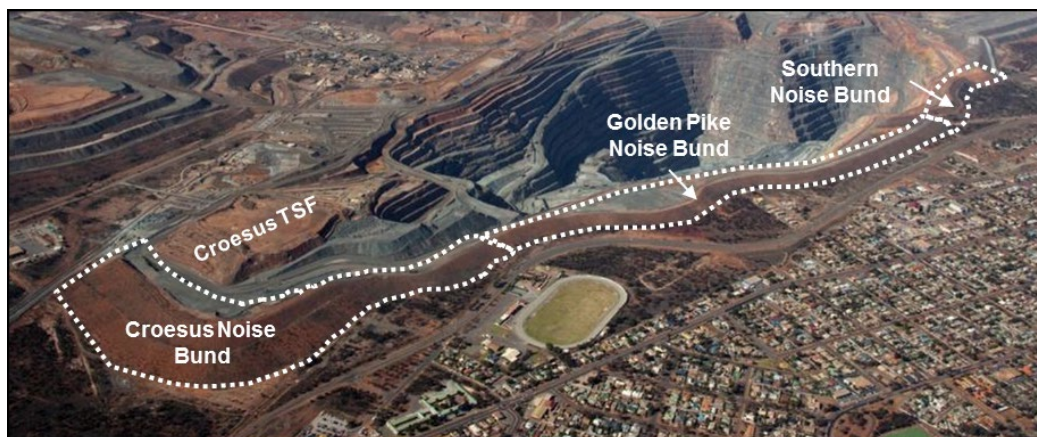
Figure 5-47: Environmental Noise Bund

Located on the western side of the Fimiston Open Pit, the Environmental Noise Bund has been constructed from competent waste rock (with small oxide areas) to reduce noise carried across the town from mining and processing activities. It will be retained post closure to assist with noise impact to the City of Kalgoorlie-Boulder. The ENB has three distinct sections (Figure 5-47):

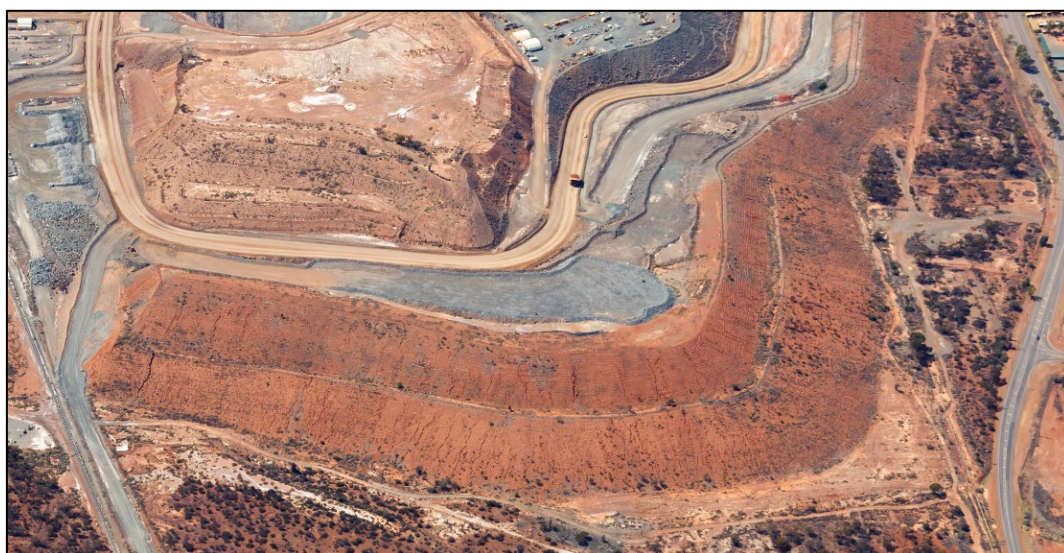
Figure 5-48: Croesus Noise Bund (2021)

The Croesus NB (Figure 5-48) is located at the north-western corner of the Fimiston Open Pit and is Highly Visible from the Goldfields Highway. The Croesus NB partially encapsulates the Croesus processing plant footprint (decommissioned in 1997).

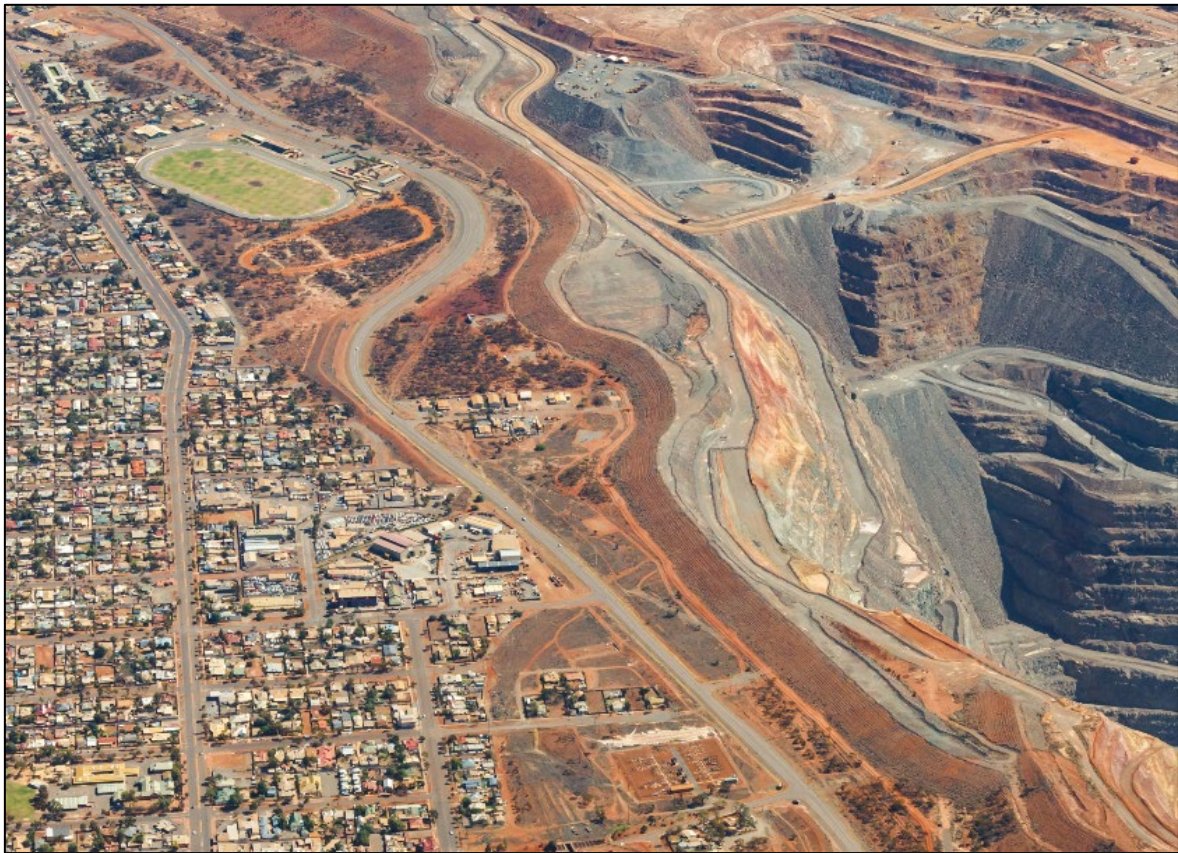
Figure 5-49: Golden Pike Noise Bund (2021)

The Golden Pike Noise Bund (Figure 5-49) was constructed to replace the original noise bund that was to be mined through during the Golden Pike Cutback. It is constructed from waste rock (predominately dolerite and basalt) and, in some areas, oxide material. It is a single lift and ranges in height from 14-17 m. In 2017 a wall remediation project in Fimiston Open Pit resulted in a narrowing of the width of the Golden Pike NB footprint in the vicinity of the project, with no change to the western side of the NB.

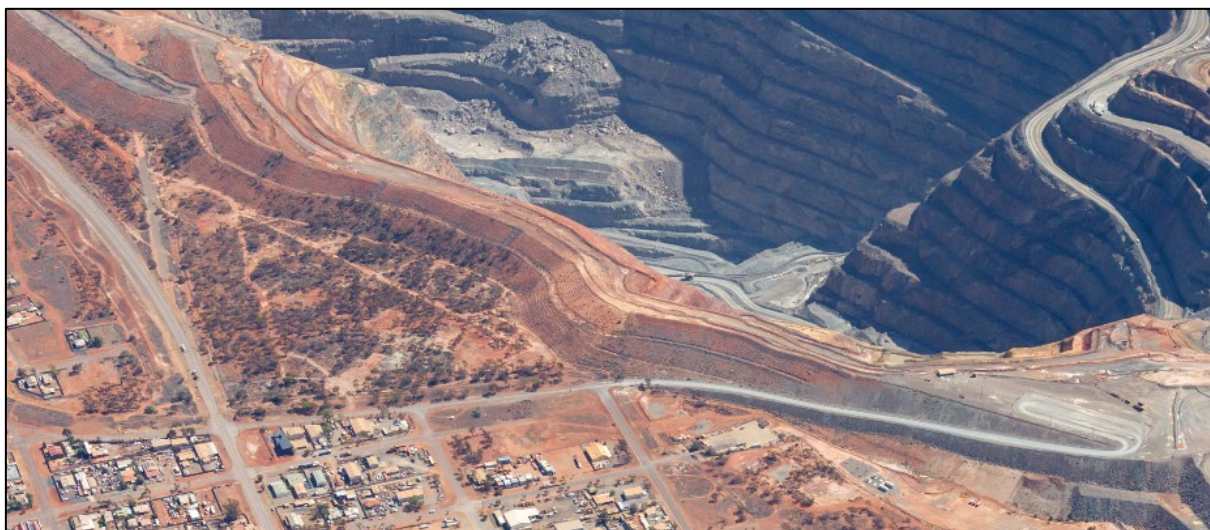
Figure 5-50: Southern Noise Bund (2021)

The Southern NB (Figure 5-50) was initially constructed in 1991 with one 15 m lower lift and 10 m upper lift in waste rock and oxide, and rehabilitated in 1995/1996. The southern section was constructed in 2003 from oxide and rehabilitated shortly after.

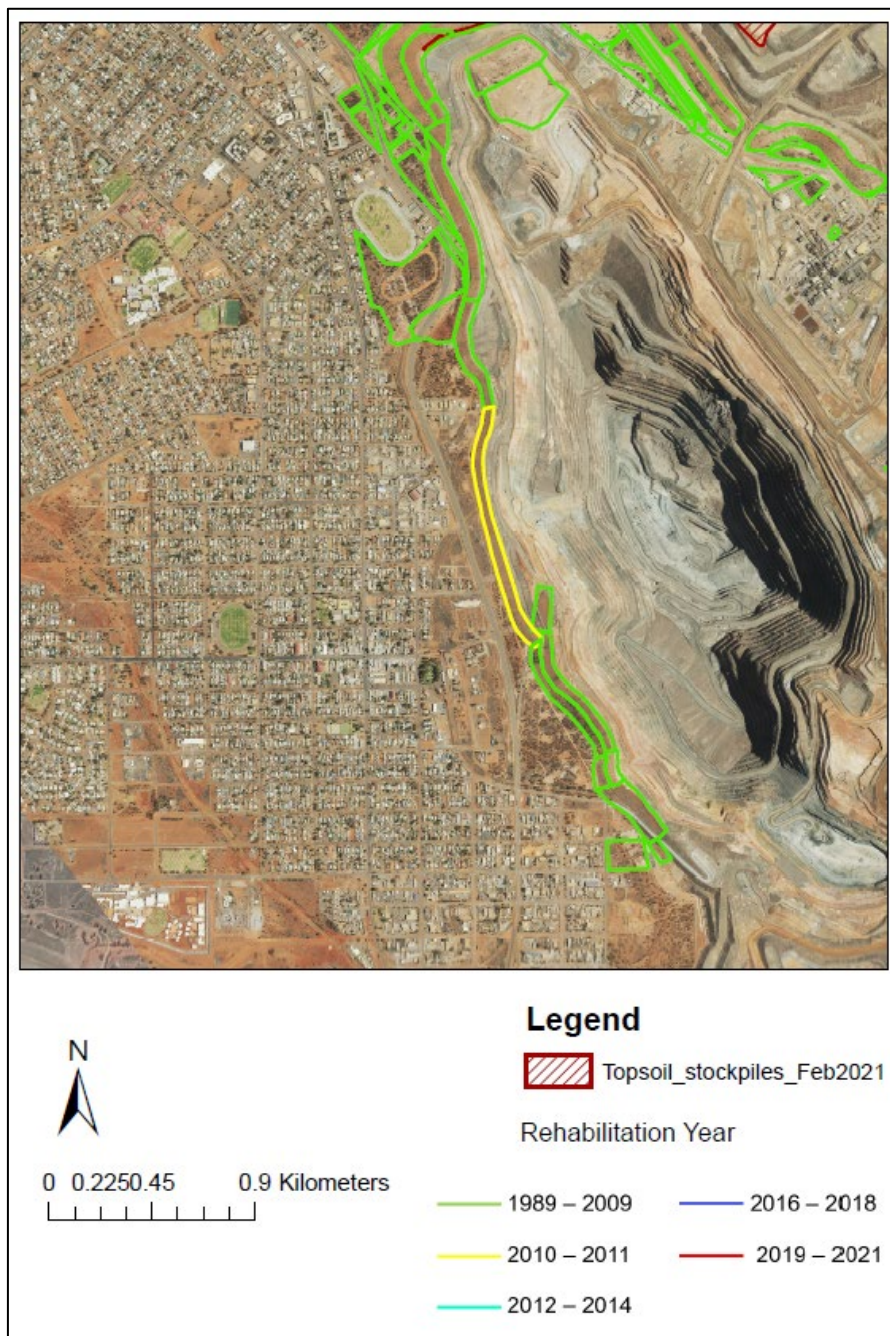
Figure 5-51: Environmental Noise Bund Current Rehabilitation Status (2021)

All sections of the Noise Bund have been rehabilitated, with techniques reflecting rehabilitation philosophy at the time of construction.

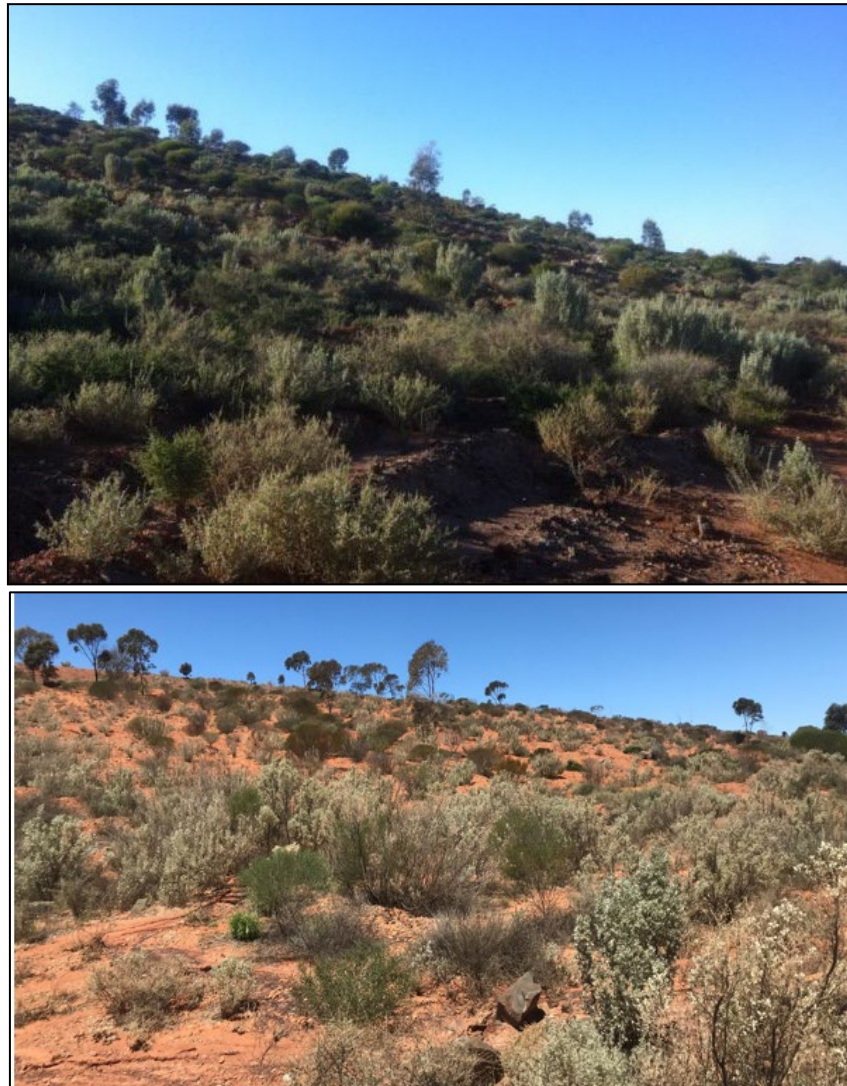
Figure 5-52: Croesus Noise Bund Lower Lift, Western Side 2013 (top) and 2021 (bottom)

Visual observations during 2012 to 2014 have highlighted vegetation success on the lower lifts. Vegetation monitoring conducted in 2014 indicated that this landform has achieved 'satisfactory' rehabilitation success, although there were marked differences in some measures between transects. Erosion monitoring of this landform in 2014 showed actively eroding gullies, most likely due to the remaining thickness of the topsoil in some areas and the low percentage rock cover on the surface.

The lower lift of the west facing northern section of the Croesus Noise Bund was rehabilitated in 2001. Rehabilitation material was applied over the oxide/hard rock material. The area was ripped, hydro-mulched and seeded. Repair work was completed on several gullies on the west facing slopes in 2003, but erosion has reformed.

In 2009, the southern section of the first lift of this waste dump was re-graded to approximately 20°, sheeted with 300 mm of rehabilitation material and seeded by hand.

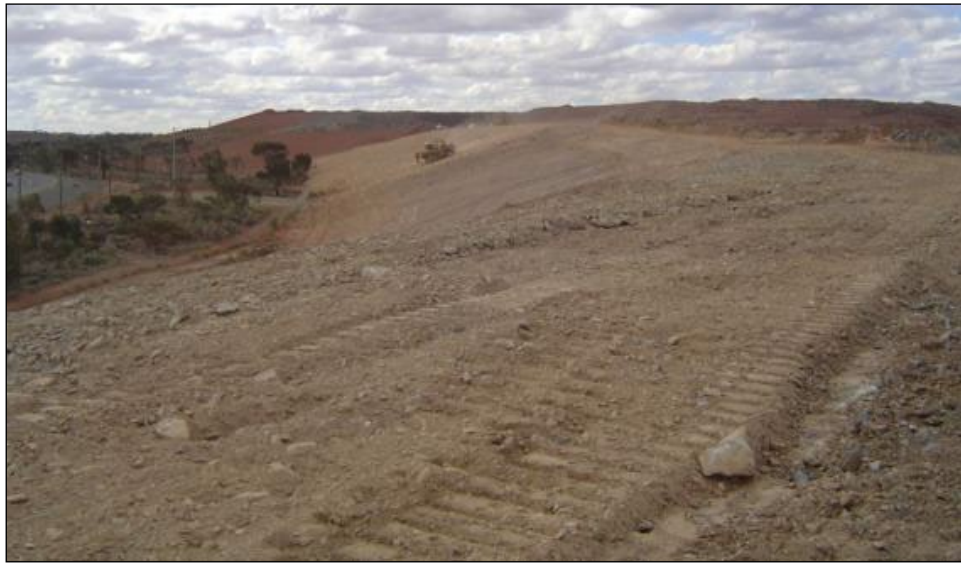
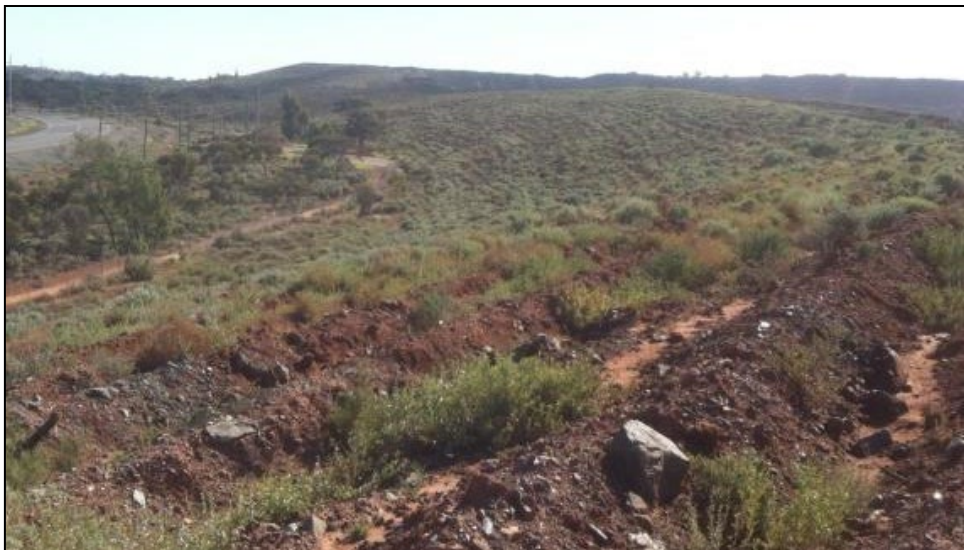
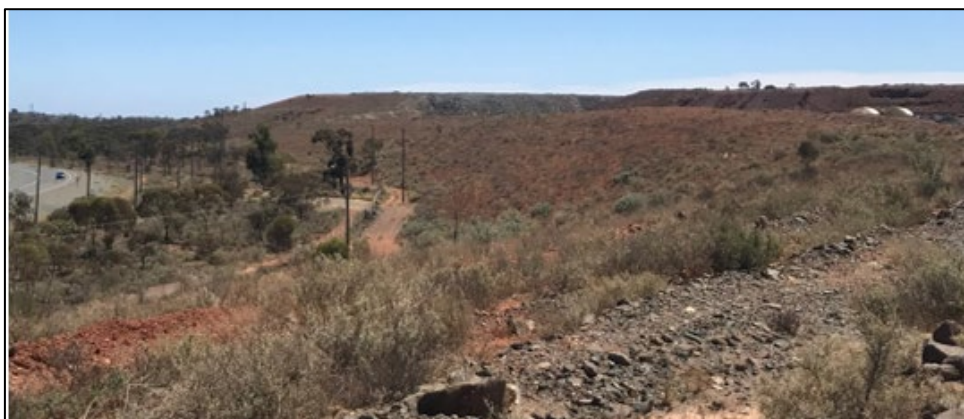
Figure 5-53: Golden Pike Noise Bund

Rehabilitation occurred from 2011 and 2012, consisting of re-grading to 18-20°, sheeting with 300 mm of rehabilitation material (stripped from the Golden Pike Cutback and Northern WRD footprint) and deep contour ripping and seeding with the KCGM pioneer seed mix.

Visual observations from 2012 have noted good recruitment of lower storey species and minimal erosion (Figure 5-53). There is a small section of gullying which developed following large rainfall events in early 2013 where insufficient water control on the dump top led to ponding against the crest bund, with eventual failure of the bund. Due to the depth of material placement, gullying depth is limited by underlying waste rock and is unlikely to continue to deepen.

(Top: Battering 2011. Middle: 2013 Progress of rehabilitation Bottom: 2021)

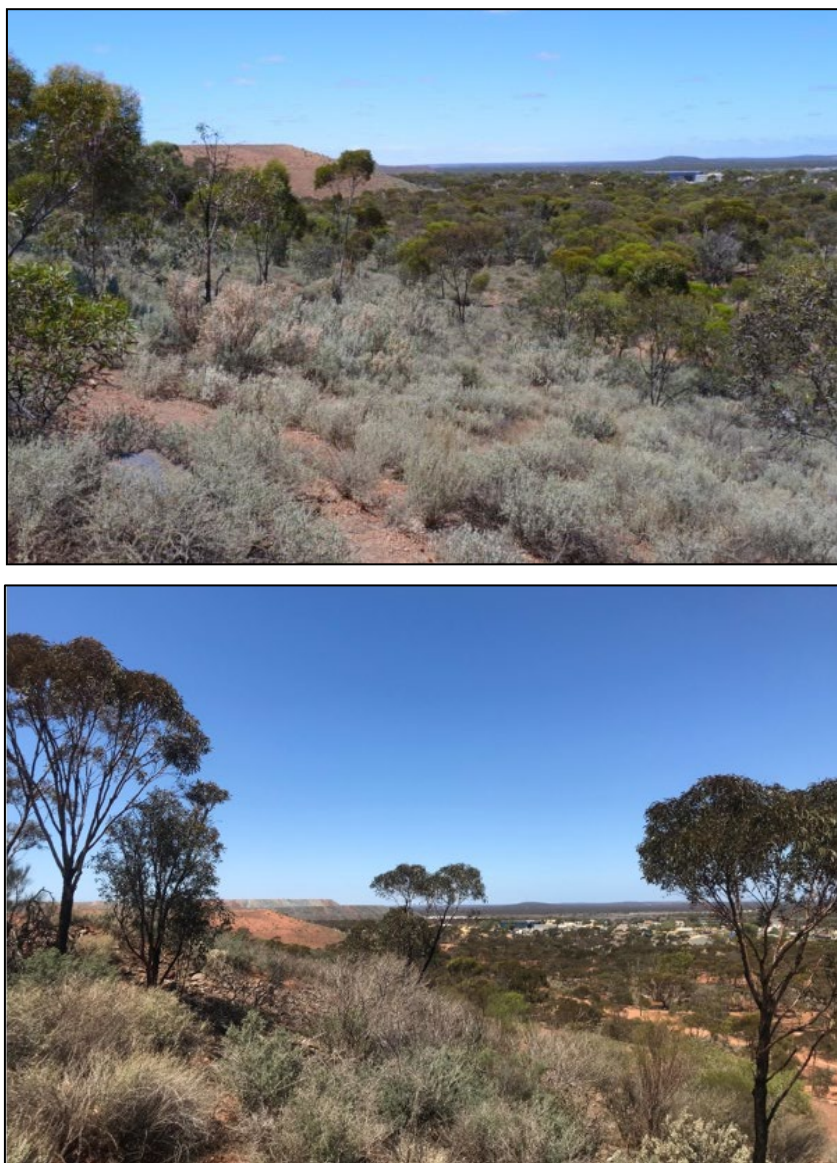
Figure 5-54: Southern Noise Bund Lower Lift Status of Rehabilitation 2013 (top) and 2021(bottom)

Visual observations from 2012 have indicated that the lower lift has excellent vegetation condition with high diversity, all three strata and several species indicating the community has attained some level of resilience (Figure 5-54). The upper lift is not performing as well, with limited species diversity and cover, possibly due to quality of rehabilitation material used. Some gullying has been observed in the northern section within rock drains, although this appears to be self-armouring.

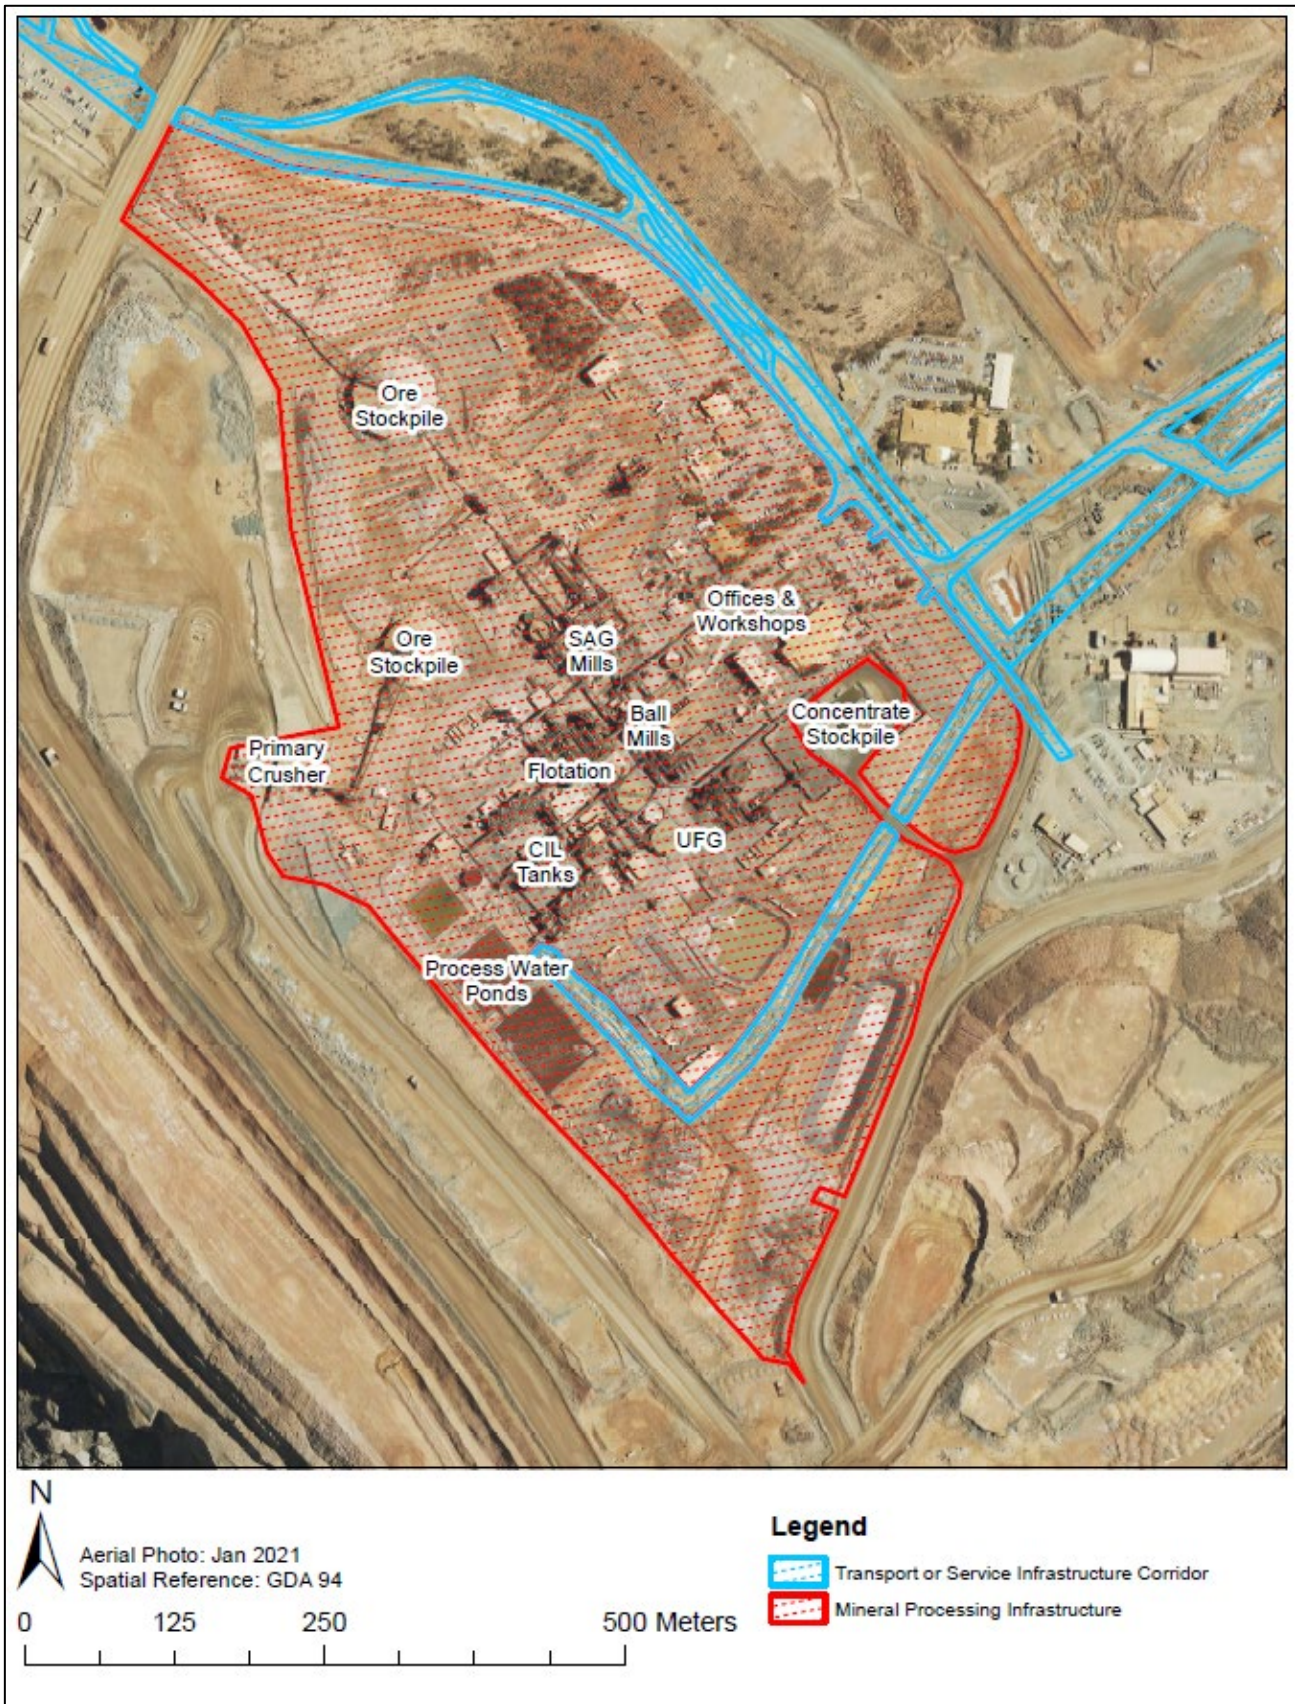
Figure 5-56: Fimiston Processing Plant

In the flotation circuit, the gold bearing refractory sulphide is separated and referred to as concentrate. The concentrate is de-slimed (removal of the very fine fraction), with the slimes then leached to recover the contained gold at the Fimiston Plant. The coarse fraction is then separated into two streams. Currently, one stream is washed, filtered, and transferred to the Gidji Processing Plant for further processing. The other stream is directed to a UFG circuit at Fimiston. The UFG reduces the particle size of the concentrate to expose enough gold surfaces to facilitate cyanide leach recoveries. After grinding, it joins the slimes to be leached at the Fimiston Plant in the two cyanide CIL adsorption circuits where the gold is extracted. The Fimiston Plant also comprises elution, electrowinning circuits and facilities for smelting, pouring and production of gold bullion.

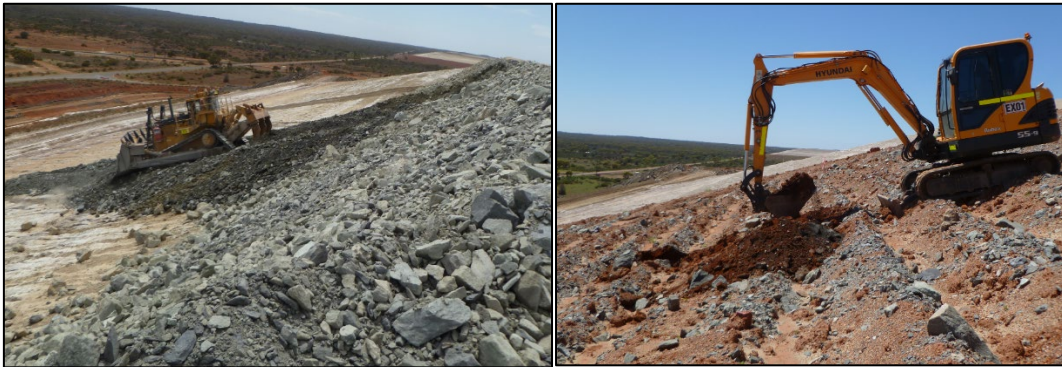
Figure 5-61: Fimiston I TSF Trial Earthworks in Progress (2016 and 2017)

A trial of the proposed Fimiston TSF rehabilitation design was undertaken on a 1 ha area on the northern flank during late 2016 into early 2017. Objectives of the trial were to conduct earthworks to identify the optimum equipment and methodology for implementation, including slope preparation. Three plots were constructed, with varying cover thicknesses, trialling a modified version of the erosion resistant cover design successfully used on the Fimiston WRDs. Investigations also included the selection of suitable capping material from the adjacent WRD. After completion of the earthworks, excavations were done to inspect the profile of the cover. This information was fed into implementation planning for Fimiston II TSF rehabilitation works, which commenced in 2019.

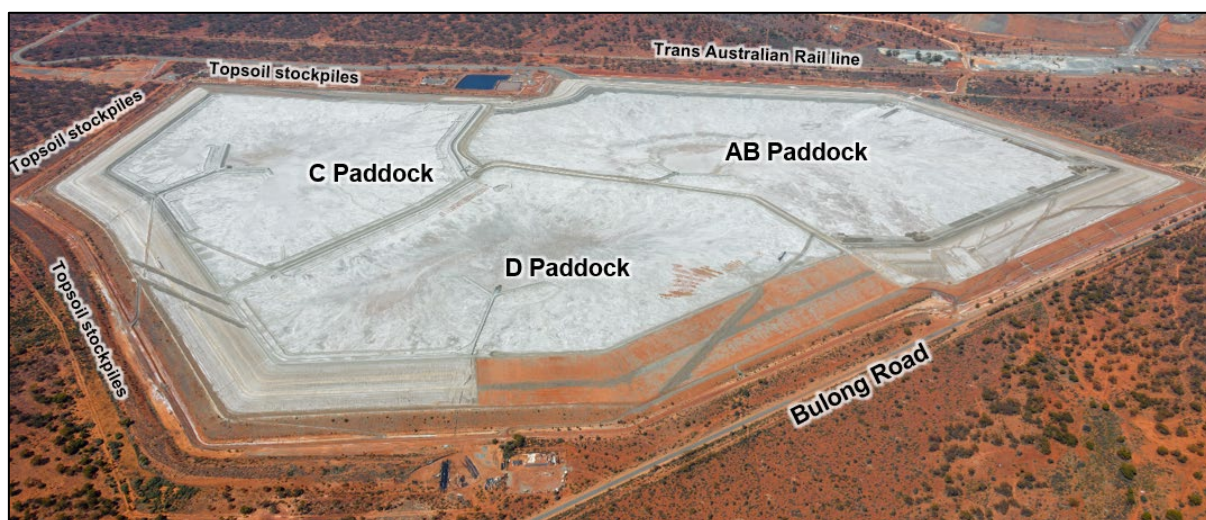
Figure 5-65: Fimiston II TSF, before buttressing (2021)

The Fimiston II TSF (Figure 5-65) covers a footprint area of 378 ha and is located to the east of the Trans-Australian Railway Corridor. A and B paddocks (now AB Paddock) were initially constructed in 1991/1992 and sub-aerial slurry discharge via multiple spigot discharge points around the perimeter and internal embankments commenced in 1992. The facility was expanded in 1994 and 1995 to incorporate C Paddock and D Paddock, respectively. The starter embankments were constructed from soils sourced from within the footprint. Subsequent upstream raise construction has utilised tailings sourced from within the TSF (Golder, 2013). Currently the TSF is approximately 50 m high and is planned to reach a height of 60 m, with embankments slopes of 14-18° (Figure 5-66 and Figure 5-67).
