KCGM

KCGM Mine Closure Plan 2025 (v1) Volume 1 of 3

J102 Golden Mile/KCGM (S0236564, S0236565, S0236563), J177 Kaltails

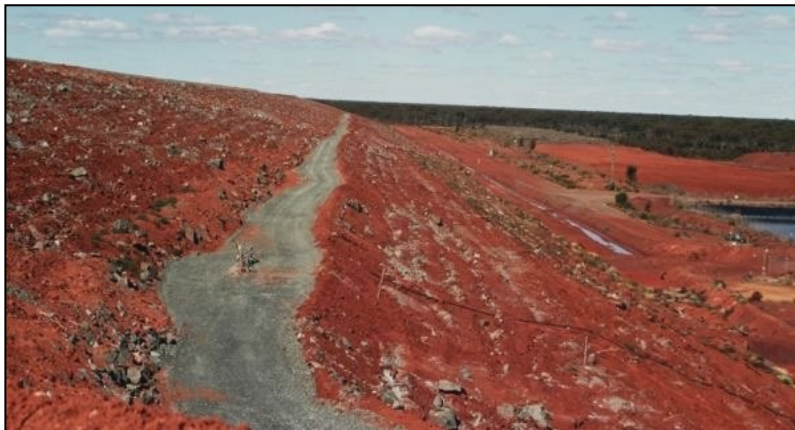
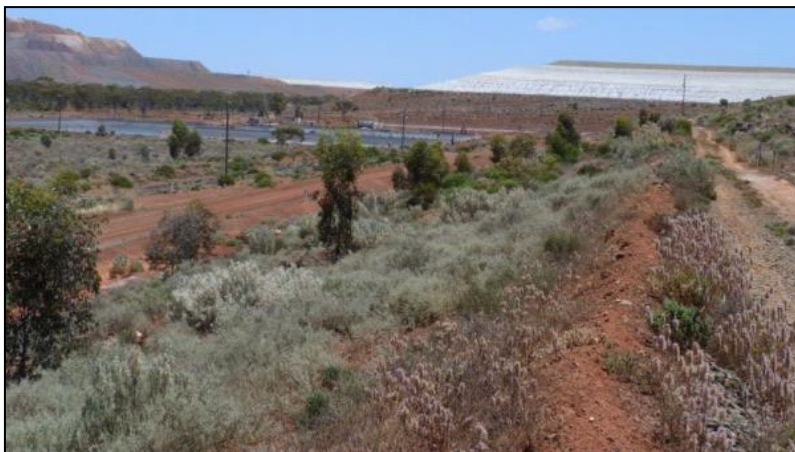
This area of rehabilitation was “On track, continue monitoring” during 2011 LFA monitoring (Outback Ecology, 2012a). All key indices of ecosystem function (stability index, erosion, and lower storey plant cover) were within the average regional range. Vegetation is predominantly chenopod shrubs with a limited overstorey of perennial species. Visual observations indicate that vegetation recruitment is reduced in northern areas, possibly as a result of the harsh aspect and significantly reduced rainfall in recent years. Visual observations from 2012-2014 indicate that the south western slopes, with a southern aspect, shows particularly good vegetation growth and appears to be relatively stable with minimal erosion (Figure 5-68).

Facing East 2004 (top). Facing North 2013 (middle) & 2021 (bottom)

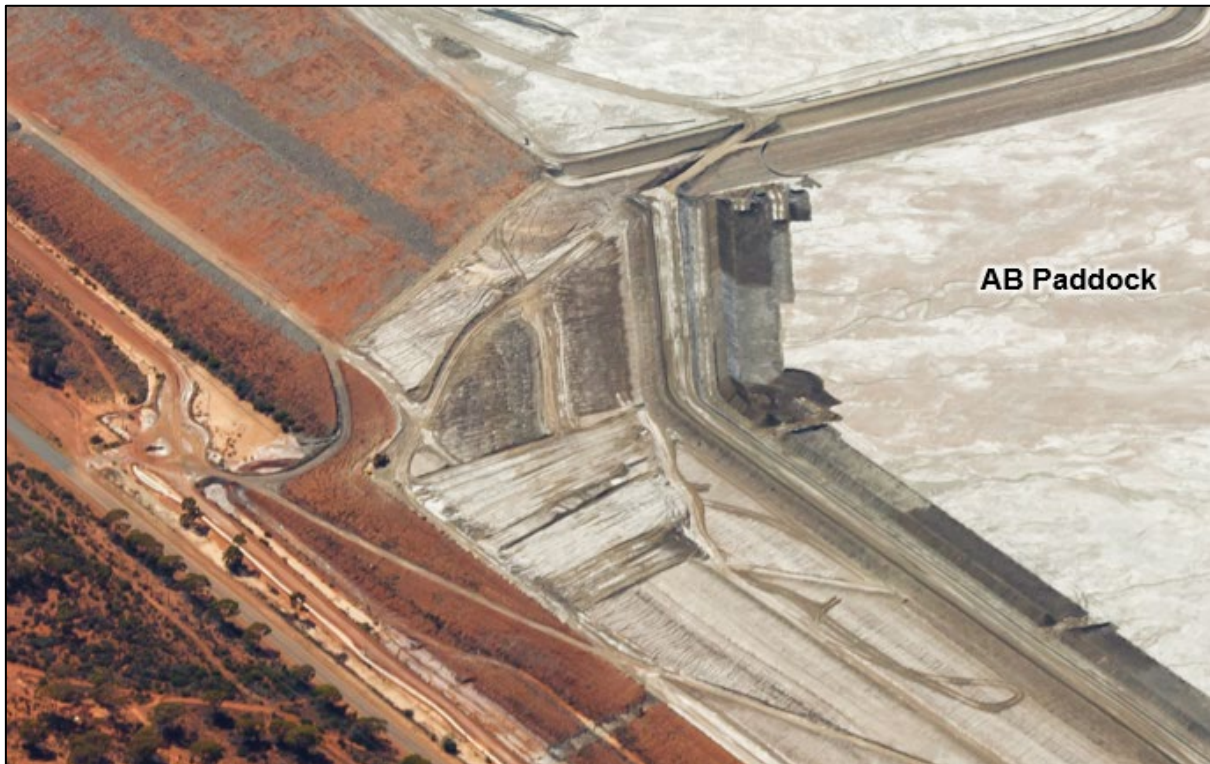
Figure 5-71: Fimiston II TSF 2021 commencement of reshaping of AB Paddock

Reshaping work commenced AB Paddock in 2021, starting with reshape of the north wall and progressing onto the west wall (Figure 5-71).

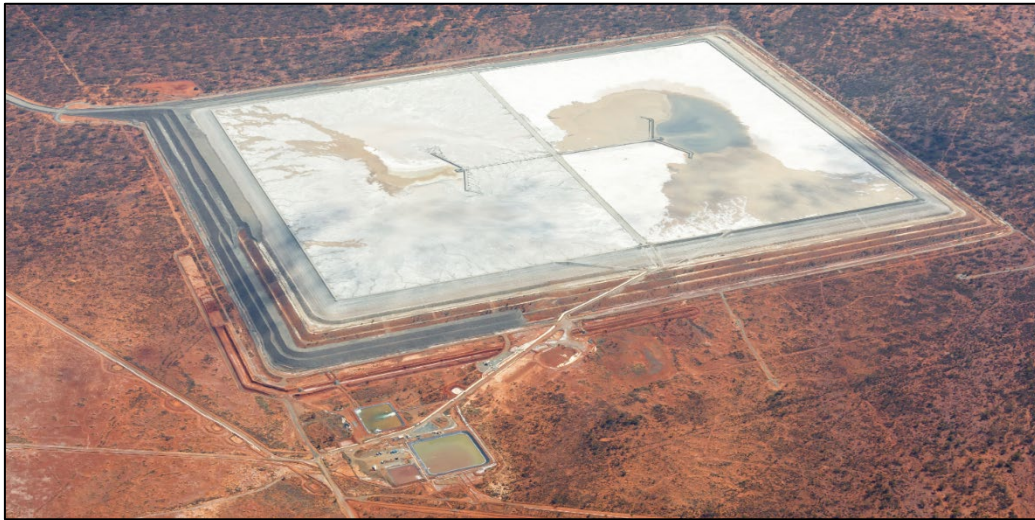
Figure 5-77: Kaltails with Buttress (2021)

During the period 2019 to 2020, a rock buttress was placed on the lower flanks for the Kaltails TSF to ensure geotechnical stability criteria will be met for future lifts (Figure 5-77). Since then the buttress has been extended several times and will continue to be enlarged while the TSF is operational. The entire lower outer slopes will be buttressed by closure.

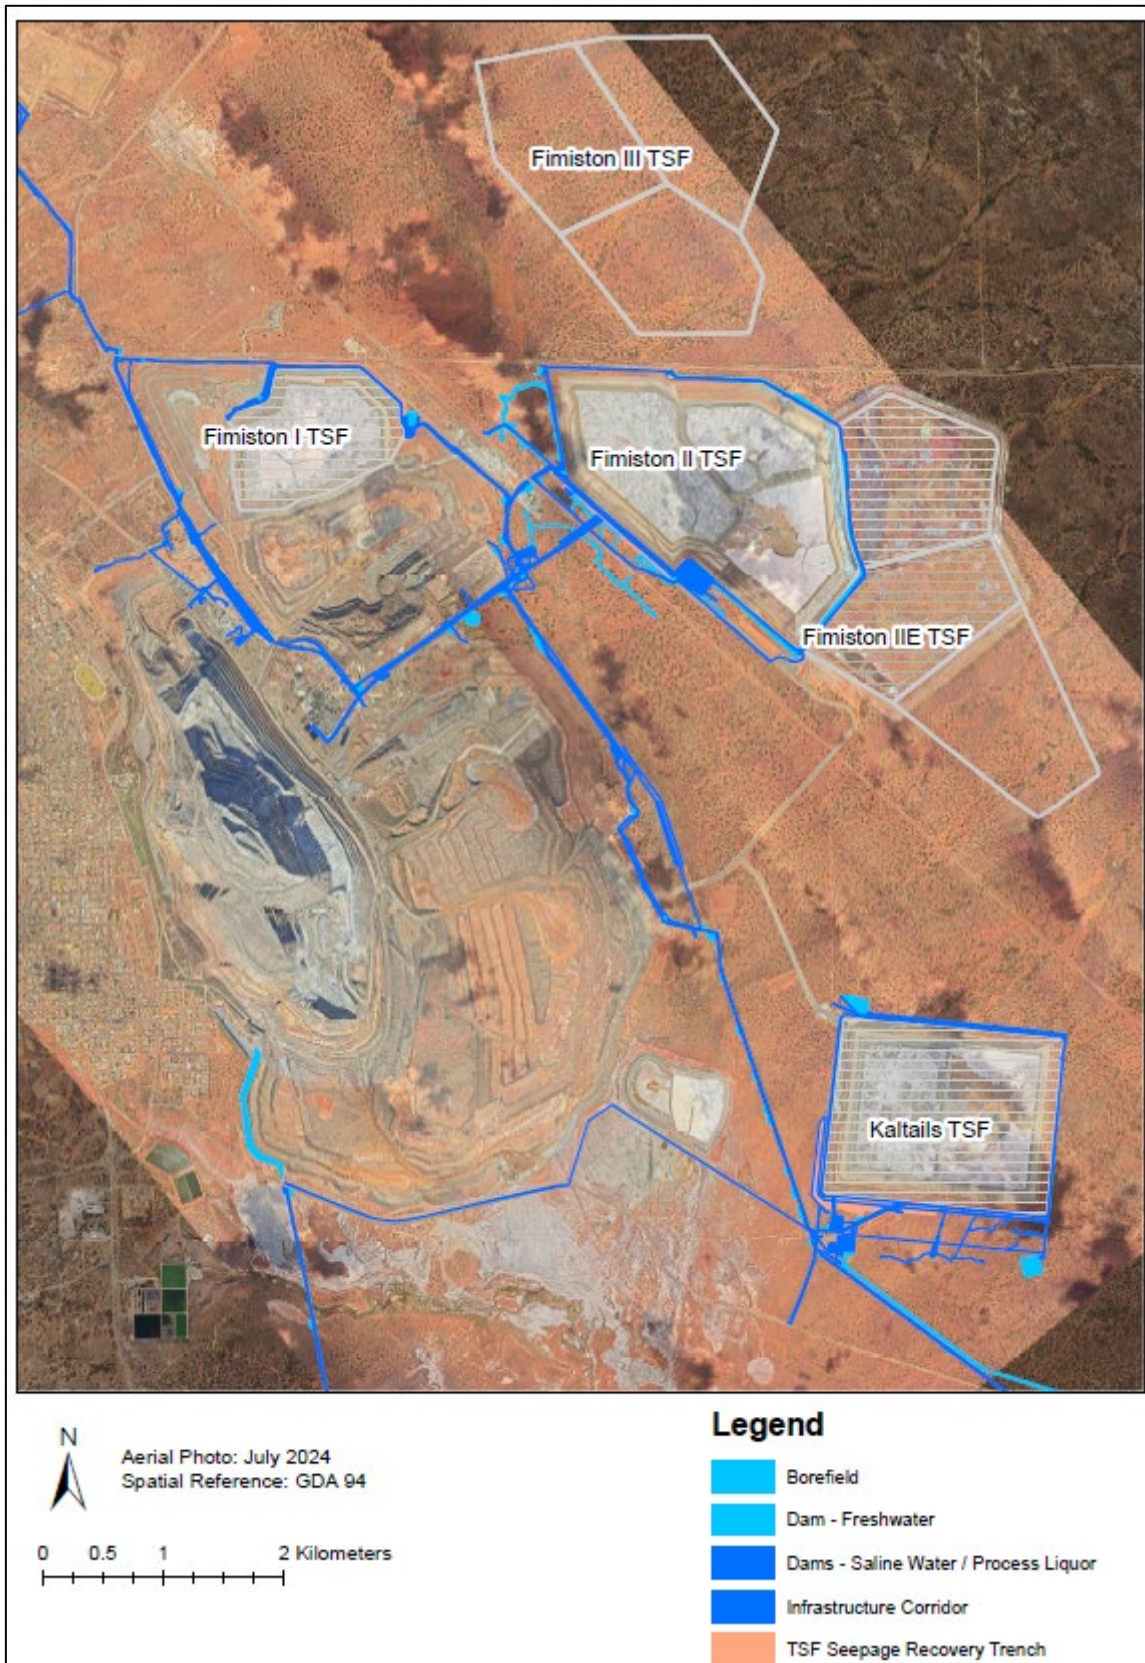
Figure 5-81: Water Containment Facilities Domain and Site Dams Feature

This feature consists of lined fresh and saline water dams, Fimiston seepage interception borefield (Eastern borefield, between Fimiston I and Fimiston II TSFs), Kaltails seepage interception borefield (Kaltails TSF borefield) and Trafalgar Production Borefield and associated bundled pipelines at the Fimiston Operational Area (Figure 5-81). The borefields have DWER licences. The site dams are used for fresh or saline water storage or management. All dams used for the storage of process and saline waters are lined. The saline water transfer ponds have been reported to the DWER as a potentially contaminated site (AOC88). Site dams will be progressively rehabilitated when they are no longer required (Figure 5-81).

The Fimiston Seepage and Groundwater Interception System (Figure 5-81) is located around the Fimiston I and Fimiston II TSFs and consists of production and monitoring bores (called the Eastern Borefield), trenches, pipelines and dams.

The Kaltails Seepage Interception System (Figure 5-81) is located around the Kaltails TSF and consists of production and monitor bores, trenches, pipelines and dams.

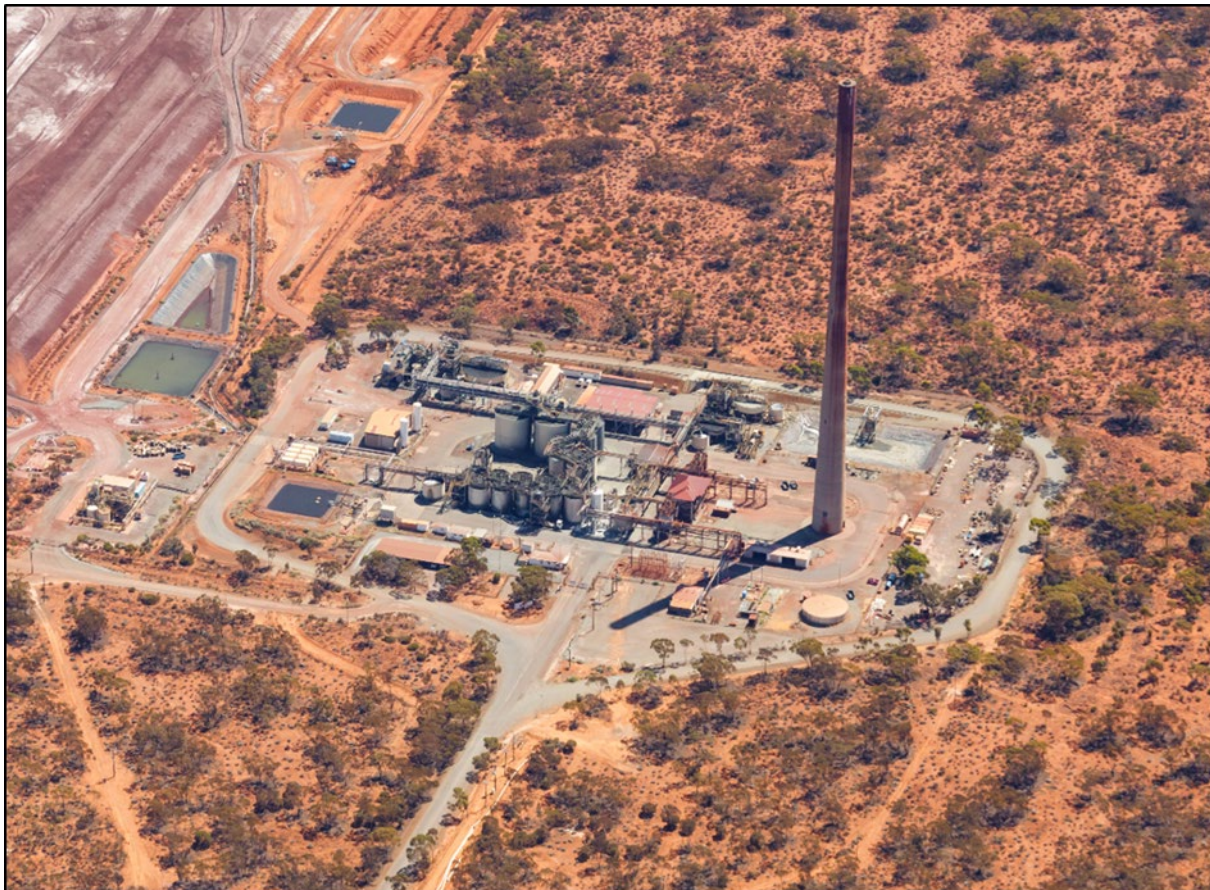
Figure 5-83: Gidji Processing Plant (2021)

The Gidji Processing Plant (Figure 5-83 and Figure 5-84) was commissioned in 1989 to treat concentrate from the Fimiston Plant. This provided the opportunity for the phased decommissioning of the remaining three in-town roasters and the establishment of a central roasting facility, Gidji, located 18 km north of the City. The facility covers approximately 5 ha. The Gidji Processing Plant is licenced for a throughput of 438,000 tpa of gold concentrate produced by the Fimiston Processing Plant.

Currently, gold-bearing concentrate produced in the Fimiston Processing Plant flotation circuit is trucked to Gidji Processing Plant for further processing via Ultra Fine Grind enabling more effective gold recovery. Tailings from the process are deposited at the Gidji TSFs located adjacent to the Gidji Processing Plant.

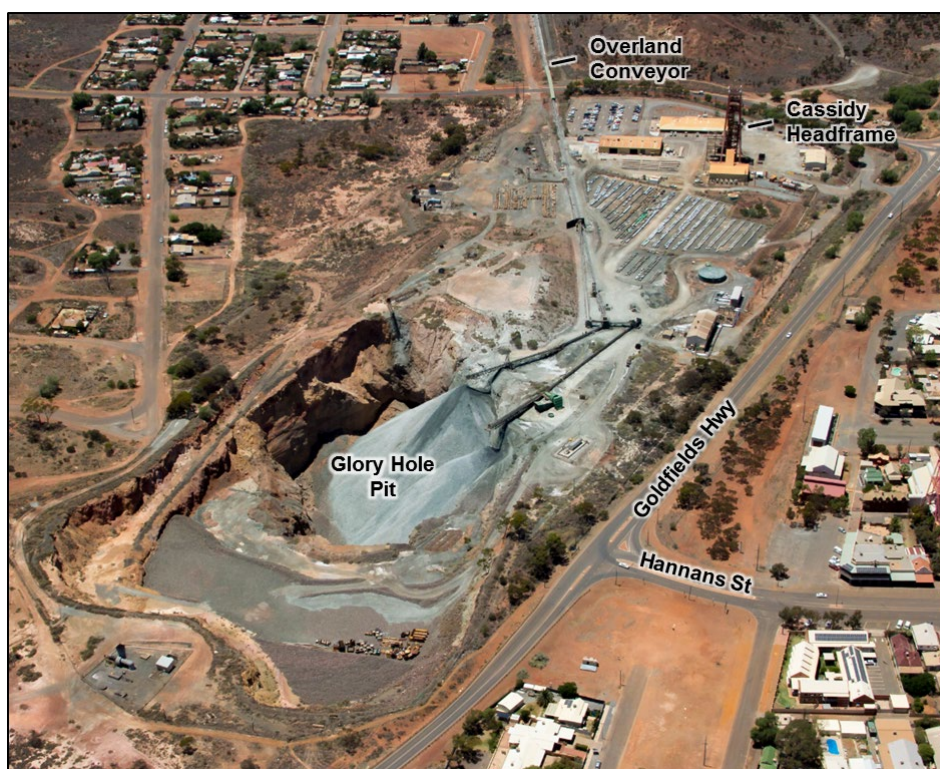
Figure 5-91: Mt Charlotte Mining Infrastructure

Mt Charlotte Mining Infrastructure includes (Figure 5-91):

- Glory Hole Pit;
- Underground Mine; and
- Surface Operations (including headframe, conveyor and core yard).

Mt Charlotte is expected to operate until 2025 (current LOM). The conveyor belt is expected to exist for some time after underground operations end, to finalise backfill of underground voids and buttressing of the MT Charlotte Open Pit.

The Mt Charlotte (Glory Hole) Pit is located immediately to the north of the Cassidy Headframe, located at the eastern end of Hannan Street (Figure 5-91). It covers an area of 5 ha, has a maximum depth of 64 m, maximum length of 350 m and maximum width of 200 m. When the Mt Charlotte E1 crown pillar present in the underground workings below the pit was removed in 1978, the Mt Charlotte Open Pit was joined with the underlying stopes of the Mt Charlotte Underground Mine. The volume of the open pit is estimated at 953,700 m³. Crushed rock from the Fimiston Open Pit is transported to the Mt Charlotte Pit via conveyor, with the Mt Charlotte Open Pit used as a conduit to feed the crushed rock to underground through a series of voids, where it is utilised for backfilling the underground stopes. The crushed rock stockpiles in the Mt Charlotte Open Pit are managed at maximum volume, to aid buttressing of the pit walls.

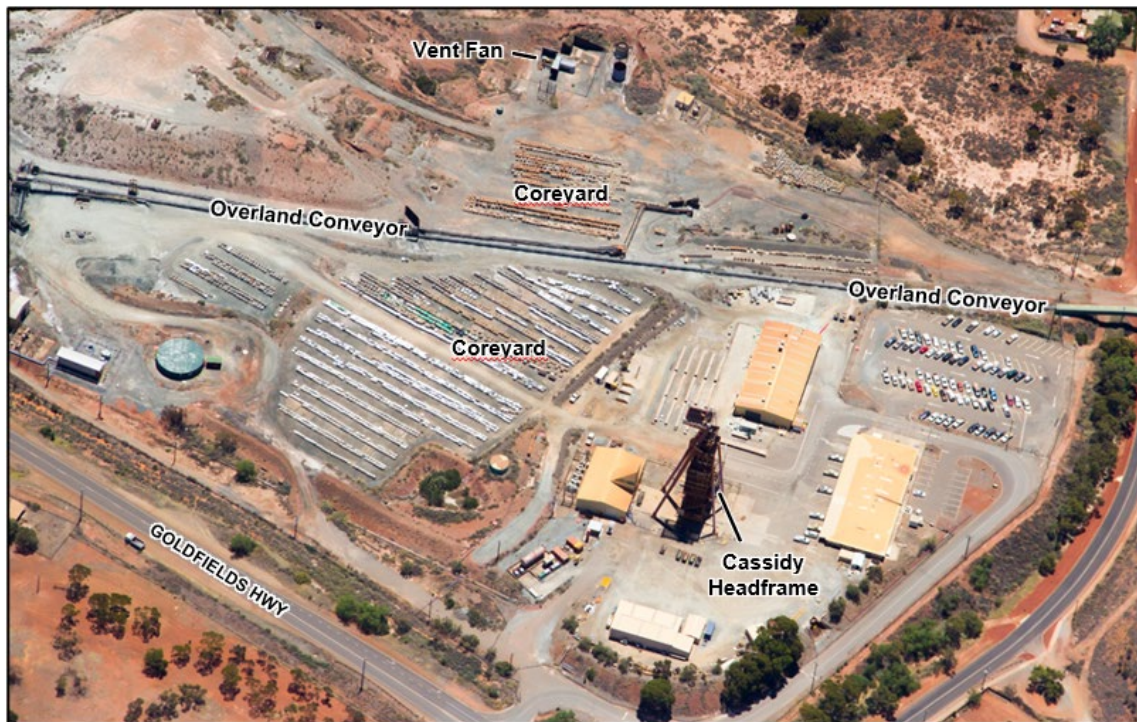
Figure 5-92: Mt Charlotte Surface Infrastructure

- Coreyards and shed;
- Cassidy Headframe and winder room; and
- Overland Conveyor.

Several sheds and disused offices (used when the headframe was the primary access point for the underground mine) also exist. Small workshops and hydrocarbon storage are also present.

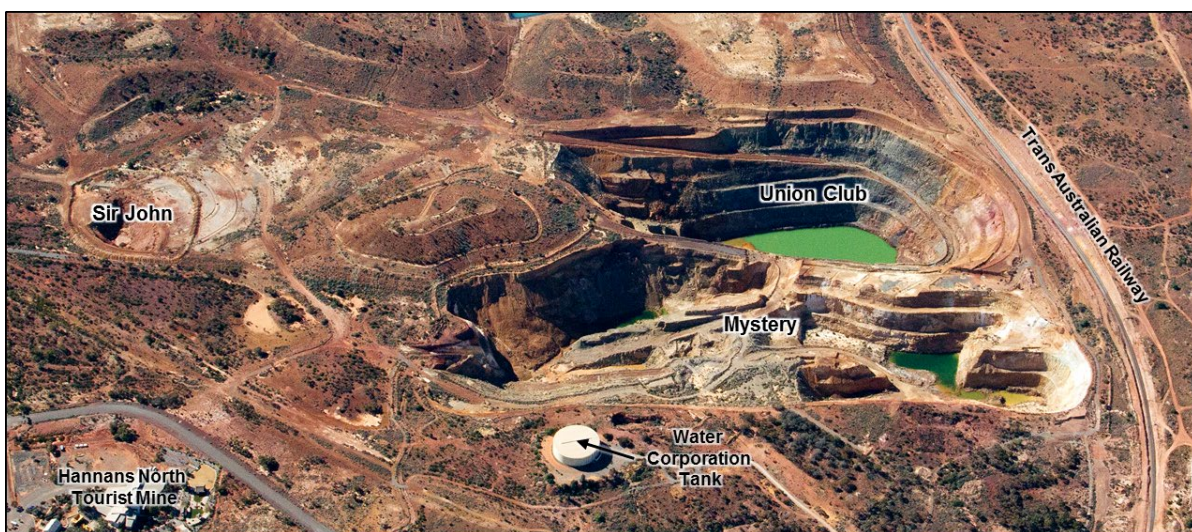
Figure 5-97: Mt Percy Open Pits and Surrounding Infrastructure

Features of the Mining Infrastructure Domain at the Mt Percy Operational Area include the Mystery and Union Club Open Pit and Sir John Open Pit (Figure 5-97). Most of the mining at Mt Percy occurred pre KCGM ownership, with the area rehabilitated by 2001. The dimensions of the Open Pits are summarised in Table 5-13.

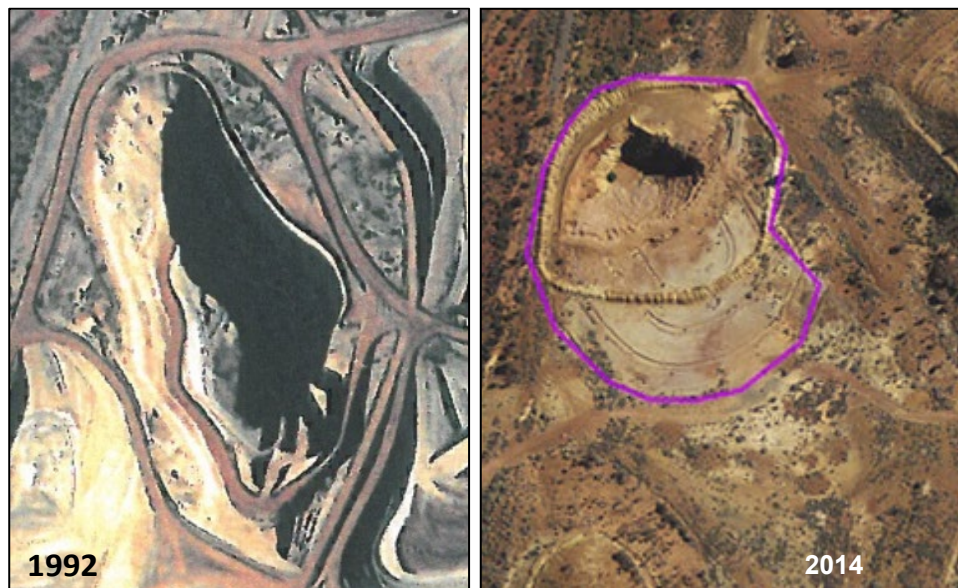
Figure 5-99: Sir John Open Pit Feature (showing extent of backfill) 1992 to 2014

After mining of the Sir John Pit was completed, the pit was partially backfilled with mine waste, tailings material was removed from the vicinity of the Hannans North Tourist Mine (formerly the Australian Prospectors and Miners Hall of Fame site) and Black Flag Beds shale was removed from a cleanup of the Mt Percy ROM Pad (Figure 5-99). The Sir John Open Pit was reported to the DWER as a potentially contaminated site (AOC31).

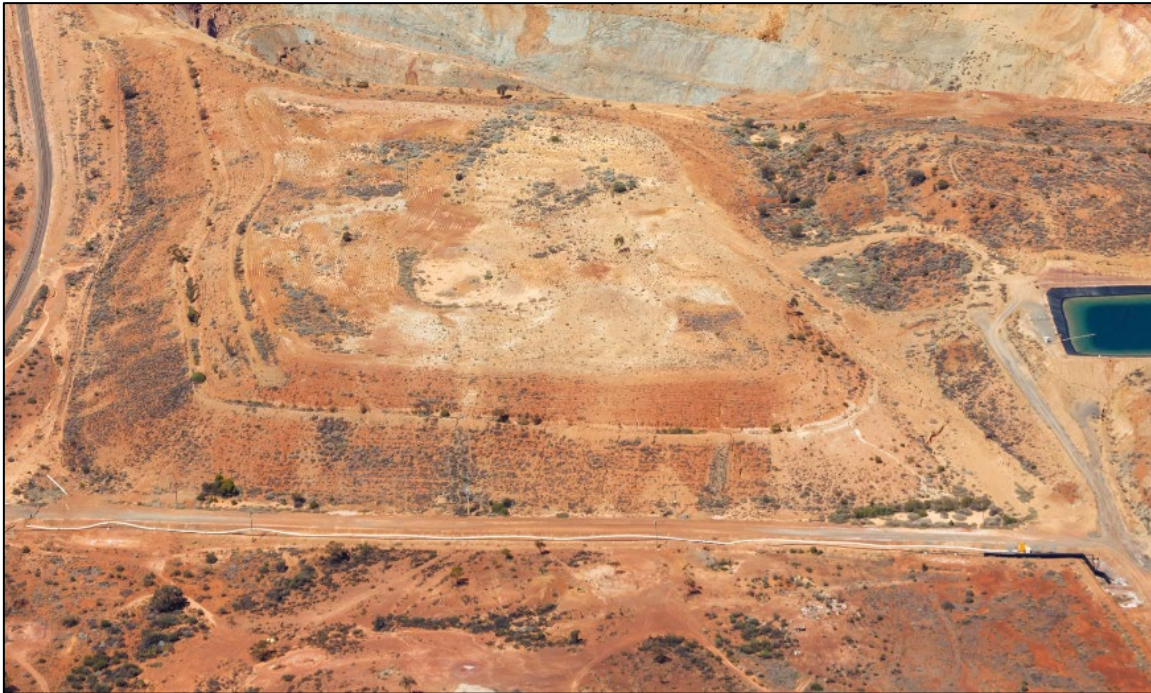
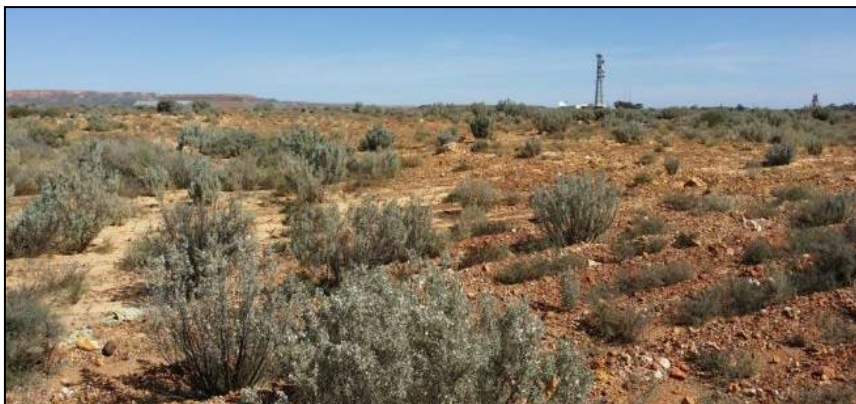
Figure 5-102: Union Club WRD Upper Surface (Bottom 2014; Top 2021)

EFA monitoring in 2011 classified this area as “On track, continue monitoring” (Outback Ecology, 2012b). Visual inspections from 2012 to 2014 indicate that lower storey vegetation is comprised mostly of salt tolerant species, such as *Atriplex* (Figure 5-102). Upper storey species were sparse on the batter and top of the dump, with *Casuarina sp.*

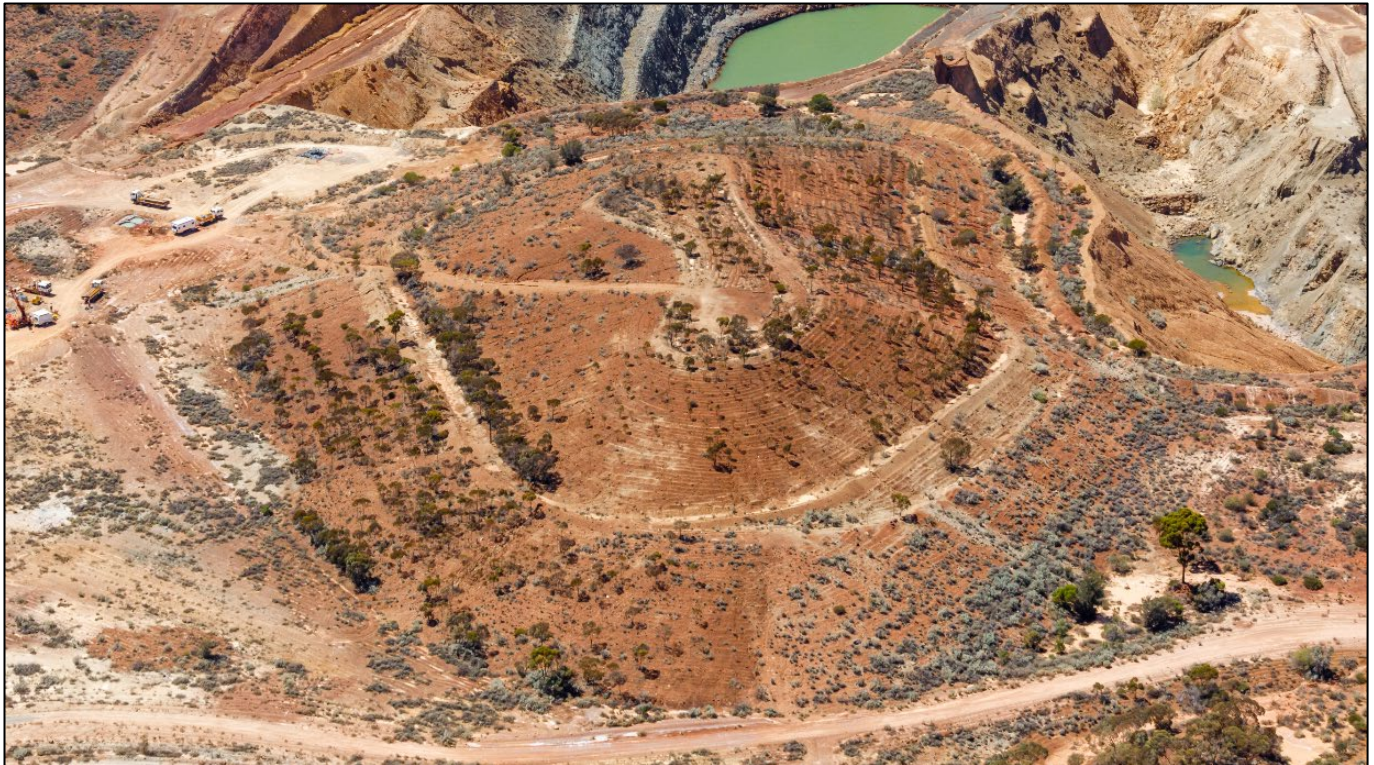
Figure 5-103: Mystery WRD (2021)

LFA monitoring in 2011 classified this area as “Below expectation” (Outback Ecology, 2012b). However, visual inspections from 2012 – 2014 indicate that vegetation appears to be in good condition (Figure 5-103), with multiple life stages and evidence of reproduction. A review by botanical professionals in 2012 described the vegetation community as a low mixed *Eucalyptus spp.* woodland over a sparse to open mid *Atriplex nummularia* shrubland over a sparse to open low *Atriplex vesicaria*, *Maireana pyramidata* and *M. glomerifolia* shrubland over isolated *Enneapogon caerulescens* grasses, with the surface relatively erosionally stable.

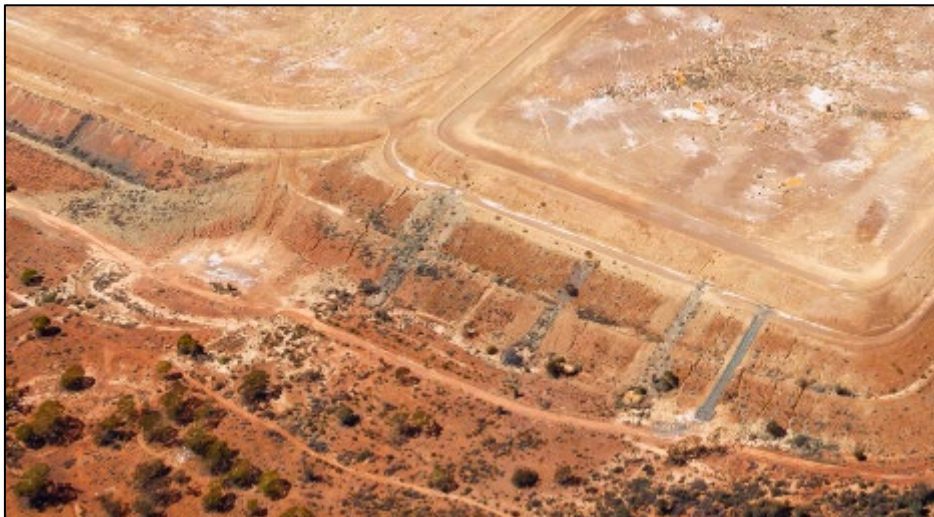
Figure 5-105: Erosion and Water Control Repairs on Mt Percy TSF Completed in 2019 (2021)

Visual observation of the feature shows that excessive erosion of the external batters is occurring in some areas outside of the monitoring transects. Rock lined drop drains have been installed in some areas in response to erosion occurring after the rehabilitation was completed (Figure 5-105). Significant gullying has occurred in the central area of the northern side due to inadequate water control.

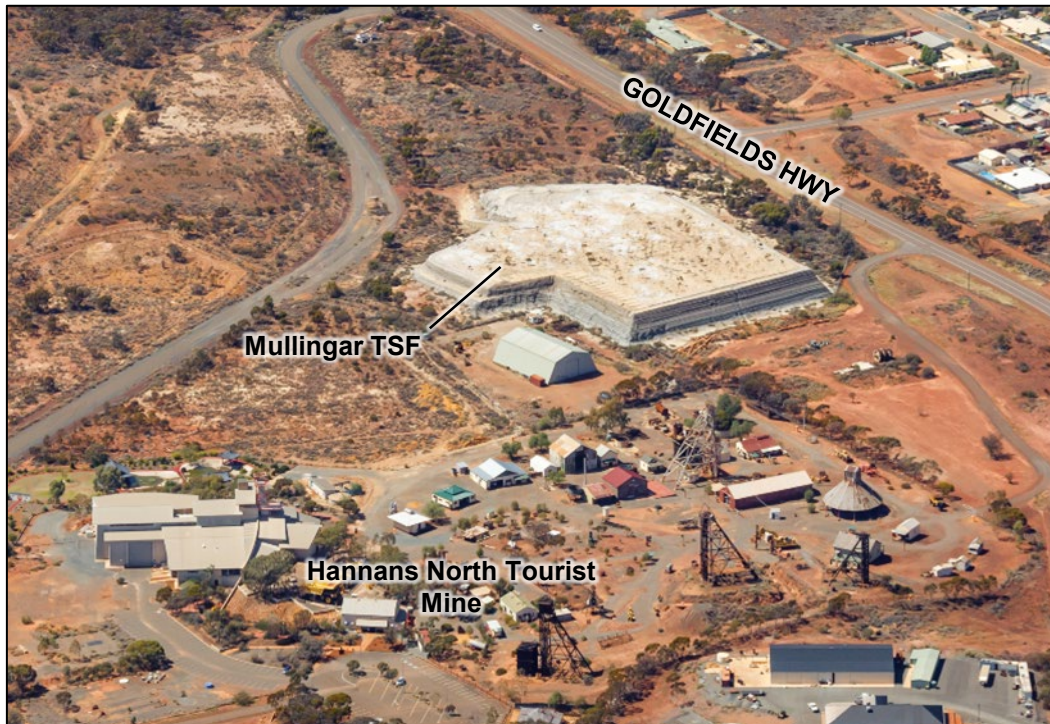
Figure 5-108: Mullingar Tailings Storage Facility (2021)

The Mullingar TSF, located on the southern portion of the Hannans North Tourist Mine, is the last remaining hand-built TSF on the Golden Mile (Figure 5-108). It was constructed by hand pre-1960 with steep (48°) external batters, has an area of 1.65 ha and is approximately 9 m high. The TSF is not included on a register of heritage sites. The Mullingar TSF has been reported to the DWER as a potentially contaminated site (AOC12) and rehabilitation of the facility will be required to comply with the requirements of the Contaminated Sites Act. For this reason, the TSF will need to either be encapsulated in situ or rehandled to an appropriate location.

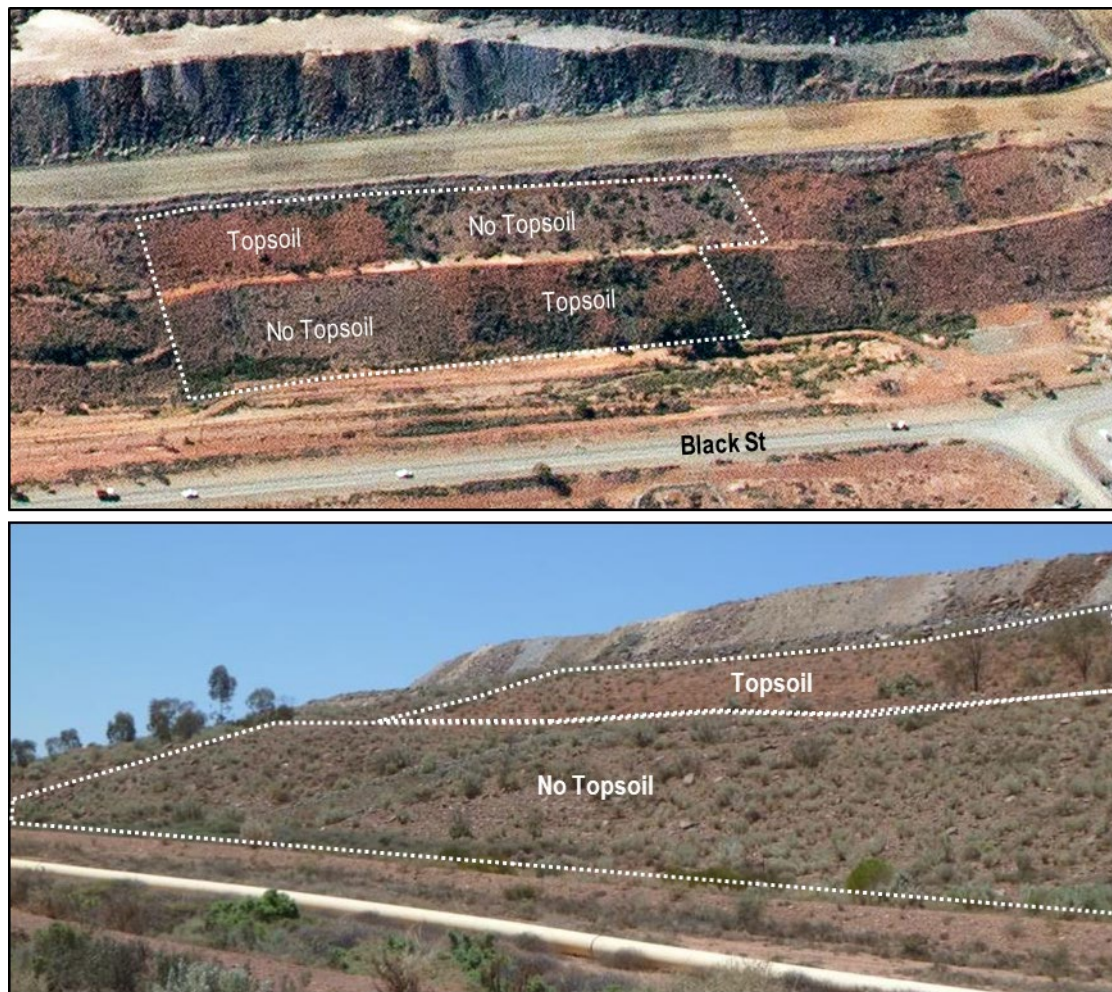
Figure 5-111: North Eastern WRD 'Black St Trials' Trial 1 Section Location

Trial 1 was established in 1992 to investigate waste rock landform revegetation, with and without the application of topsoil on waste rock/oxide (Figure 5-111). The applicable site was spread with topsoil to a depth of 20 cm, ripped and then sown with an 8 kg/ha site specific seed mix, and spread with Agras MoZnCu fertiliser at a rate 200 kg/ha. The two treatments included:

Initial outcomes of Trial 1 (waste rock/oxide only) after two to four years indicated that areas with topsoil had greater plant density, cover and species diversity than those with hard rock/oxide only. However, review of this trial area in 2012 (20 years after trial was initiated) by botanical professionals indicated that in the “No Topsoil” areas there was minimal erosion, reasonable vegetation cover but only in one stratum (shrub) and low species diversity, but with several age classes of shrubs which indicates recruitment episodes and therefore evidence of resilience.

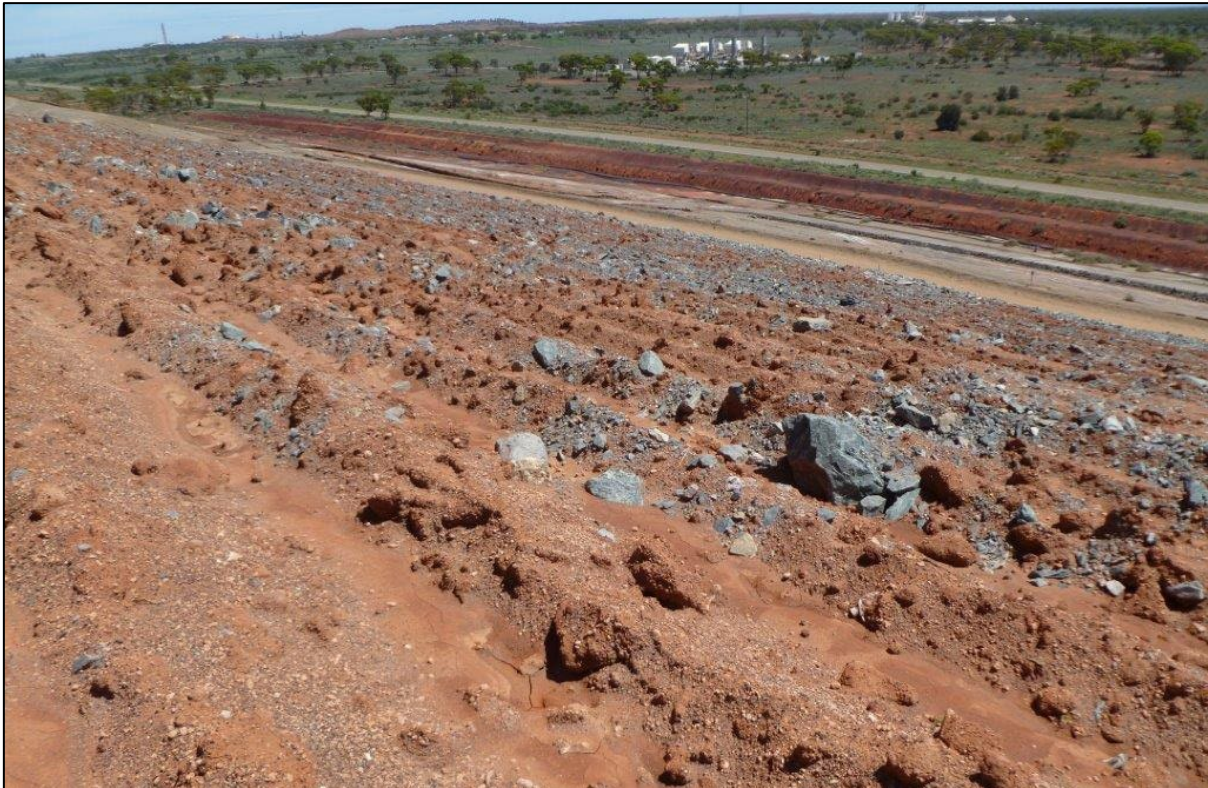
Figure 5-112: Fimiston I TSF Trial Immediately after Completion of Earthworks (Feb 2017)

After rock capping, the trial area was topsoiled using material from a stockpile that was approximately 5 m high and significantly compacted (Figure 5-112). After receiving good rainfall, germination occurred from seed stored within the seedbank, evidencing the amount of viable seed contained in the topsoil stockpile (more than 15 years old) (Figure 5-113).
