# KCGM Mine Closure Plan 2025 (v1) Volume 1 of 3

Mineral Field 26

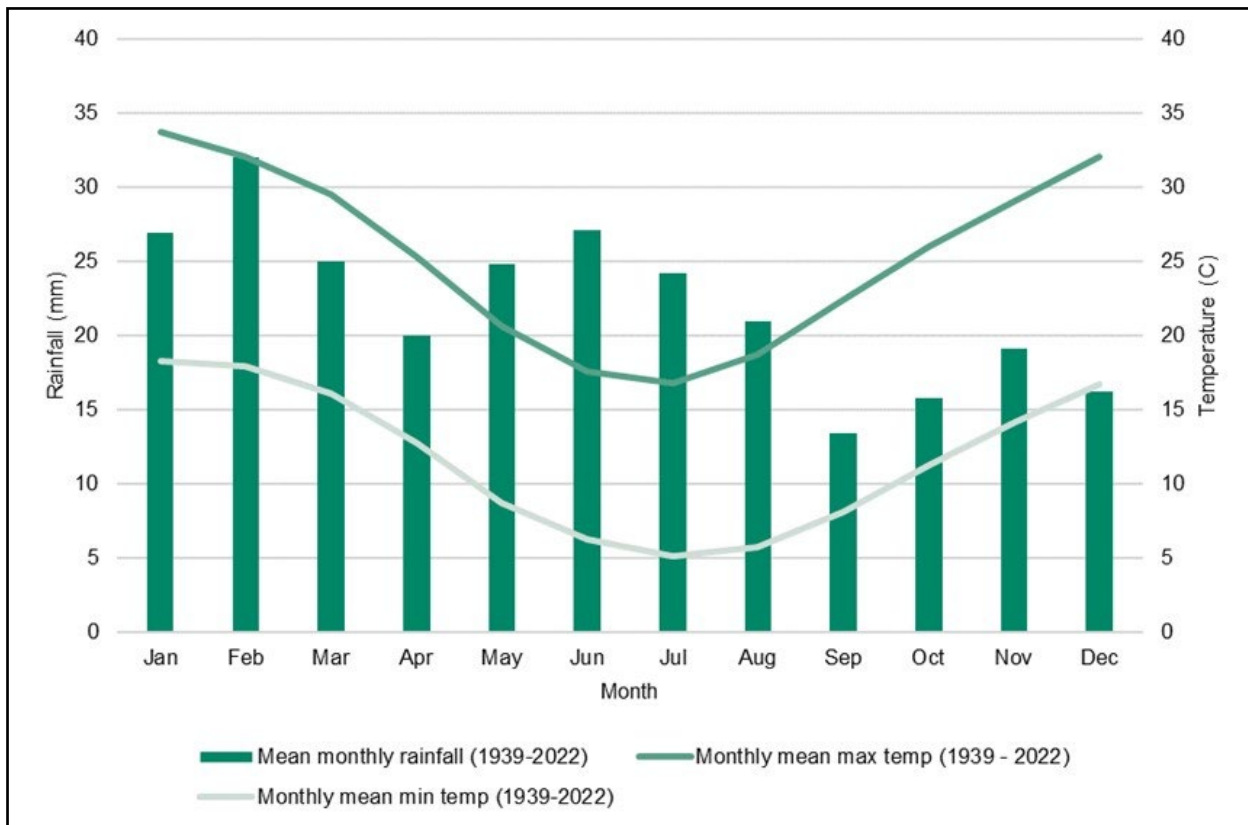
Figure 5-1: Long-term Monthly Climate Averages for Kalgoorlie-Boulder (1940-2022)

The Kalgoorlie region has a semi-arid climate with hot summers and mild winters. Annual rainfall varies between 108 and 530 mm with an average of 266 mm, with rainfall occurring during all months of the year (Figure 5-1). Significant summer rainfall is experienced due to tropical monsoon systems moving across the state from the north. Winter rainfall generally originates from broad frontal lows that move in from the west.

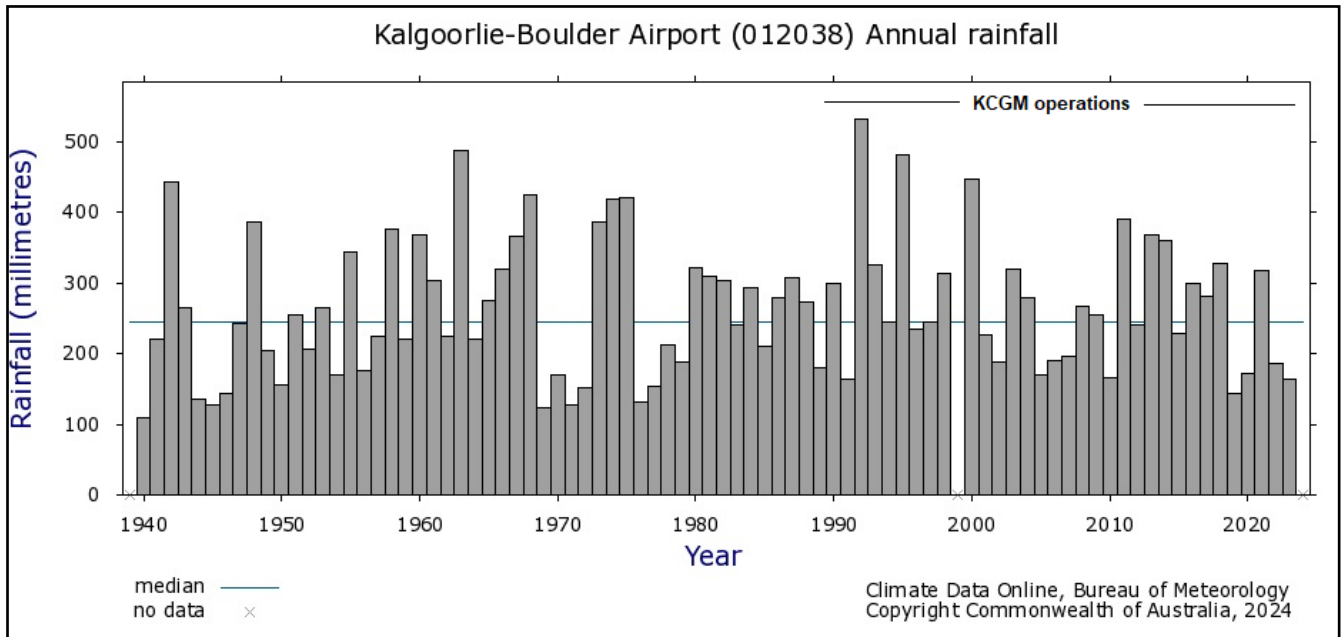
**Figure 5-2: Annual Rainfall Trends Over Time**

Rainfall and temperature annual averages during KCGM’s operational period are presented in Figure 5-2. The graph illustrates the low rainfall and high temperatures experiences over the last few years, particularly 2019 and 2020. The impact of this has been noticeable in vegetation monitoring data.

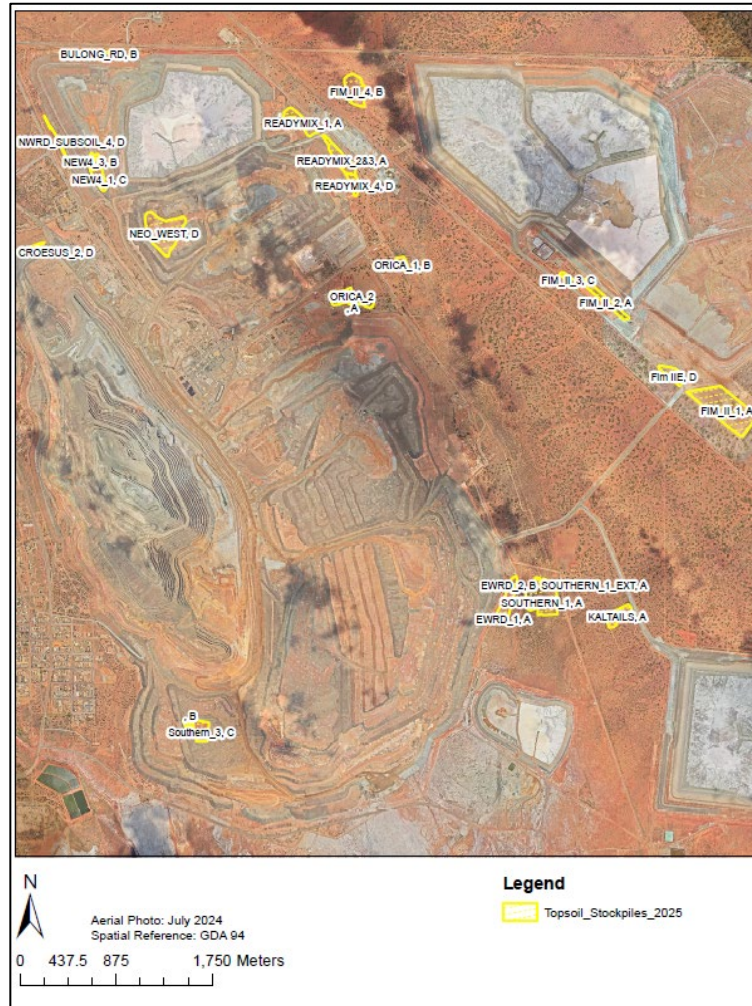
Figure 5-8: Fimiston Rehabilitation Materials Stockpiles (2025)

Topsoil stockpiles are located at Fimiston (Figure 5-8) and Gidji (Figure 5-9) Operational Areas. Rehabilitation at Mt Percy has already been completed (before 2001), with all available topsoil utilised. Mt Charlotte does not have any topsoil stockpiles due to the age of the operation. The Regional Operational Area will likely utilise topsoil pushed up to form windrows or stockpiled during construction of service corridors.

The classification system uses five classes based on physical, chemical, and geochemical characteristics, and resulting suitability for placement within constructed and rehabilitated landforms. An inventory of available rehabilitation materials includes stockpiled soil and oxide. Table 5-2 summarises the general characteristics of the classes of the Rehabilitation Materials in Fimiston stockpiles, the location of which is shown in Figure 5-8.

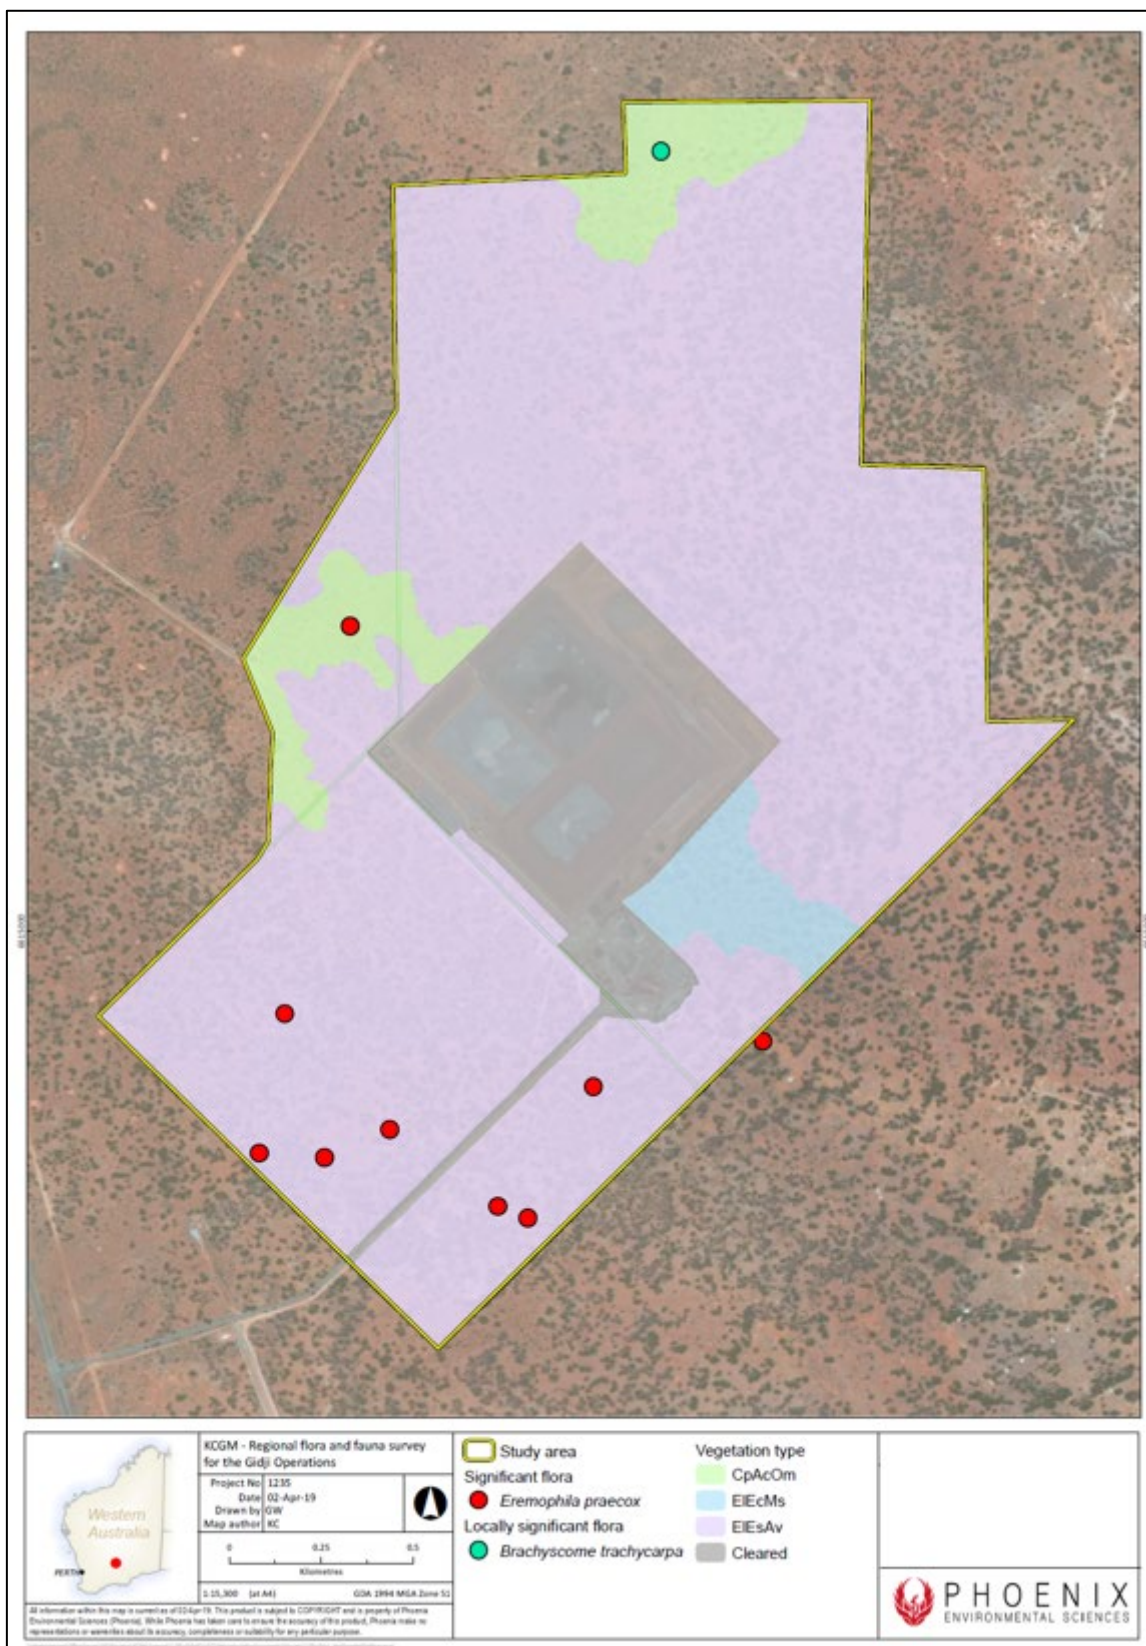
Figure 5-16: Vegetation Types adjacent to Gidji Operational Area

**Table 5-4: Gidji Operational Area Vegetation Types**

VEGETATION TYPE	VEGETATION DESCRIPTION
EIEsAv	Woodland Mid <i>Eucalyptus lesouefii</i> woodland, occasionally with <i>E. longicornis</i> , over mid sparse to open <i>Eremophila scoparia</i> , <i>Maireana sedifolia</i> and <i>Senna artemisioides</i> subsp <i>filifolia</i> shrubland over isolated low <i>Atriplex vesicaria</i> , <i>Olearia muelleri</i> and <i>Scaevola spinescens</i> shrubs.
EIEcMs	Woodland Mid <i>Eucalyptus lesouefii</i> and <i>E. salubris</i> woodland over isolated tall <i>Eremophila caperata</i> shrubs over low <i>Maireana sedifolia</i> , <i>Scaevola spinescens</i> and <i>Maireana triptera</i> shrubland.
CpAcOm	Woodland Low <i>Casuarina pauper</i> woodland over mid open <i>Acacia ?coolgardiensis</i> , <i>Cratystylis microphylla</i> and <i>Eremophila oppositifolia</i> shrubland over low sparse <i>Olearia muelleri</i> and <i>Rhagodia eremaeae</i> shrubland.

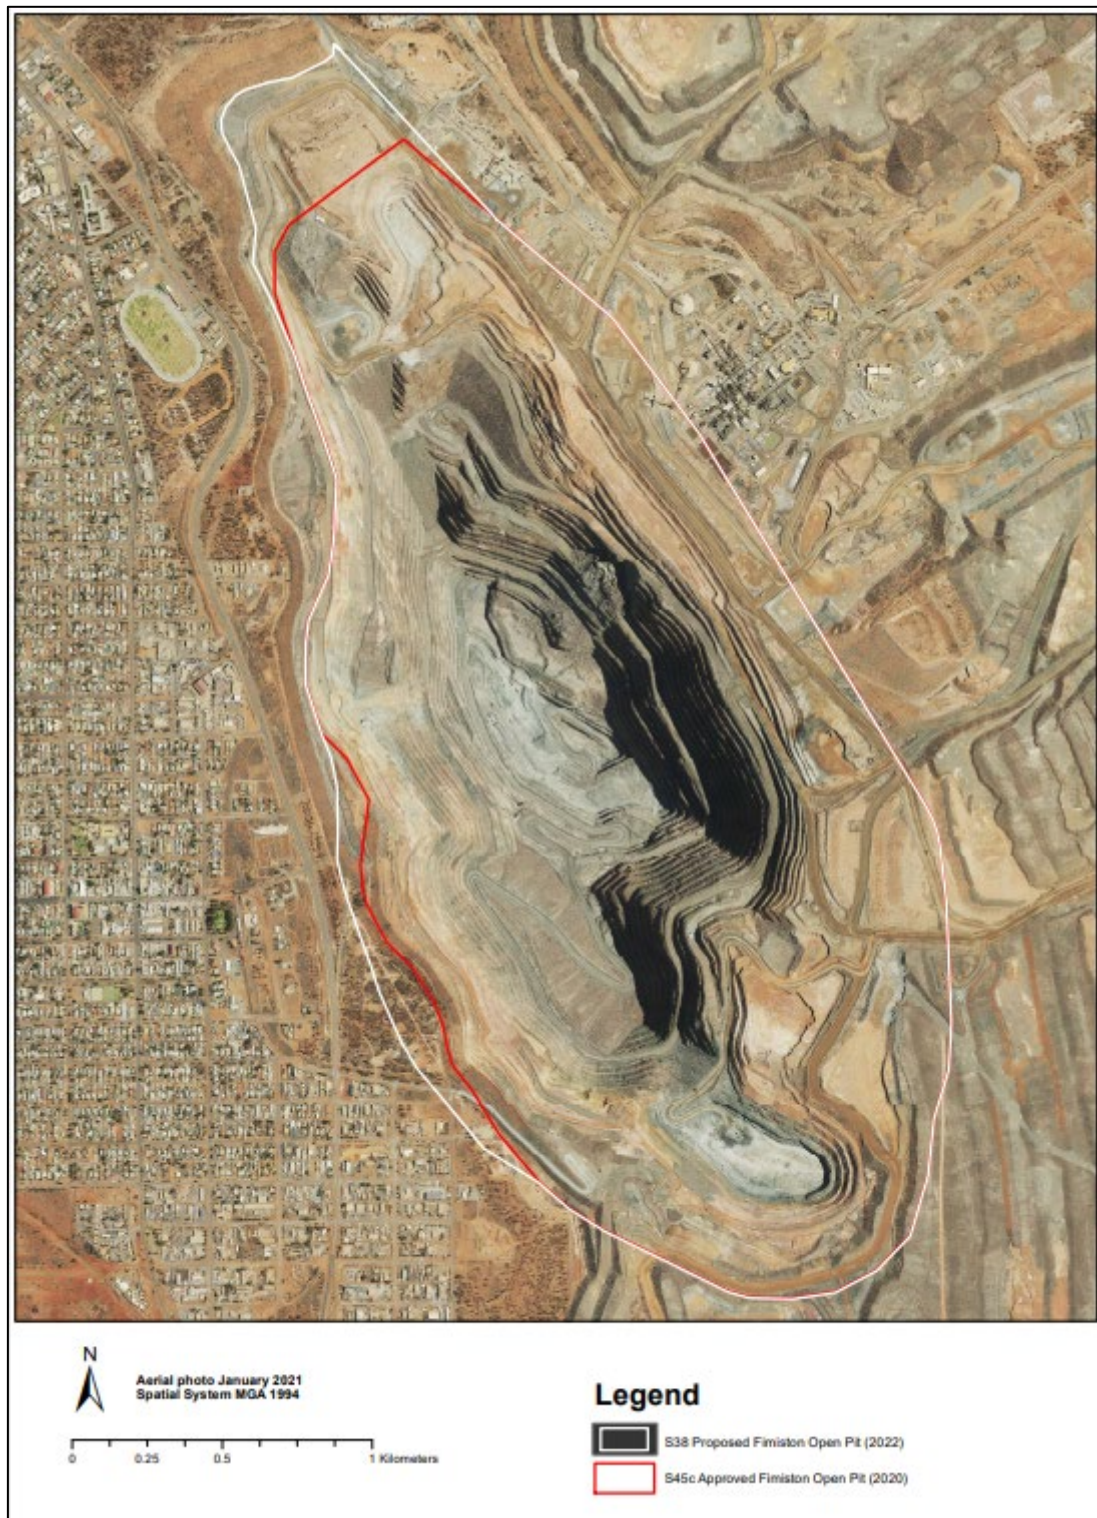
**Figure 5-19: Fimiston pit shells**

The Fimiston Open Pit (Figure 5-19) is currently the only active open pit managed by KCGM and is planned to continue to be mined until 2034 (2021 LOM Plan). The Open Pit footprint incorporates the Brownhill, Chaffers,

Croesus, Golden Pike, North Kalgoorlie, Morrison, Oroya, Stores, Trafalgar, Great Boulder (Fimiston South S45c Approval) and Ivanhoe (Fimiston South S38 approval) pits /cutbacks. The Fimiston open pit is one of the largest open pit gold mines in Australia, extending approximately 1.5 km wide, 3.5 km long and 600 m deep.

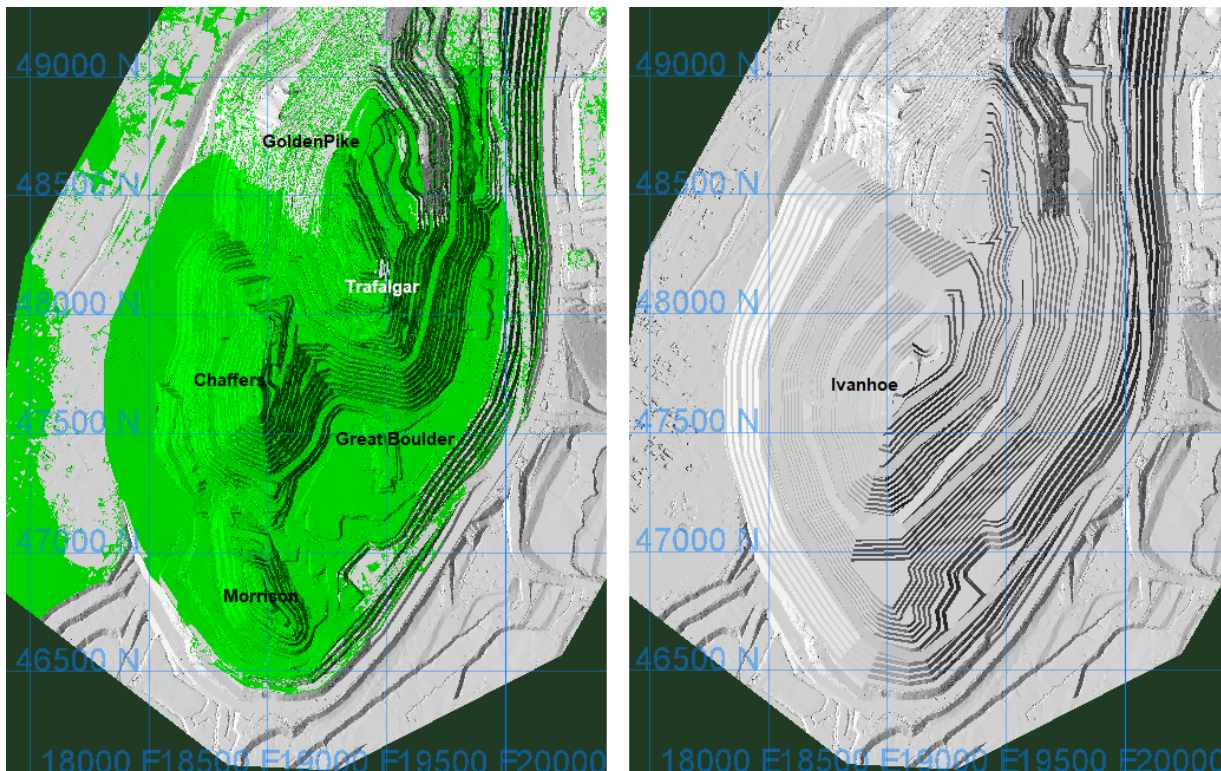
**Figure 20: Ivanhoe cutback footprint (green) overlaid on existing mining areas (left frame) and Final Ivanhoe pit shell (right frame)**

In 2024/25 Itasca Australia was commissioned to undertake a geotechnical feasibility study of the proposed Ivanhoe Cutback Project. This proposed cutback (extension) of the existing Fimiston (Super) Pit extends over the earlier Chaffers, Morrison, Trafalgar and Golden Pike cutbacks ([Figure 201](#)) and targets extensions to the Fimiston mineralization and geology, down dip and along strike of Chaffers, Trafalgar and Morrison areas. Of particular concern was the possible geotechnical stability risk posed by the cutback of the western edge of the mine pit towards the national road and Boulder urban infrastructure.

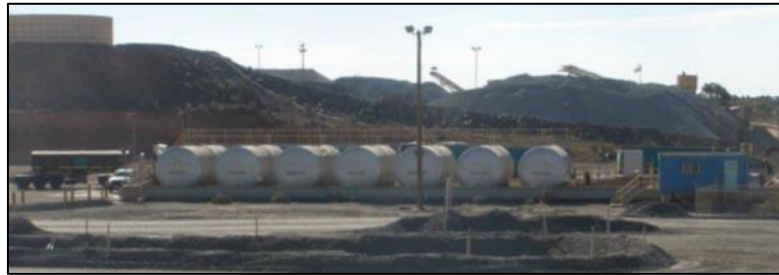
**Figure 5-22: Fimiston Mining Fuel Farm**

The Fimiston Mining Fuel Farm (Figure 5-22) consists of seven 110,000 litre tanks in a bunded area with a concrete apron for the refuelling of light vehicles, trucks, and ancillary equipment. The area is located north of the Fimiston Plant, adjacent to Black Street.

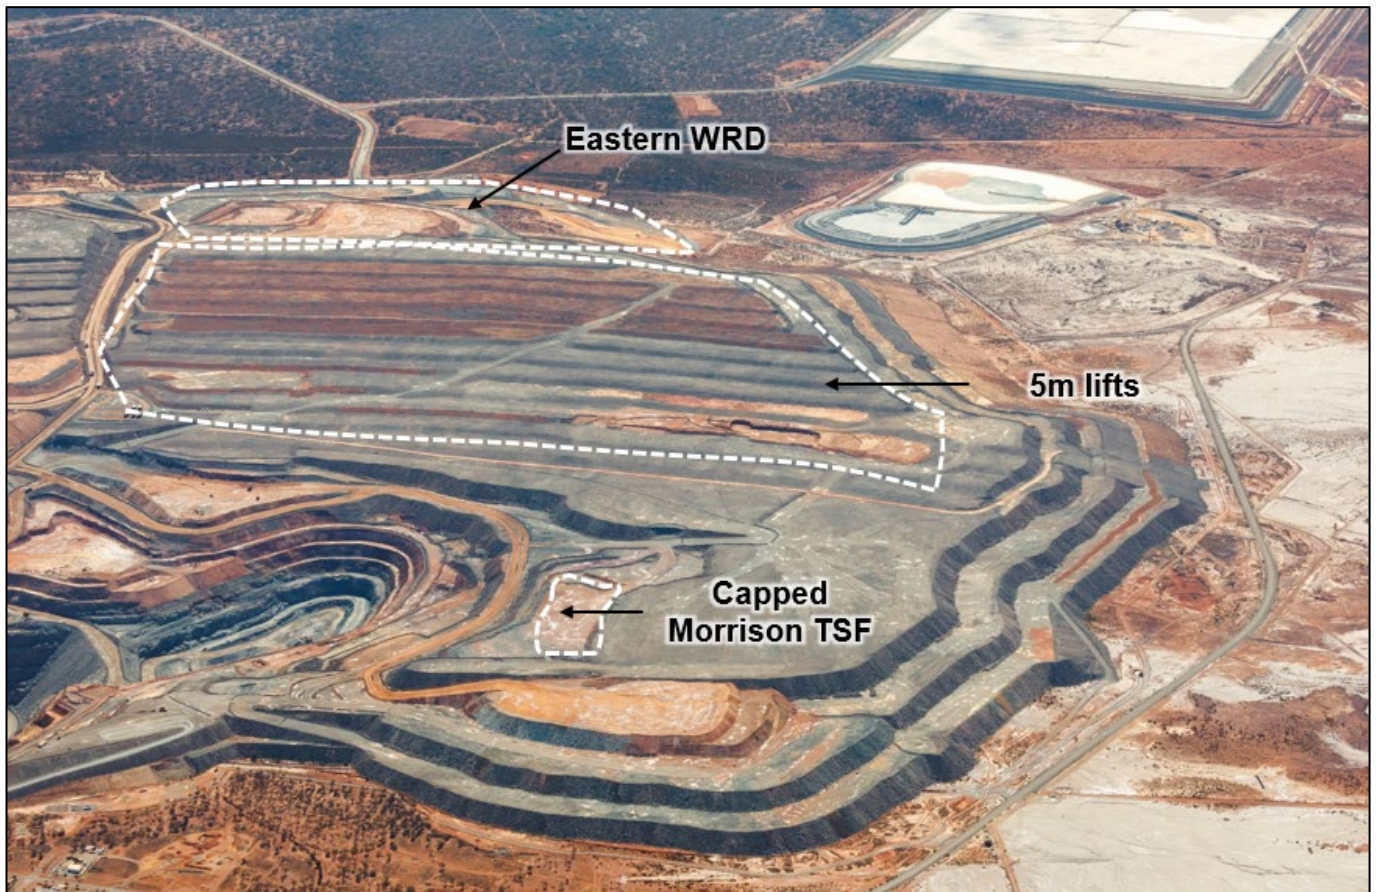
**Figure 5-26: Trafalgar WRD viewed from the Southeast (2021)**

Previously, the western facing upper area of Trafalgar WRD consisted of 5 m lifts, with a terraced appearance to optimise the available waste dumping capacity (Figure 5-26) under the airport Obstacle Limiting Surface (OLS).

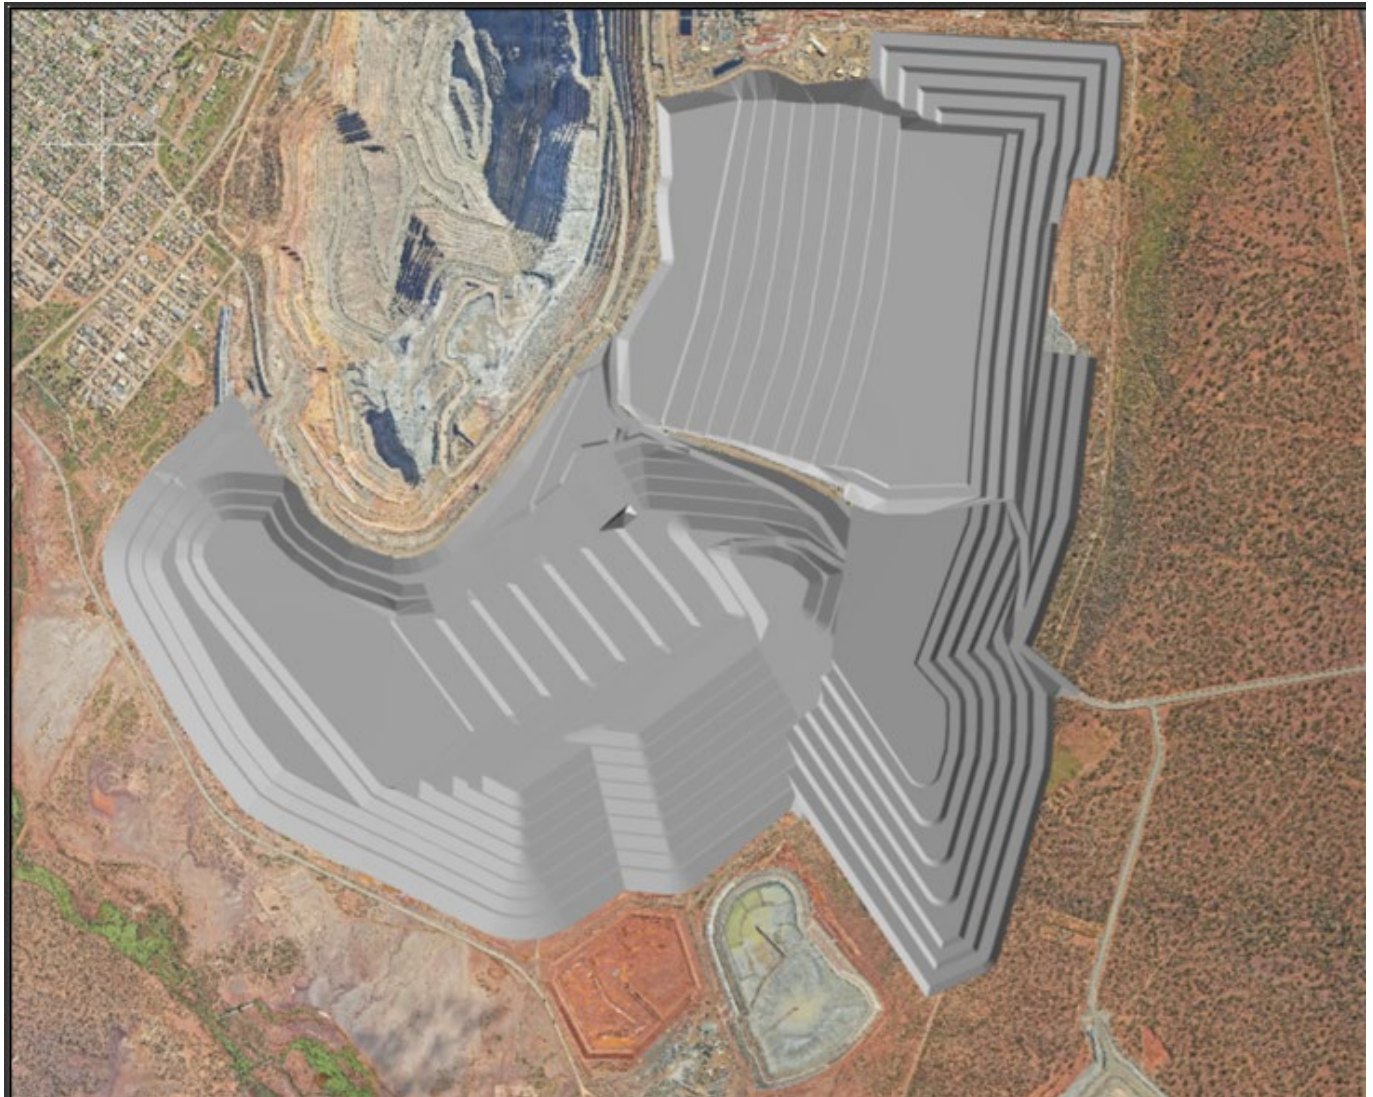
**Figure 5-27: Proposed Southern WRD Design (mine site grid)**

The closure design implemented on the new Trafalgar WRD/ Far Eastern WRD/ Southern WRD design will be the erosion resistant design, already implemented on the Trafalgar/ Southern WRDs, with the visual amenity strategy guiding topsoil placement. The design consists of 16° -17° slopes with 10 m wide berms, and a high percentage rock cover. Extensive technical work supports this design, including the trials undertaken at Northern WRD.

Topsoil from the footprint area will be recovered and stockpiled. Oxides (Class D) in the impacted rehabilitation have been sampled and will be assessed based on their geochemical properties to determine which areas have growth media materials suitable for recovery. Figure 5-27 shows the new Trafalgar WRD design.

As part of the Fimiston South Project, a new phased design height change is in progress for the Southern WRD, with a final eastern height of 140 m. To achieve this design, KCGM have been in discussions with relevant approvers and stakeholders in the aviation sector; namely CASA, Air Services Australia, Kalgoorlie Airport (Shire owned) as well as consultation with all main airlines flying into Kalgoorlie-Boulder. An additional height increase has been approved (higher than the OLS), with a new design implemented on Trafalgar WRD. This design may be extended northwards over Oroya WRD. Figure 5-27 shows the new Southern WRD design.

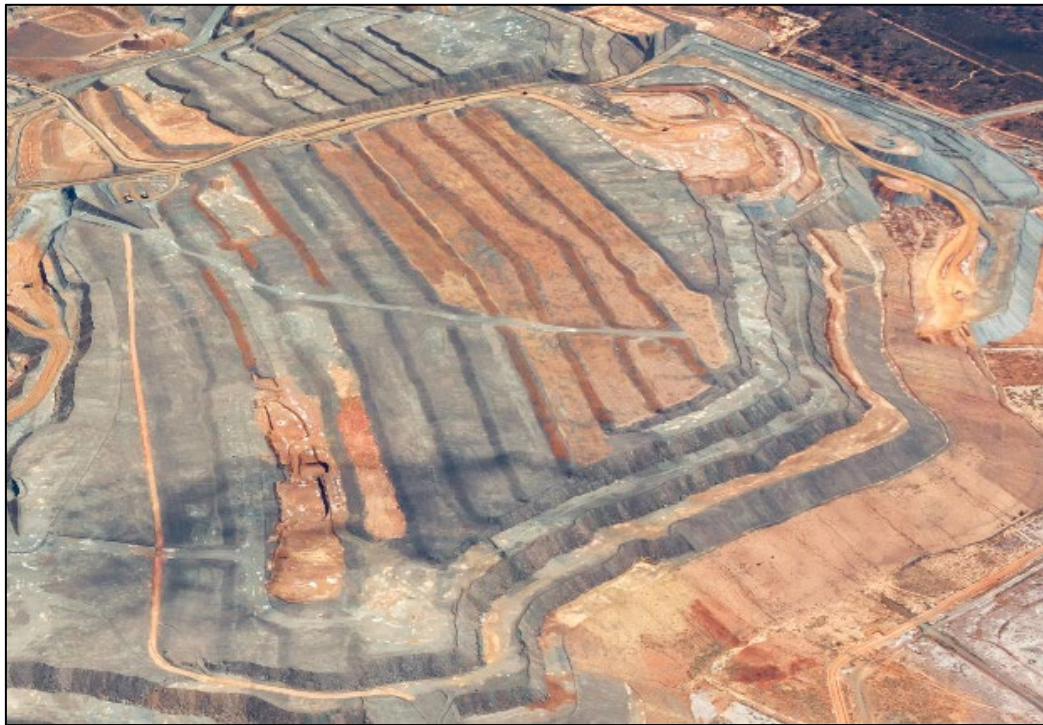
**Figure 5-30: 5 m Lift Rehabilitation (2021)**

Rehabilitation of the Trafalgar 5 m lifts commenced in 2015 with rocky, shallow batters and very wide benches in alignment with the ‘erosion resistant’ design (Figure 5-30). Material placement has been guided by the Visual Amenity rating of the location, with better rehabilitation materials used on the western facing “highly visual” slopes. Oxide has been used on the “non visible” benches (flat areas). As this material is saline it will take time to leach to become a

suitable growth medium for salt tolerant species. Good germination has occurred on the topsoiled slopes, with slower germination on the oxide covered flat area (natural leaching is required to attain a soil conductivity that is conducive to germination of salt tolerant species).

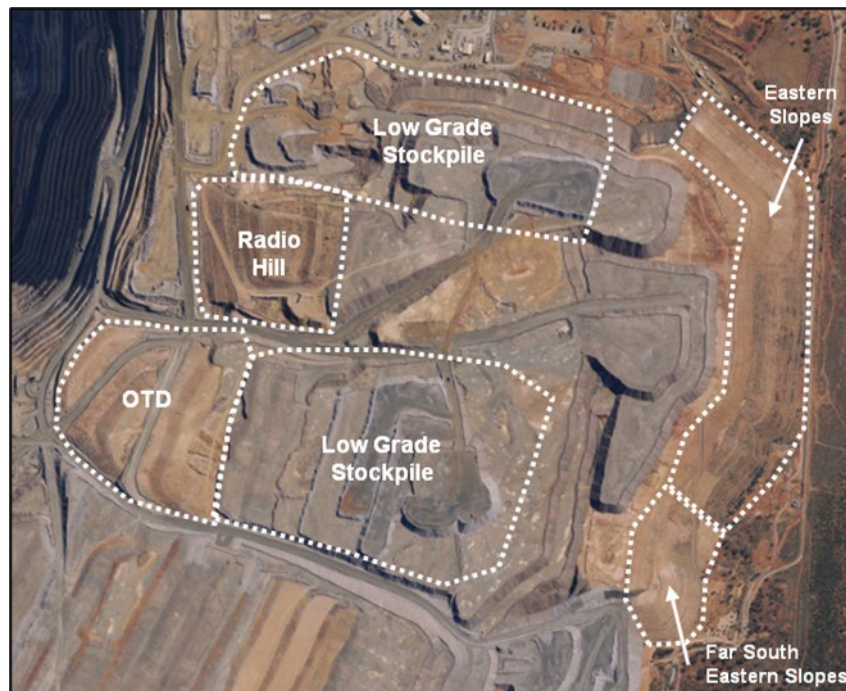
**Figure 5-31: Oroya WRD Areas**

The Oroya WRD is an active WRD, located to the north of, and abutting Trafalgar WRD, separated by the haul road to the Eastern WRD. It encompasses Radio Hill and Old Tetley’s Dump (OTD) (Figure 5-31). The WRD is still active, with almost two thirds of the WRD comprising Marginal or Subgrade stockpiles which will be processed during operations.

The closure design implemented on the new Southern WRD design over Oroya WRD will be the erosion resistant design already implemented on the western side of Oroya WRD/ Southern WRD, with the visual amenity strategy guiding topsoil placement. The design consists of 16° -17° slopes with 10 m wide berms, and a high percentage rock cover. Extensive technical work supports this design, including trials at Northern WRD. The northern portion of Oroya WRD consists of subgrade stockpiles, which will be processed, and replaced with waste rock.

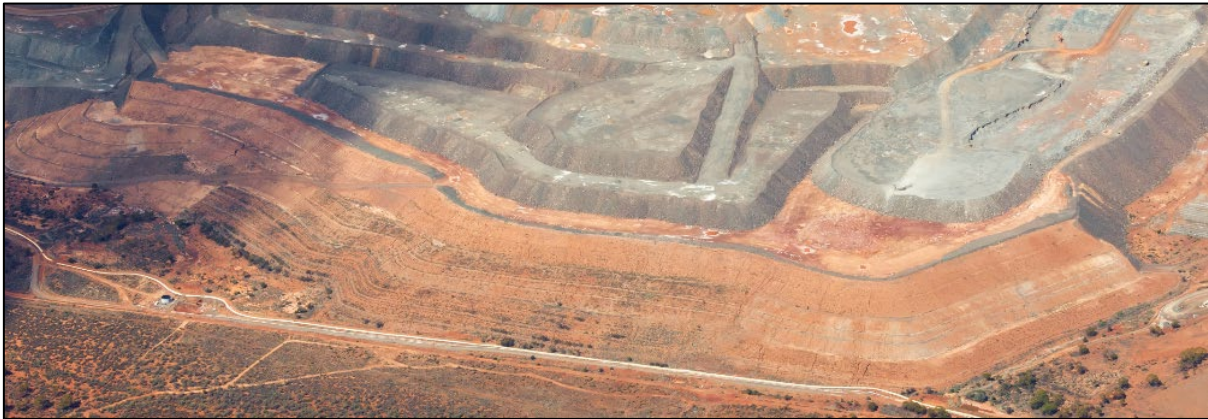
**Figure 5-33: Oroya WRD, Eastern slopes (2021)**

Oroya WRD has some good revegetation areas, particularly on the lower eastern slopes (Figure 5-33). Better quality materials were used on Oroya lower Eastern slopes, with several trials for the use of mycorrhizal fungi and 'moonscaping' completed. The depth of materials applied to the southern slopes (abutting Trafalgar) has been significant, with the amount of surface rock cover insufficient to mitigate erosion. The batters have three "water harvesting" drainage control berms which have not been cut accurately along the contour, resulting in the concentration and subsequent spilling of storm runoff. In the original design, these contour berms were to have discharged to drop structures, but they were not installed. However, as the contour drains were installed inaccurately, the drop structures would not have functioned as intended and the final rehabilitation outcomes would not have been improved.

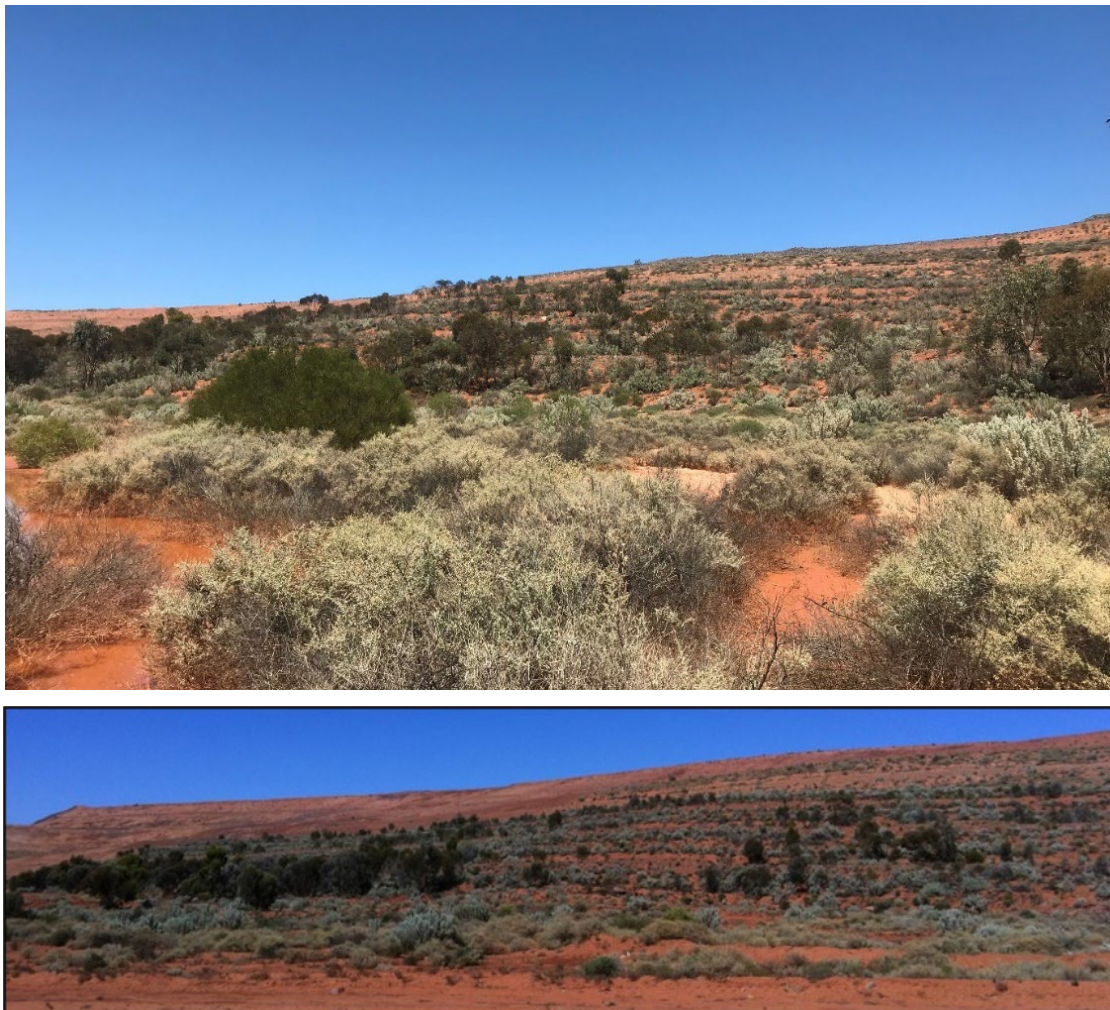
**Figure 5-34: 1998 Rehabilitation – southern lower lift (2013 below and 2021 above)**

A section of the bottom lift of the eastern batters of the Oroya WRD (Figure 5-34) was rehabilitated in 1998 by pushing the slopes down to 14°, sheeting with growth medium, deep ripping and cutting in narrow back sloping contour berms. Seeding was undertaken at 10 kg/ha with application of Agras 1 fertiliser at 100 kg/ha, with different seed mixes applied to the lower, middle and upper parts of all slopes. In recent years, vegetation in this area is showing stress due to high average annual temperatures and several years of low annual rainfall (as discussed in Section 5.1.1).

Erosion remains an issue for these areas due to the depth of oxide material applied. However, erosion will be limited to the interface between oxide cover and underlying waste rock. A rocky crest bund has been installed above this area to manage stormwater and prevent failure of the crest bund, which was previously constructed of low strength oxide material.

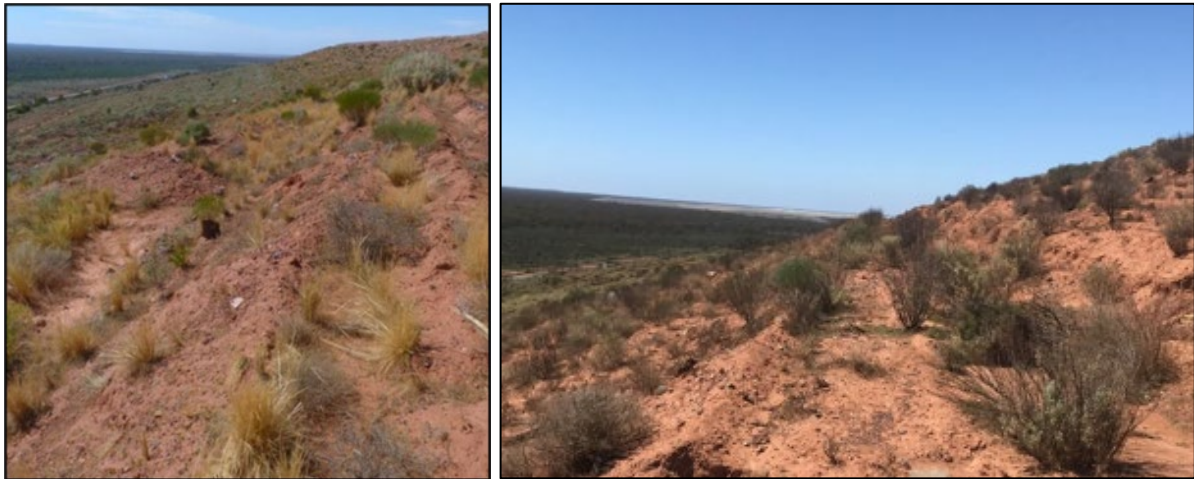
**Figure 5-35: Oroya WRD Third Lift Eastern Batter – Status of Rehabilitation (2013 left and 2021 right)**

Visual inspections have observed that despite relatively good recruitment and growth of lower storey and emergent upper storey vegetation, many of the furrows created during contour ripping have been filled with sediment, with evidence of early gullying and tunnelling. In recent years, vegetation in this area has showed stress due to high average annual temperatures and several years of low annual rainfall (as discussed in Section 5.1.1). Progress of revegetation is shown in Figure 5-35.

In 2018, a large robust crest bund with 10 m of rock armouring behind it was constructed along the crest on the eastern side of Oroya WRD, to prevent crest bund failure.

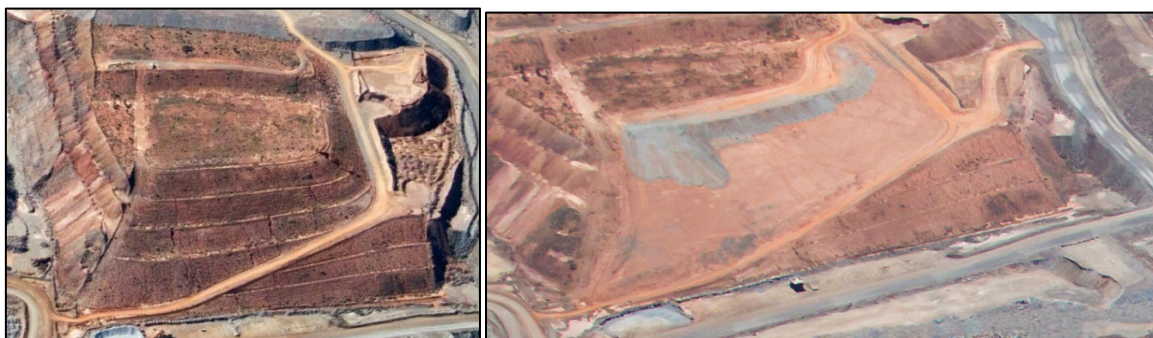
**Figure 5-36: Radio Hill Prior to 2017 (Left) and during 2017 Remedial Works (Right)**

Due to the medium visual amenity rating of the area, and potential relocation of the Public Lookout, remedial works were implemented on the WRD in 2017/8 (Figure 5-36). The WRD has been recontoured, sheeted with a layer of waste rock, and had growth media reapplied. A robust rocky crest bund and back sloping rock crest area, to prevent tunnel erosion through the upper oxides, also forms part of the design. The area was rehabilitated again in 2017/8, with a rock capping placed over the oxide waste and subsequent replacement of original Class D topsoil. Additional Class A topsoil was brought in to supplement the works. Significantly improved regrowth has occurred on the Class A soils compared to the Class D soils, highlighting the difference in soil properties (Figure 5-37).

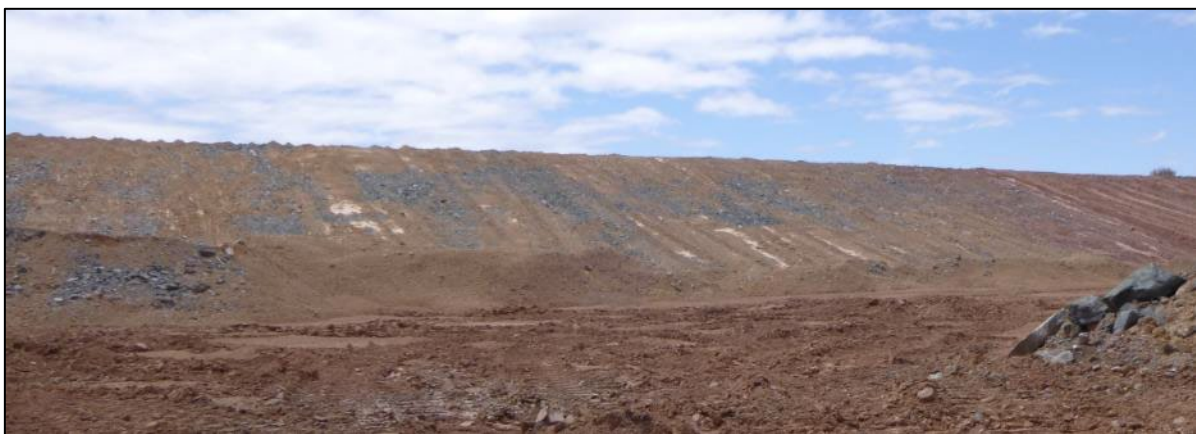
**Figure 5-38: OTD Remedial Works in Progress 2017 (Oroya WRD)**

Old Tetley’s Dump (OTD) is a small segment of the Oroya WRD that was rehabilitated in 2006 by reshaping to 20° with 5 m back sloping berms, ripping and seeding. Oxide was used as rehabilitation material.

Visual observations of this dump indicate that although vegetation growth has marginally increased, it is performing poorly vegetatively and erosionally. This is most likely due to placement of excessive poor quality oxide material. Due to the visual amenity rating of the area, and potential relocation of the Public Lookout, remedial works were implemented on the upper WRD lift in 2017 (Figure 5-38). The WRD has been stripped of excess material and a robust rocky crest back slope of 10m as part of the design. The upper surface was also reshaped to prevent overtopping. Vegetation performance has been slow, due to the salinity of the material and insufficient rain in recent years.

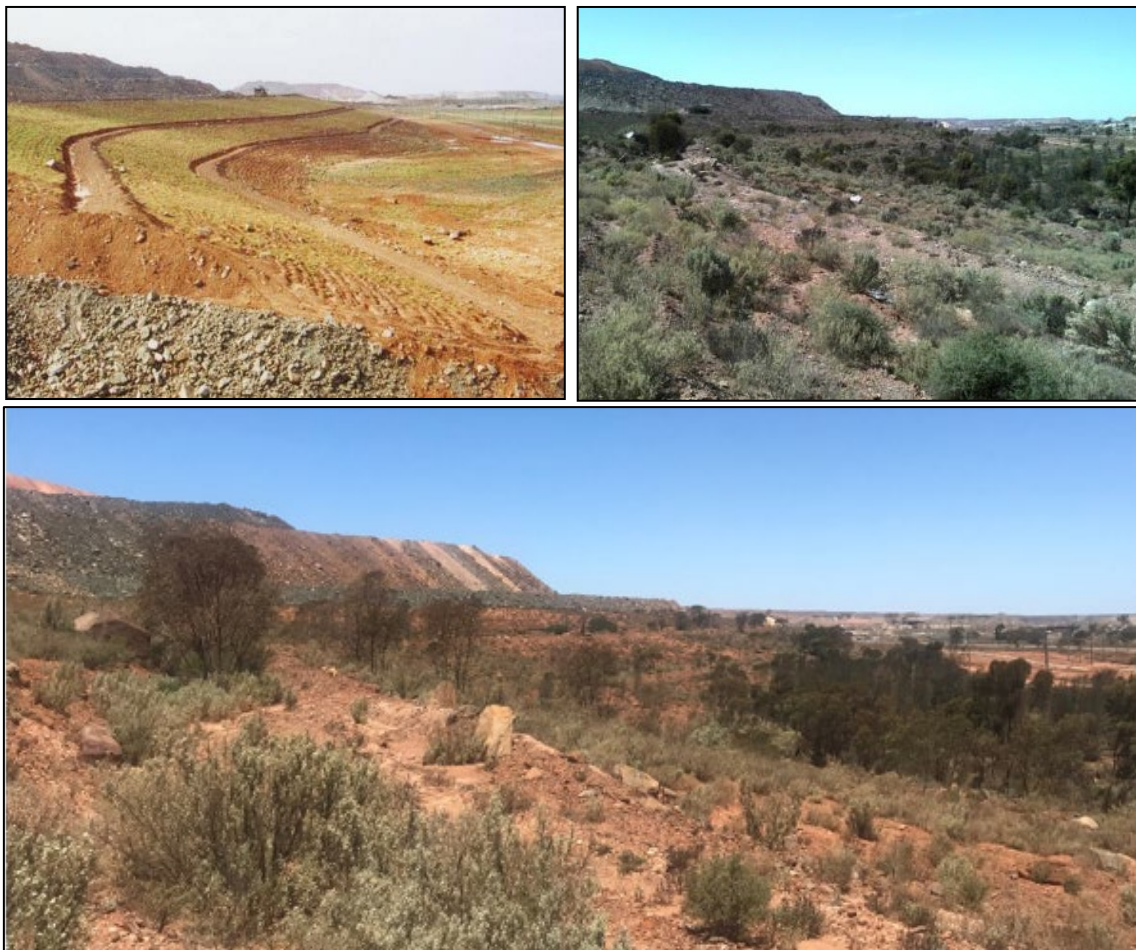
**Figure 5-41: North Eastern WRD Black Street Rehab 1998 (left), 2013 (right), and 2021 (below)**

The north western slopes, located immediately north of the Black Street trials, were rehabilitated in 1998 (**Error! Reference source not found.**). Visual observations indicate that this area appears to be performing well vegetatively, with minor erosion present. Overall, KCGM does not consider this area to be a high risk in terms of poor rehabilitation performance.

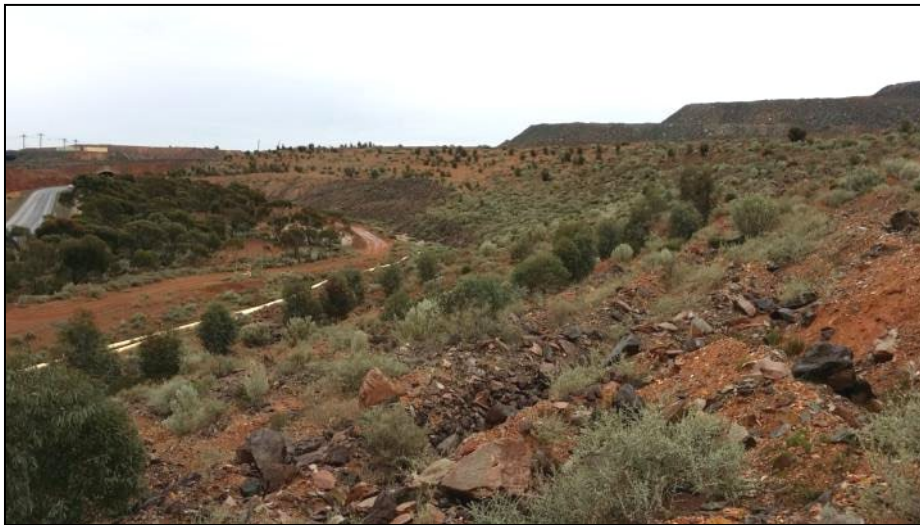
**Figure 5-43: Pad 19 Rehabilitation Progress (2014)**

Observations from 2015-2017 have shown a continued trend of vegetation recruitment, with minor erosion developing (Figure 5-43). Overall, KCGM does not consider this area to be a high risk in terms of poor rehabilitation performance.

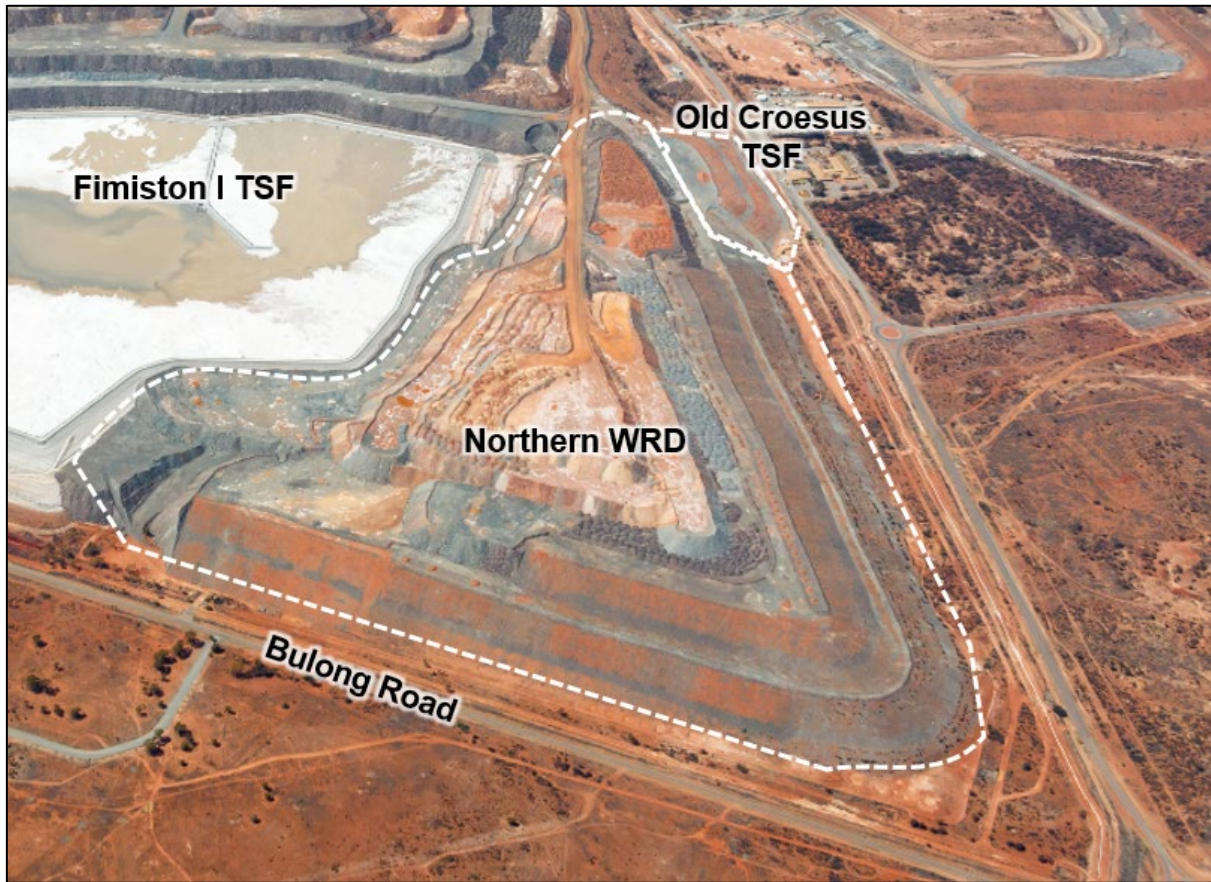
Figure 5-44: Northern WRD Viewed from the North (2021)

The erosion resistant design was successfully trialled on this WRD. The design consists of 16° -17° slopes with 10-15 m wide berms, and a high percentage rock cover. Extensive technical work supports this design.

BF shale waste material is co-disposed with waste rock within the Northern WRD, with a buffer of 40 m for high ANC dolerite/basalt on the external faces of the dump and capping of 5 m of benign material on the final upper surfaces of the dump.

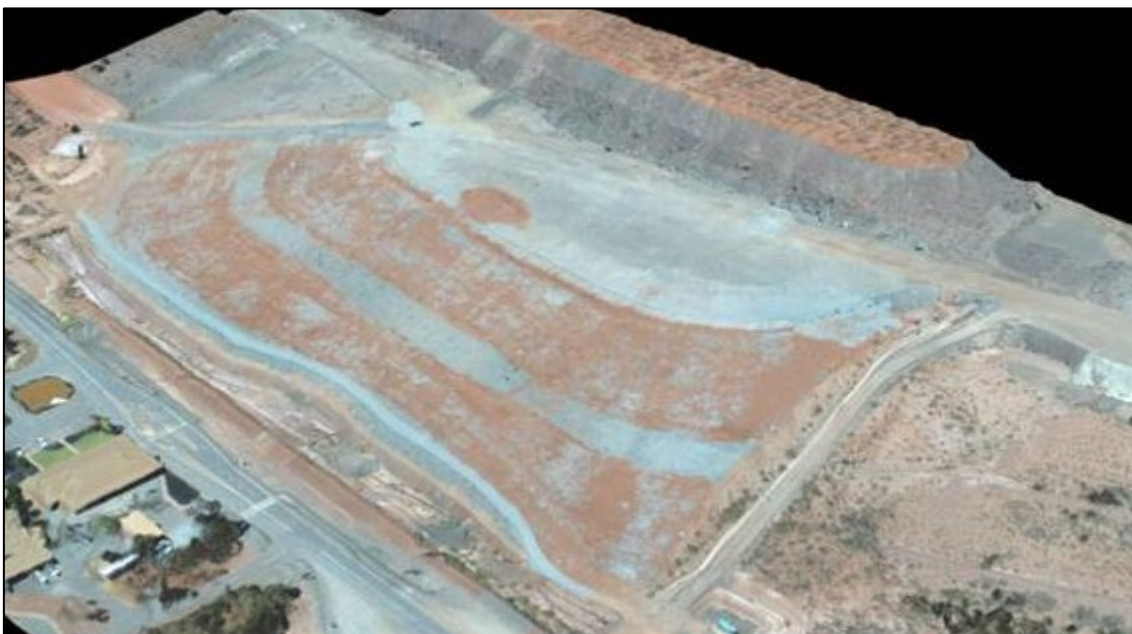
**Figure 5-46: Old Croesus 2021 Capping and Completed Rehabilitation**

Due to the continued erosion of the western flank of the TSF, remedial works were conducted during the 2020/21 period, with the TSF reshaped to a single slope, and then capped with waste rock (Figure 5-46). The upper surface was also levelled off and capped with waste rock. A robust crest bund with a backslope has been installed for water management. Class D subsoil was used as a growth medium. The slope will be seeded in 2021, although some vegetation recruitment has already occurred naturally. The TSF is now fully encapsulated.
