# KCGM Mine Closure Plan 2025 (v1) Volume 1 of 3

Mineral Field 26

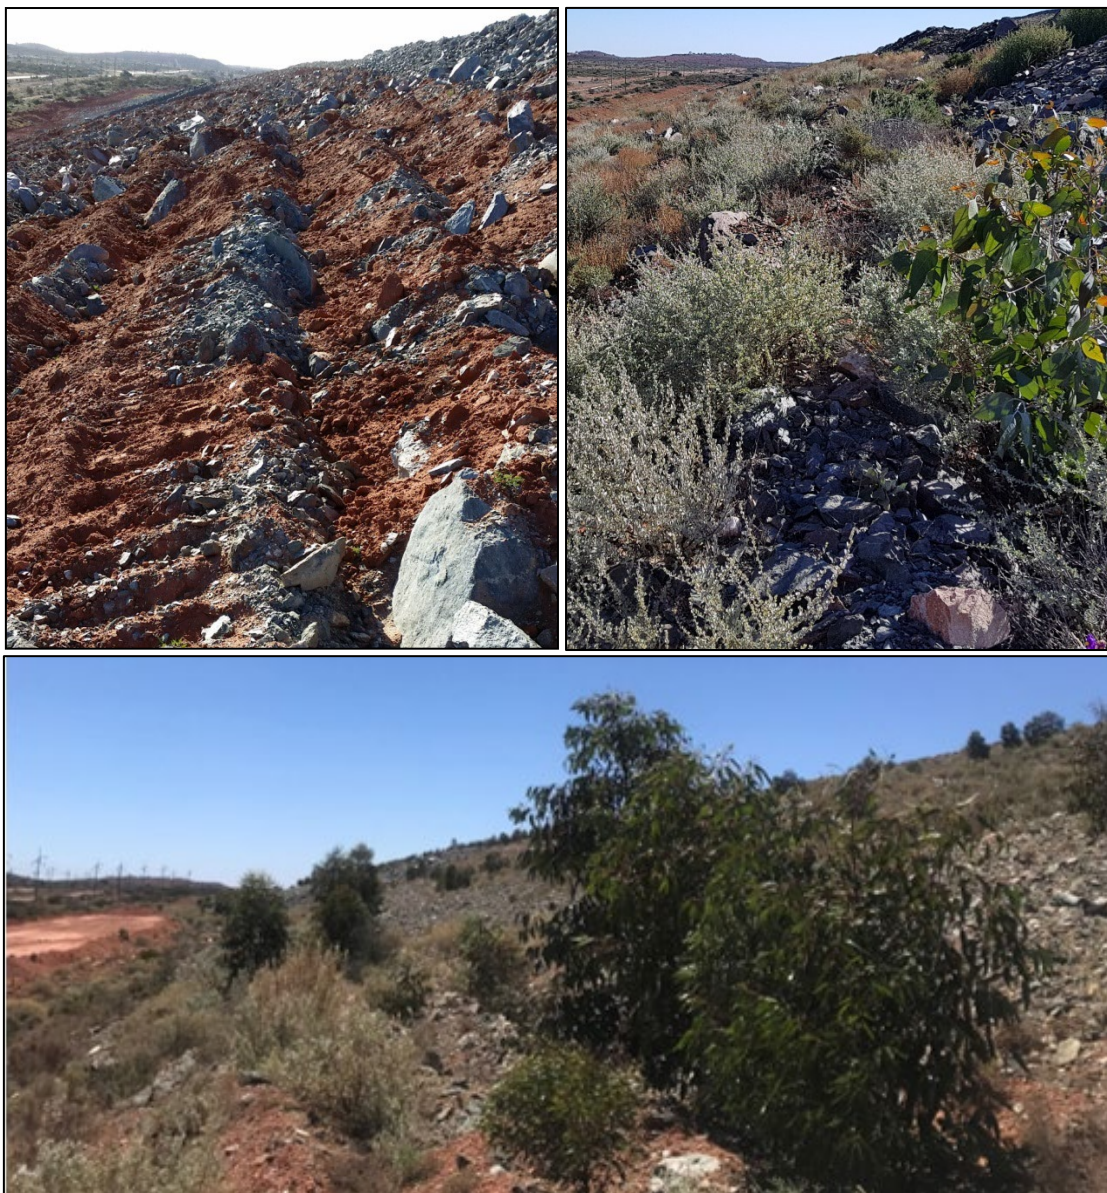
Figure 5-47: Northern WRD Western First Lift Face 2014 (top left), 2017 (top right) and 2021 (bottom)

Sections of the first and second lift of Northern WRD were used as a trial of the newly developed erosion resistant rehabilitation design. The lift was battered to 16° or 17°, with 200 mm of rehabilitation materials from nearby stockpiles applied (excluding within a rocky band 50 m up slope) and the surface ripped to produce a sufficient rocky surface cover to reduce erodibility. Rehabilitation continues on the Northern WRD when areas become available, using the same design and implementation methods. The outcomes of the trial were successful, and have been implemented across the Fimiston WRD, as new areas become available.

Hand seeding was implemented between 2014 and 2016 on these slopes, with very good vegetation recruitment. The area is showing good vegetation diversity with Eucalyptus and other perennial species noted. No erosion had been observed.

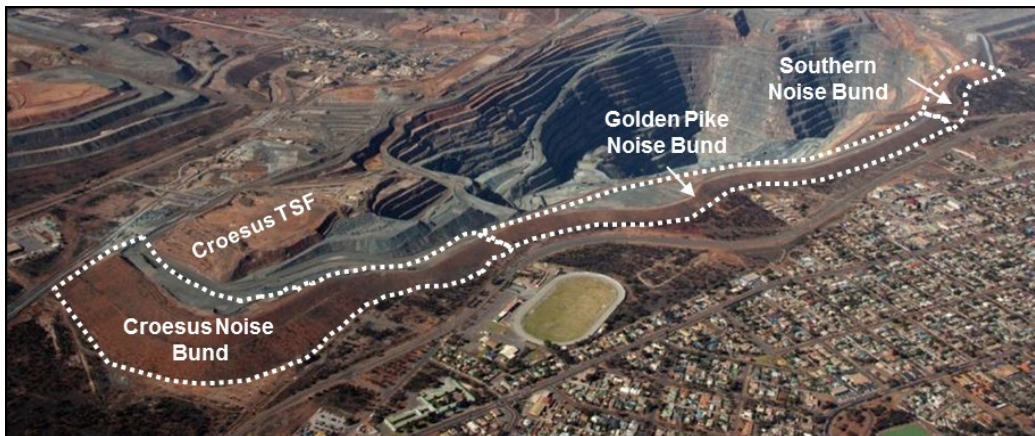
**Figure 5-49: Environmental Noise Bund**

Located on the western side of the Fimiston Open Pit, the Environmental Noise Bund has been constructed from competent waste rock (with small oxide areas) to reduce noise carried across the town from mining and processing activities. It will be retained post closure to assist with noise impact to the City of Kalgoorlie-Boulder. The ENB has three distinct sections (Figure 5-49):

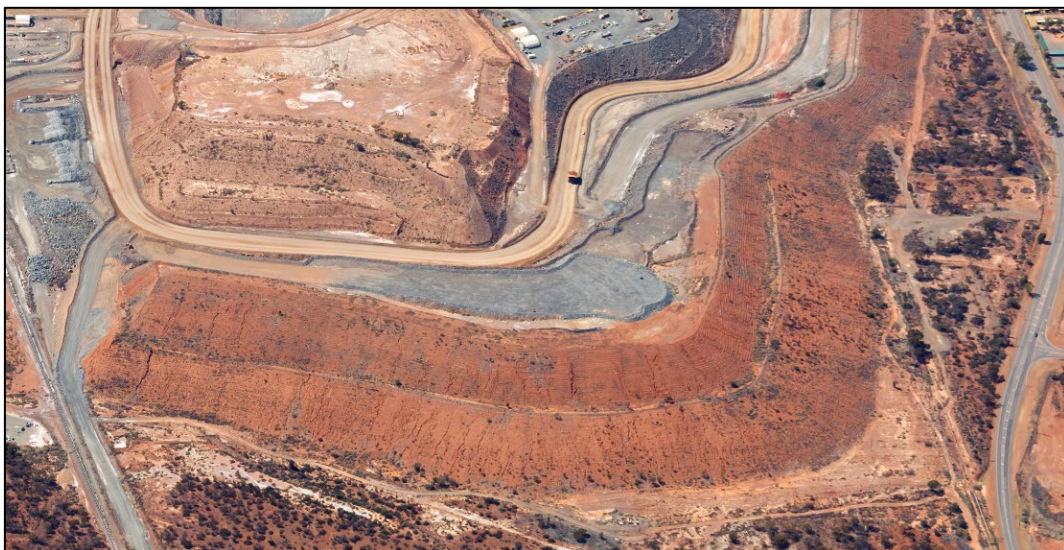
**Figure 5-50: Croesus Noise Bund (2021)**

The Croesus NB (Figure 5-50) is located at the north-western corner of the Fimiston Open Pit and is Highly Visible from the Goldfields Highway. The Croesus NB partially encapsulates the Croesus processing plant footprint (decommissioned in 1997).

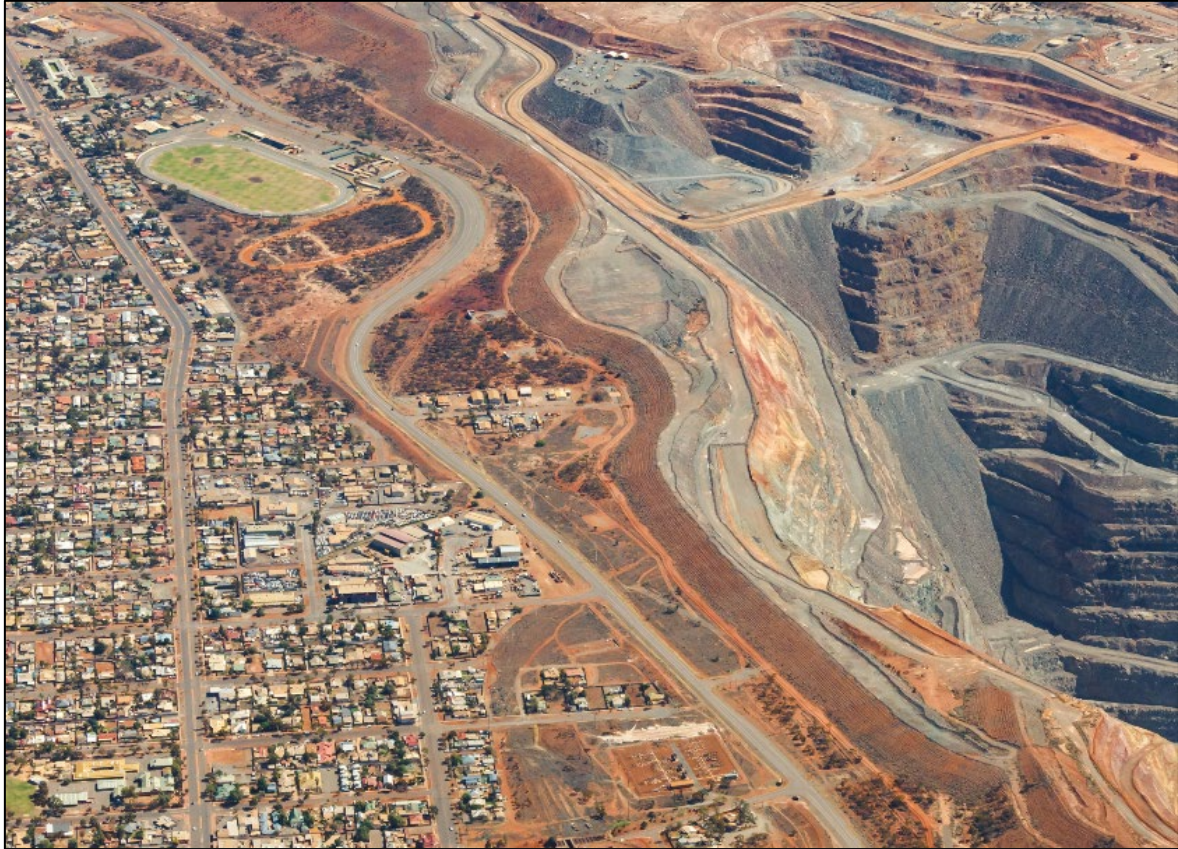
**Figure 5-51: Golden Pike Noise Bund (2021)**

The Golden Pike Noise Bund (Figure 5-51) was constructed to replace the original noise bund that was to be mined through during the Golden Pike Cutback. It is constructed from waste rock (predominately dolerite and basalt) and, in some areas, oxide material. It is a single lift and ranges in height from 14-17 m. In 2017 a wall remediation project in Fimiston Open Pit resulted in a narrowing of the width of the Golden Pike NB footprint in the vicinity of the project, with no change to the western side of the NB.

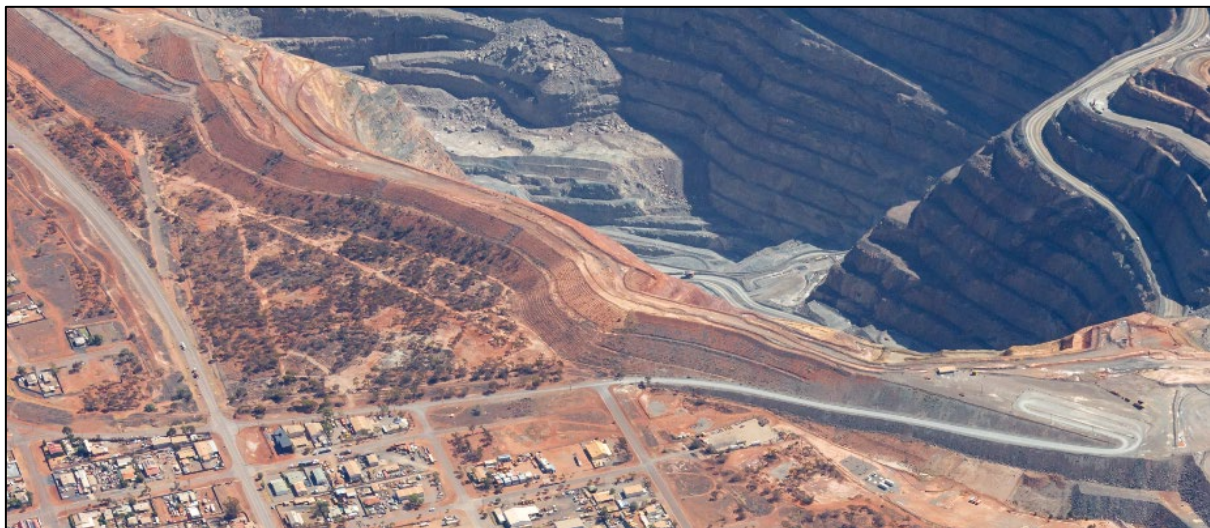
**Figure 5-52: Southern Noise Bund (2021)**

The Southern NB (Figure 5-52) was initially constructed in 1991 with one 15 m lower lift and 10 m upper lift in waste rock and oxide, and rehabilitated in 1995/1996. The southern section was constructed in 2003 from oxide and rehabilitated shortly after.

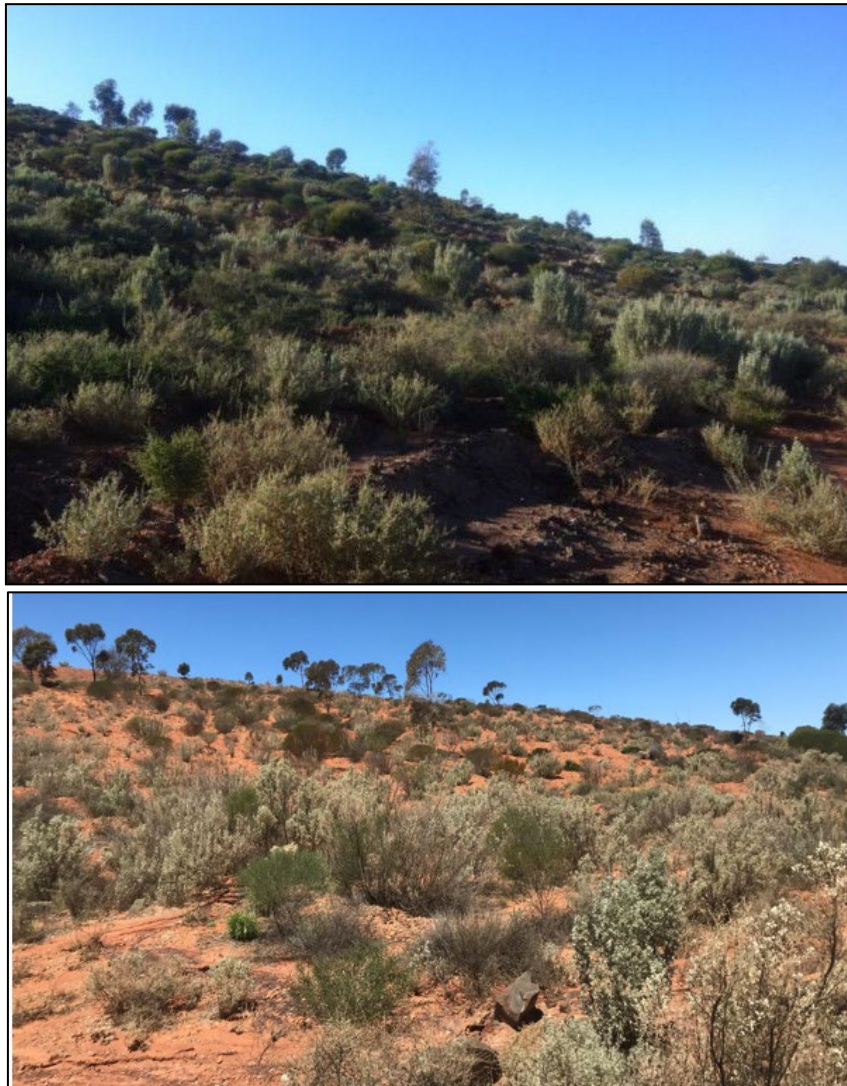
**Figure 5-54: Croesus Noise Bund Lower Lift, Western Side 2013 (top) and 2021 (bottom)**

The lower lift of the west facing northern section of the Croesus Noise Bund was rehabilitated in 2001. Rehabilitation material was applied over the oxide/hard rock material. The area was ripped, hydro-mulched and seeded. Repair work was completed on several gullies on the west facing slopes in 2003, but erosion has reformed.

In 2009, the southern section of the first lift of this waste dump was re-graded to approximately 20°, sheeted with 300 mm of rehabilitation material and seeded by hand.

Visual observations during 2012 to 2014 have highlighted vegetation success on the lower lifts. Vegetation monitoring conducted in 2014 indicated that this landform has achieved 'satisfactory' rehabilitation success, although there were marked differences in some measures between transects. Erosion monitoring of this landform in 2014 showed actively eroding gullies, most likely due to the remaining thickness of the topsoil in some areas and the low percentage rock cover on the surface.

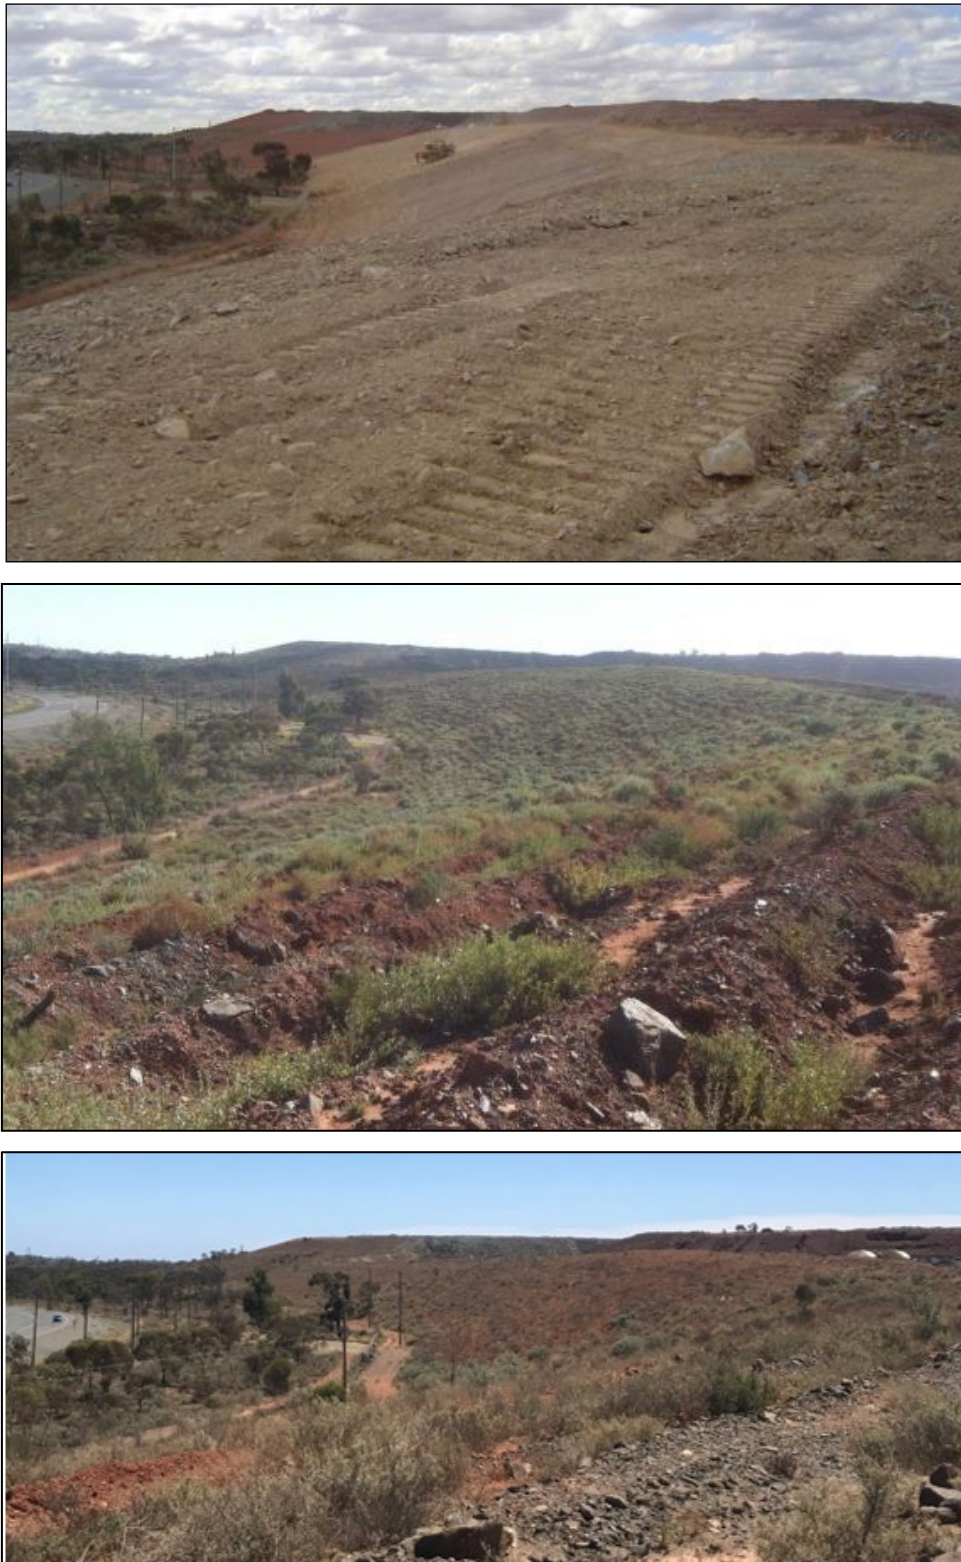
**Figure 5-55: Golden Pike Noise Bund**

Rehabilitation occurred from 2011 and 2012, consisting of re-grading to 18-20°, sheeting with 300 mm of rehabilitation material (stripped from the Golden Pike Cutback and Northern WRD footprint) and deep contour ripping and seeding with the KCGM pioneer seed mix.

Visual observations from 2012 have noted good recruitment of lower storey species and minimal erosion (Figure 5-55). There is a small section of gullying which developed following large rainfall events in early 2013 where insufficient water control on the dump top led to ponding against the crest bund, with eventual failure of the bund. Due to the depth of material placement, gullying depth is limited by underlying waste rock and is unlikely to continue to deepen.

*(Top: Battering 2011. Middle: 2013 Progress of rehabilitation Bottom: 2021)*

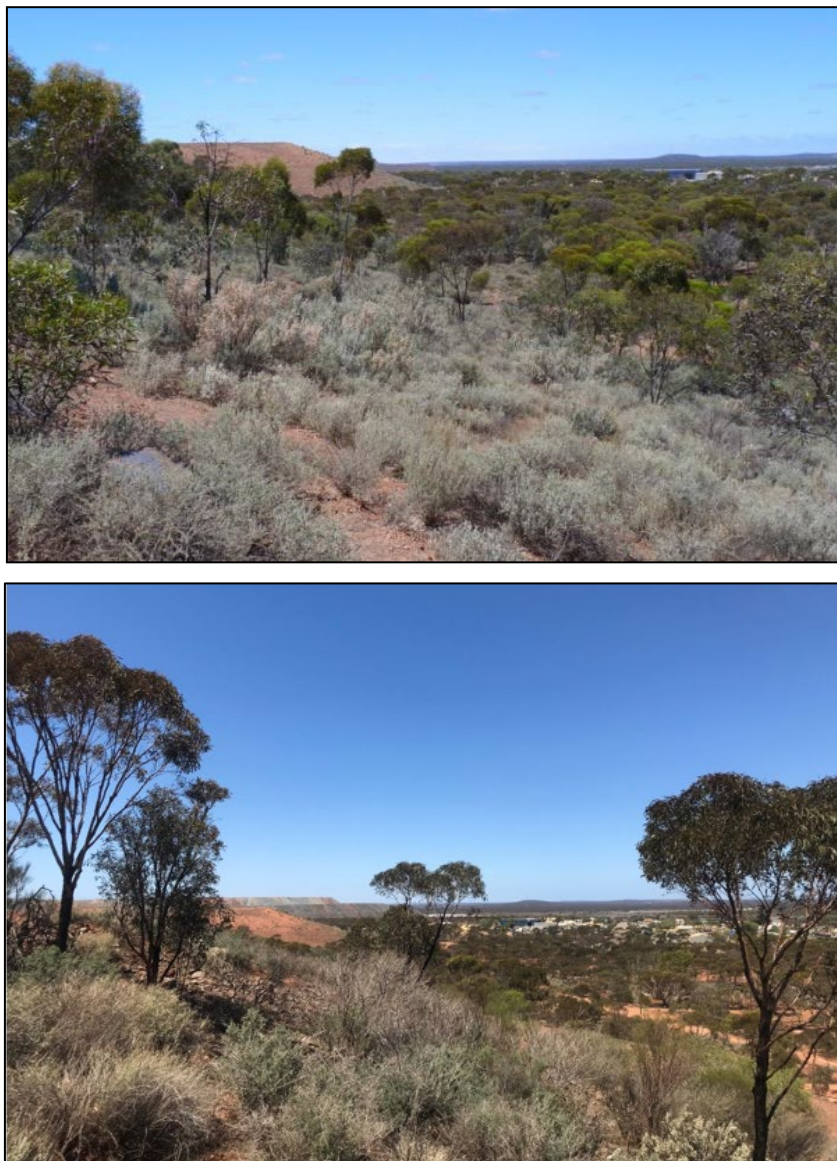
**Figure 5-56: Southern Noise Bund Lower Lift Status of Rehabilitation 2013 (top) and 2021(bottom)**

Visual observations from 2012 have indicated that the lower lift has excellent vegetation condition with high diversity, all three strata and several species indicating the community has attained some level of resilience (Figure 5-56). The upper lift is not performing as well, with limited species diversity and cover, possibly due to quality of rehabilitation material used. Some gullying has been observed in the northern section within rock drains, although this appears to be self-armouring.

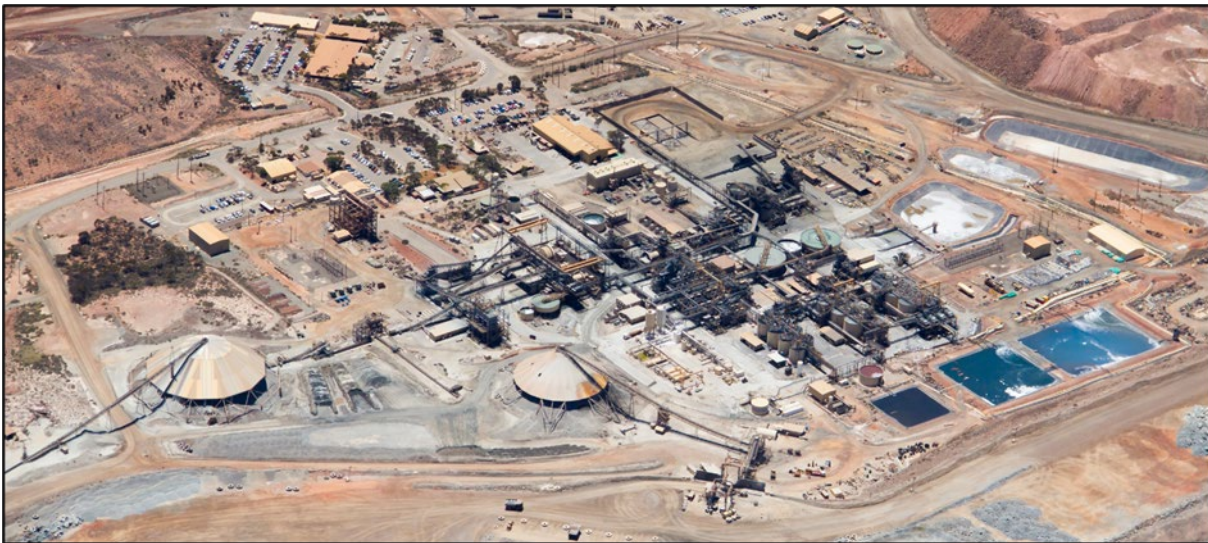
**Figure 5-57: Fimiston Processing Plant, facing west**

The Fimiston Processing Plant (Figure 5-57) was constructed with the inception of the KCGM Fimiston Open Pit in 1989. It covers approximately 20 ha, and is located to the east of the Fimiston Open Pit. Two parallel circuits process refractory sulphide ore from the Fimiston Open Pit and Mt Charlotte Underground Mine. The licenced milling production rate at Fimiston is 14.5 Mtpa. During operations, ore processing at Fimiston is managed in accordance with DWER Part V Licence Conditions. The Fimiston Plant was reported to the DWER as a potentially contaminated site (AOC57).

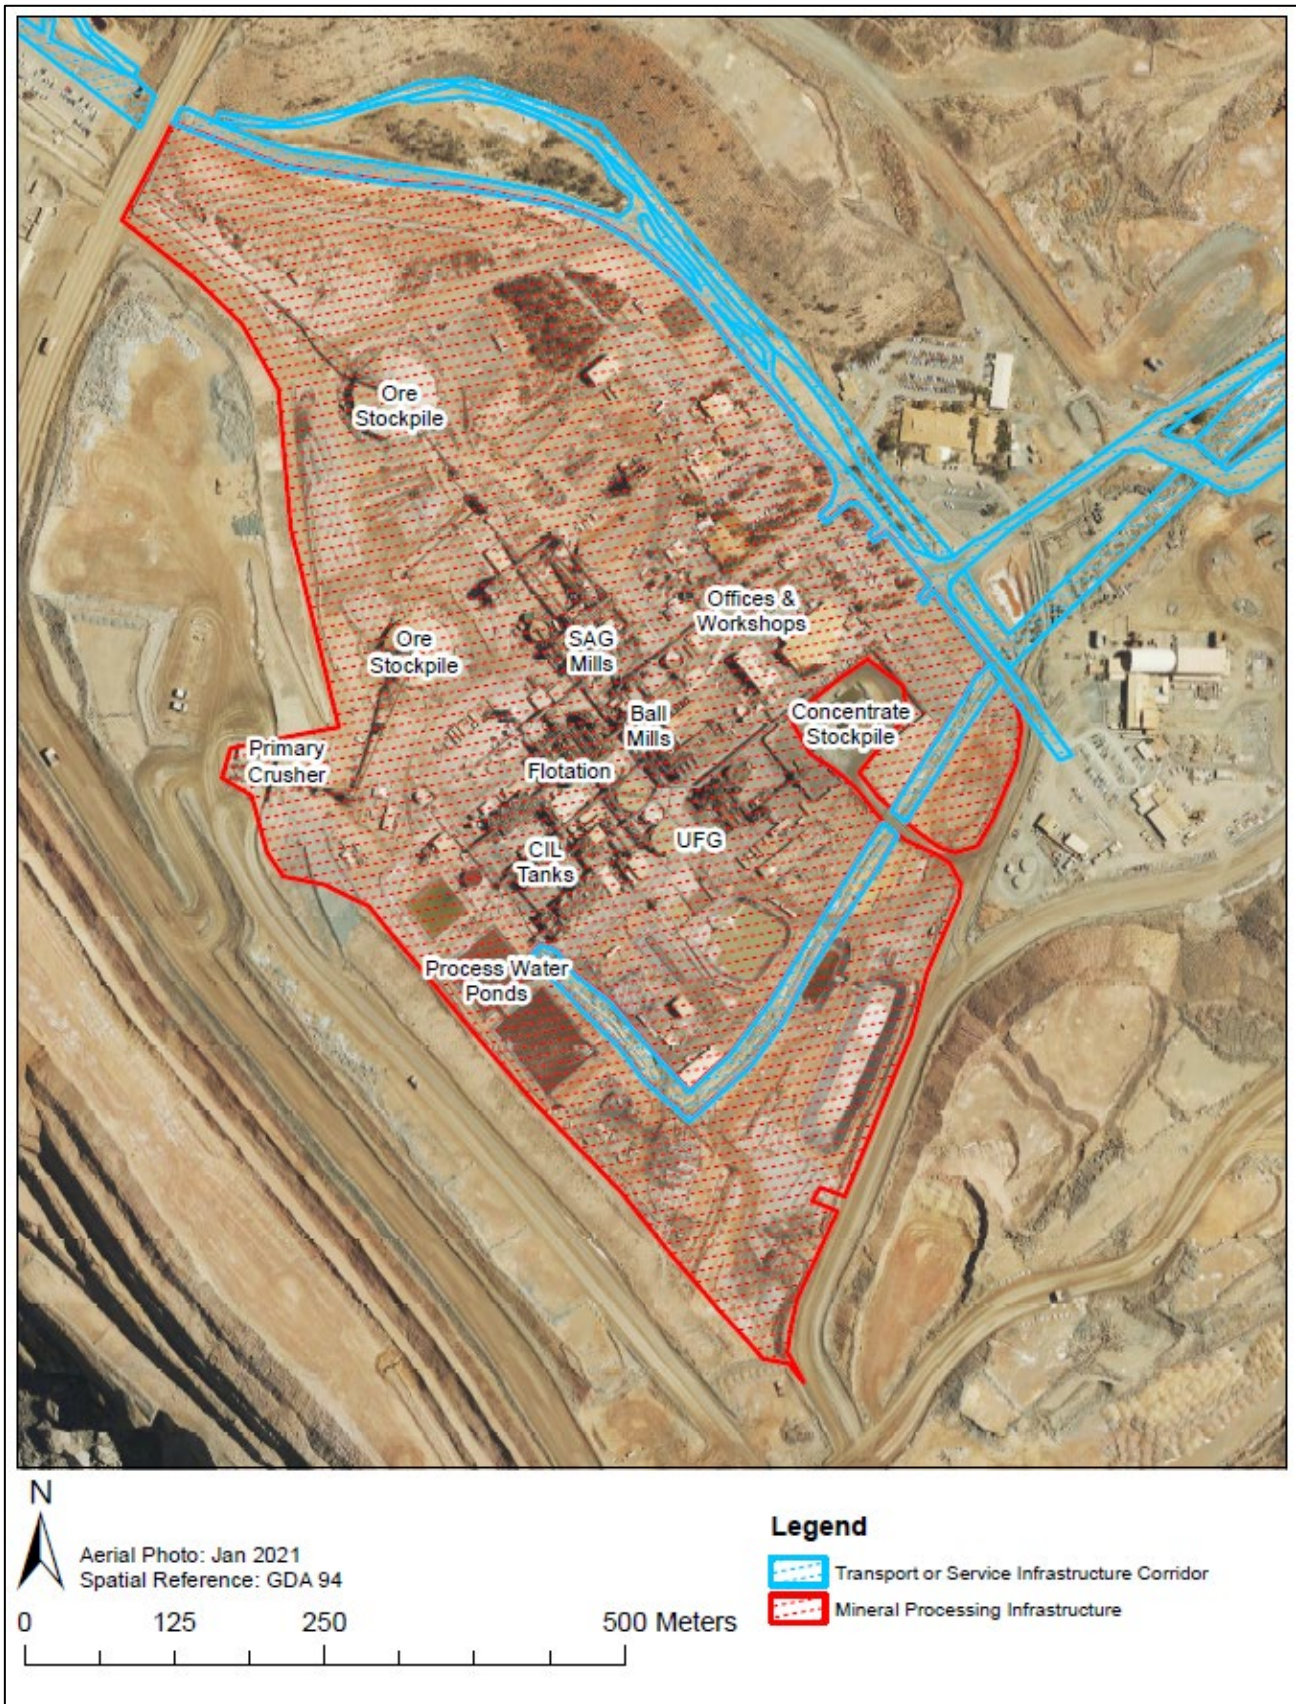
Figure 5-58: Fimiston Processing Plant

The plant comprises (as shown in Figure 5-58):

In the flotation circuit, the gold bearing refractory sulphide is separated and referred to as concentrate. The concentrate is de-slimed (removal of the very fine fraction), with the slimes then leached to recover the contained gold at the Fimiston Plant. The coarse fraction is then separated into two streams. Currently, one stream is washed, filtered, and transferred to the Gidji Processing Plant for further processing. The other stream is directed to a UFG circuit at Fimiston. The UFG reduces the particle size of the concentrate to expose enough gold surfaces to facilitate cyanide leach recoveries. After grinding, it joins the slimes to be leached at the Fimiston Plant in the two cyanide CIL adsorption circuits where the gold is extracted. The Fimiston Plant also comprises elution, electrowinning circuits and facilities for smelting, pouring and production of gold bullion.

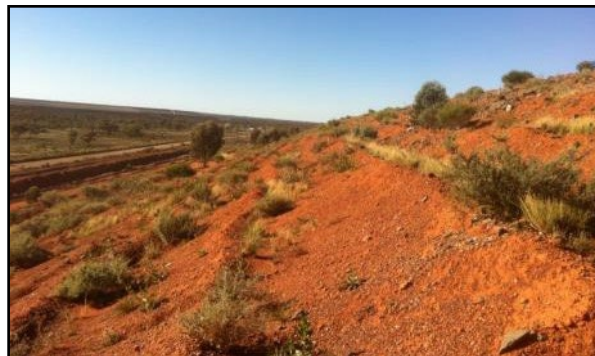
**Figure 5-62: Typical Fimiston I TSF Batter (2013)**

Rehabilitation reports record that oxide waste rock and topsoil was pushed up the eastern TSF slopes in 2005. Visual observation indicates that the tailings material was capped with competent rock at depths of up to 5 m. A topsoil or oxide material has been placed over this at depths of approximately 1 m. The upper surface of the rock cover is compartmentalised and has a crest bund to assist with water control. Due to steepness of the external embankments, the eastern slopes could not be ripped on the contour. Instead, the slopes were shaped using the blade of a D6 dozer that moved progressively up the slope and then pushed the topsoil material to form furrows. This produced very shallow banks and troughs on the rehabilitated slopes (Figure 5-62) which were then seeded. The steep slopes have experienced erosion, but have high values for plant species diversity. Visual observations in 2013 indicate good vegetation recruitment, although the steep batters and excess material placement have resulted in gully formation and erosion continues to be an issue on the eastern side, with poor water control on the mid bench.

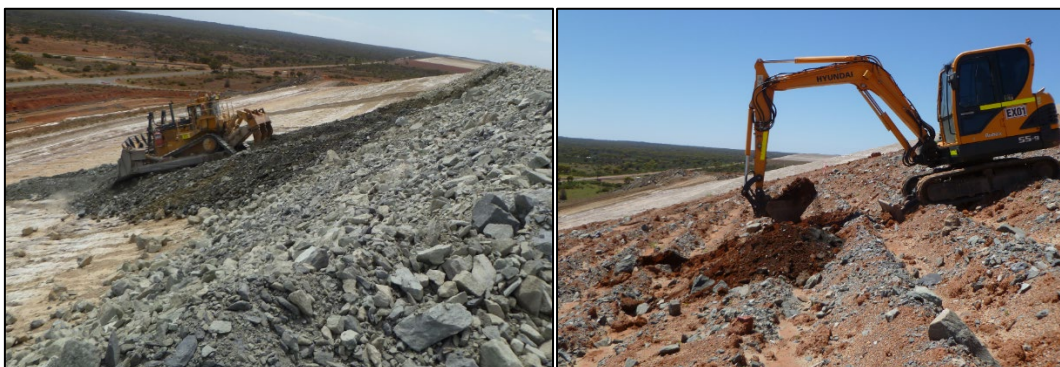
**Figure 5-63: Fimiston I TSF Trial Earthworks in Progress (2016 and 2017)**

A trial of the proposed Fimiston TSF rehabilitation design was undertaken on a 1 ha area on the northern flank during late 2016 into early 2017. Objectives of the trial were to conduct earthworks to identify the optimum equipment and methodology for implementation, including slope preparation. Three plots were constructed, with varying cover thicknesses, trialling a modified version of the erosion resistant cover design successfully used on the Fimiston WRDs. Investigations also included the selection of suitable capping material from the adjacent WRD. After completion of the earthworks, excavations were done to inspect the profile of the cover. This information was fed into implementation planning for Fimiston II TSF rehabilitation works, which commenced in 2019.

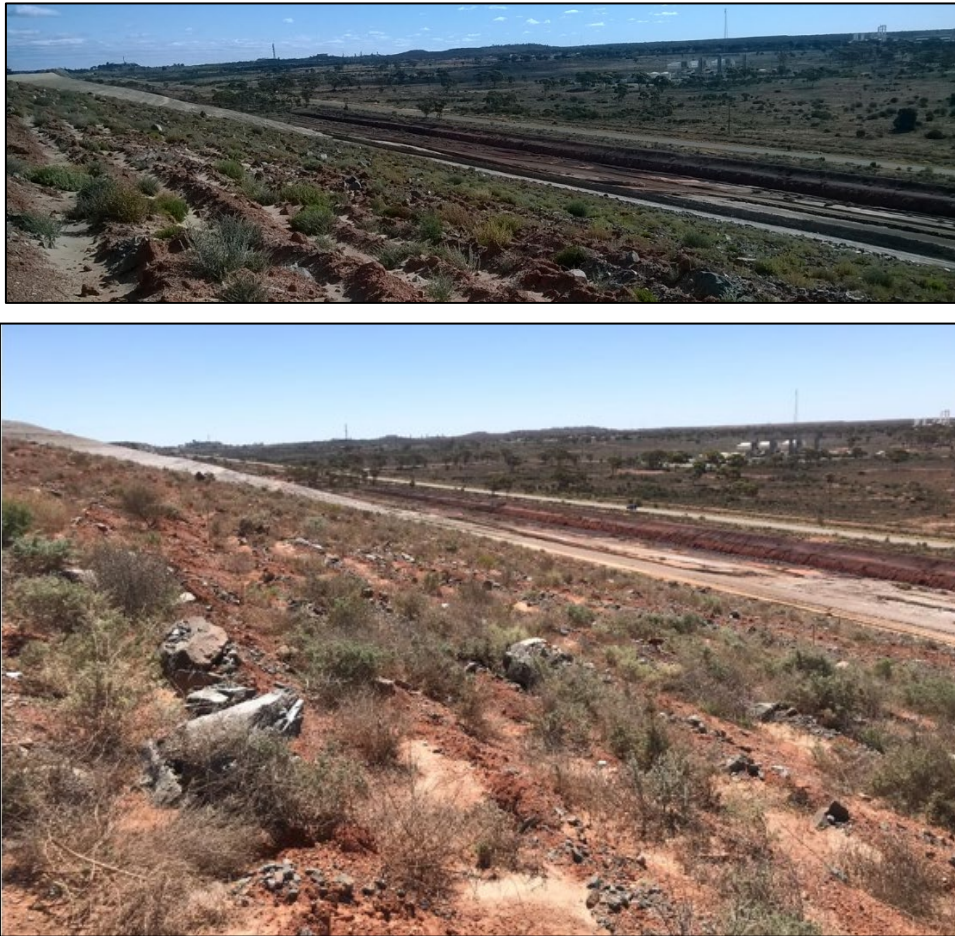
**Figure 5-66: Fimiston I TSF Cover trials, Above, 2017 and Below, 2021**

Topsoil that had been stockpiled for over 20 years was used on the trial area. An intense rainfall event occurred immediately after topsoiling, with very good germination and subsequent vegetation growth. No further seeding was done, all growth was a result of the seed bank within the stockpile. It is worth noting that the topsoil stockpile was higher than the standard 2m high and had hardset, to the point of equipment refusal. However the seed bank within the stockpile was preserved. It is thought that the height and dryness of the inside of the topsoil stockpile acted as a vault for seed preservation.

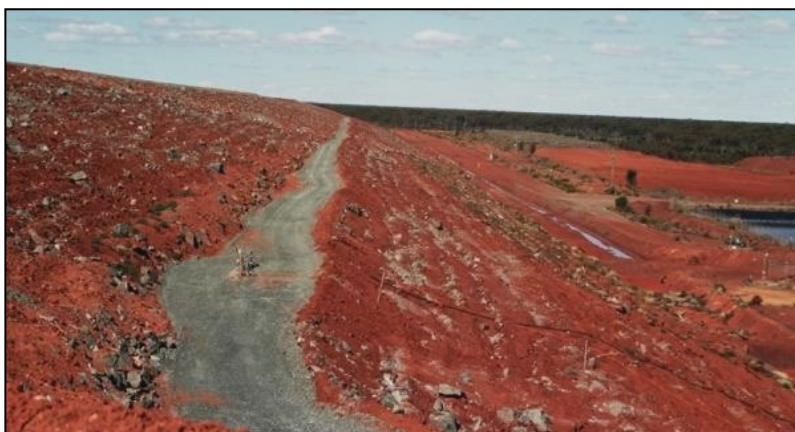
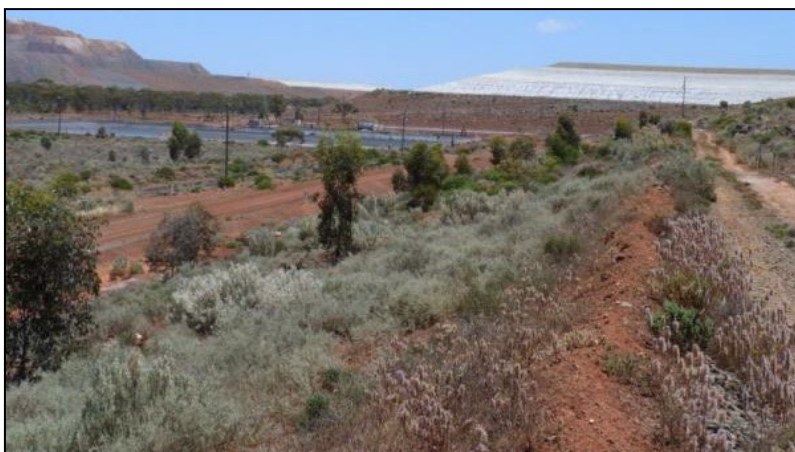
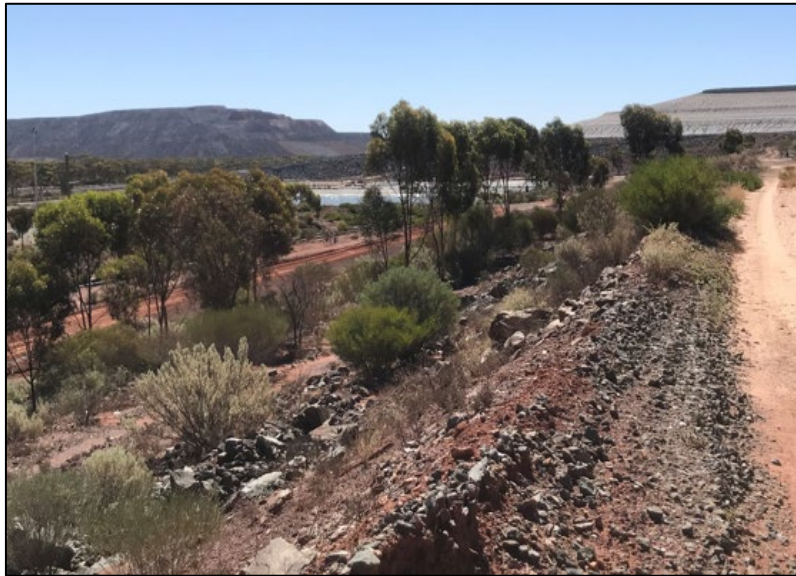
*Facing East 2004 (top). Facing North 2013 (middle) & 2021 (bottom)*

### **Figure 5-70: Fimiston II TSF 2003 Rehabilitation of Lower Lifts**

Fimiston II starter embankment and the first tailings lift were rehabilitated from December 2000 to 2003, commencing with the northern batter and working around to the western batter. The tailings material was covered with 1 m of hard rock and 300 mm of topsoil, with rock lined drop drains installed in some of the rehabilitated areas to facilitate surface water control. Seed was applied at a rate of 9 kg/ha using a hydro-mulcher, which sprayed the seed mix combined with fresh water and shredded newspaper.

This area of rehabilitation was “On track, continue monitoring” during 2011 LFA monitoring (Outback Ecology, 2012a). All key indices of ecosystem function (stability index, erosion, and lower storey plant cover) were within the average regional range. Vegetation is predominantly chenopod shrubs with a limited overstorey of perennial species. Visual observations indicate that vegetation recruitment is reduced in northern areas, possibly as a result of the harsh aspect and significantly reduced rainfall in recent years. Visual observations from 2012-2014 indicate that the south western slopes, with a southern aspect, shows particularly good vegetation growth and appears to be relatively stable with minimal erosion (Figure 5-70).

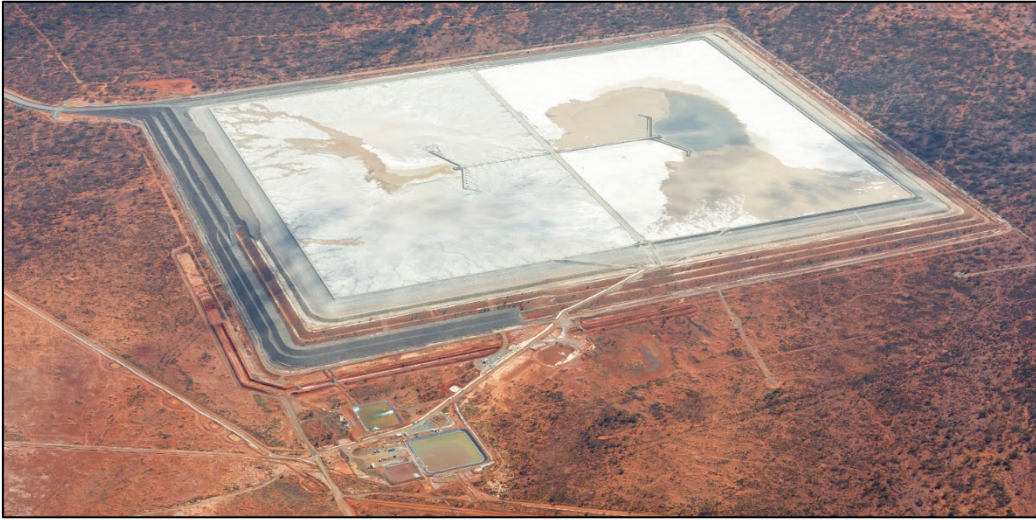
**Figure 5-79: Kaltails with Buttress (2021)**

During the period 2019 to 2020, a rock buttress was placed on the lower flanks for the Kaltails TSF to ensure geotechnical stability criteria will be met for future lifts (Figure 5-79). Since then the buttress has been extended several times and will continue to be enlarged while the TSF is operational. The entire lower outer slopes will be buttressed by closure.

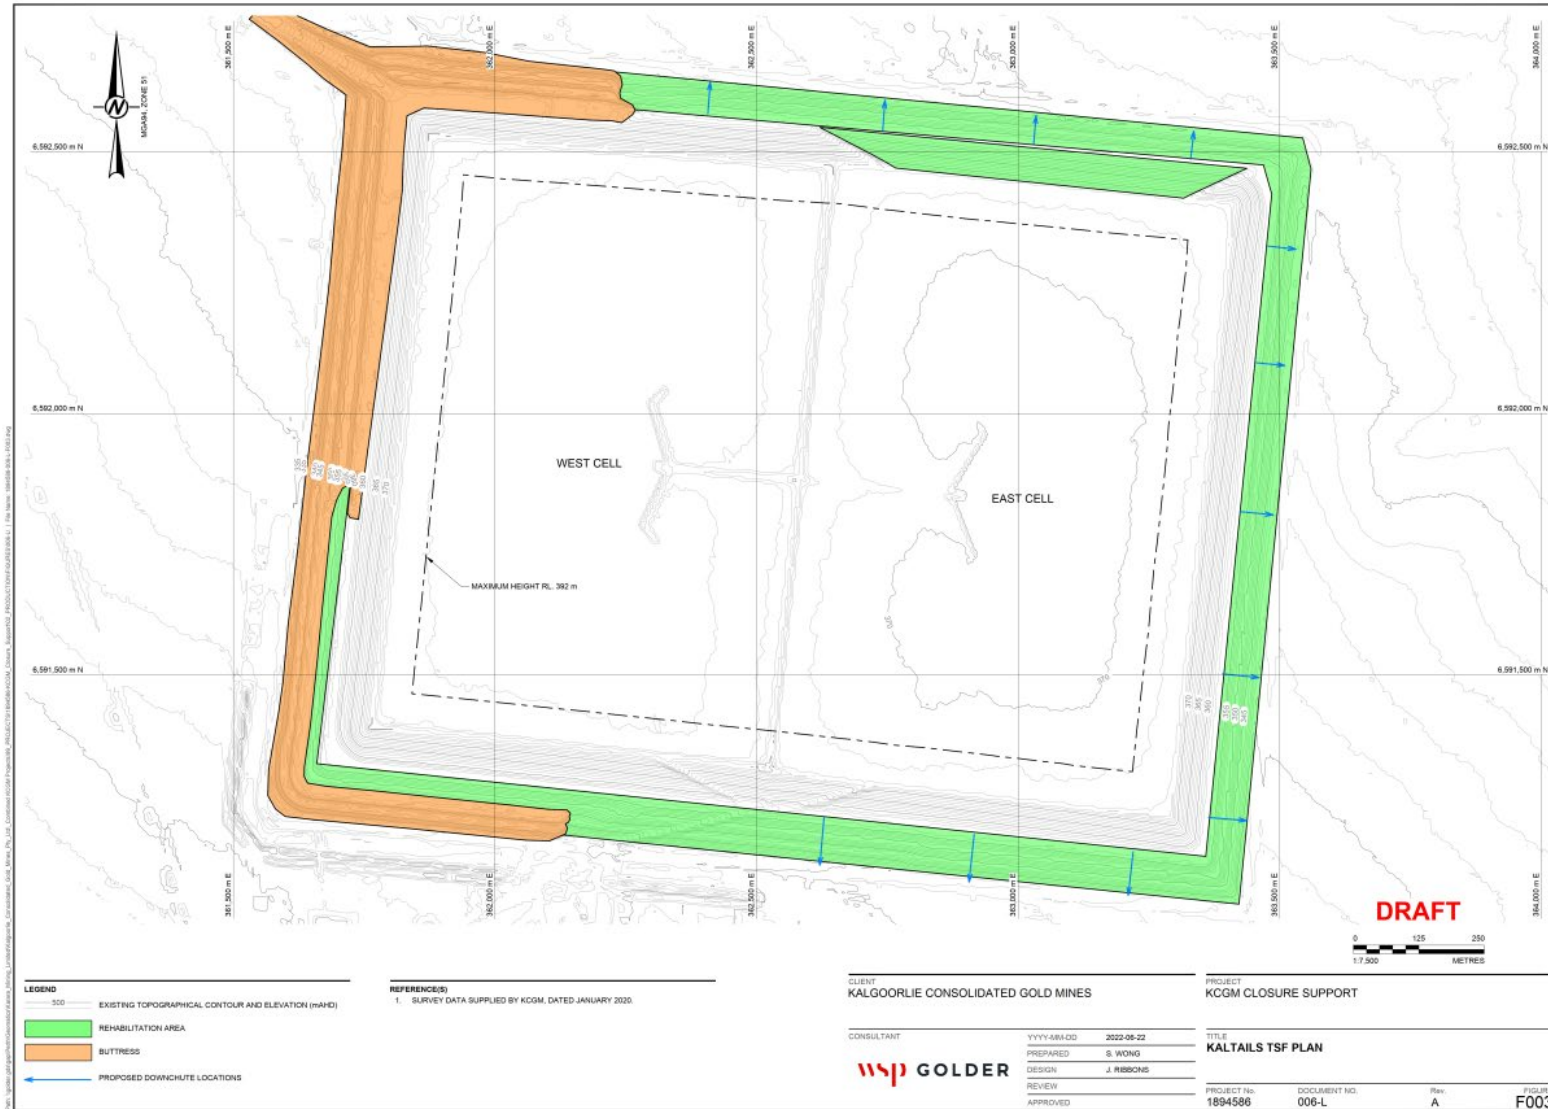
Figure 5-80: Plan View of Kaltails TSF (2020)

The Kaltails TSF was originally comprised of three cells, each with approximate dimensions 500 m by 1200 m. Embankments were constructed through the centre of each cell, resulting in a configuration of six cells, each measuring approximately 500 m by 600 m. In 2011, KCGM re-commissioned the TSF by dividing the deposition area into two equal rectangles, each roughly 750 m by 1200 m in extent (Figure 5-80) (Golder, 2013). The approved height is 60 m, with outer slopes of 16-18° (Figure 5-81).

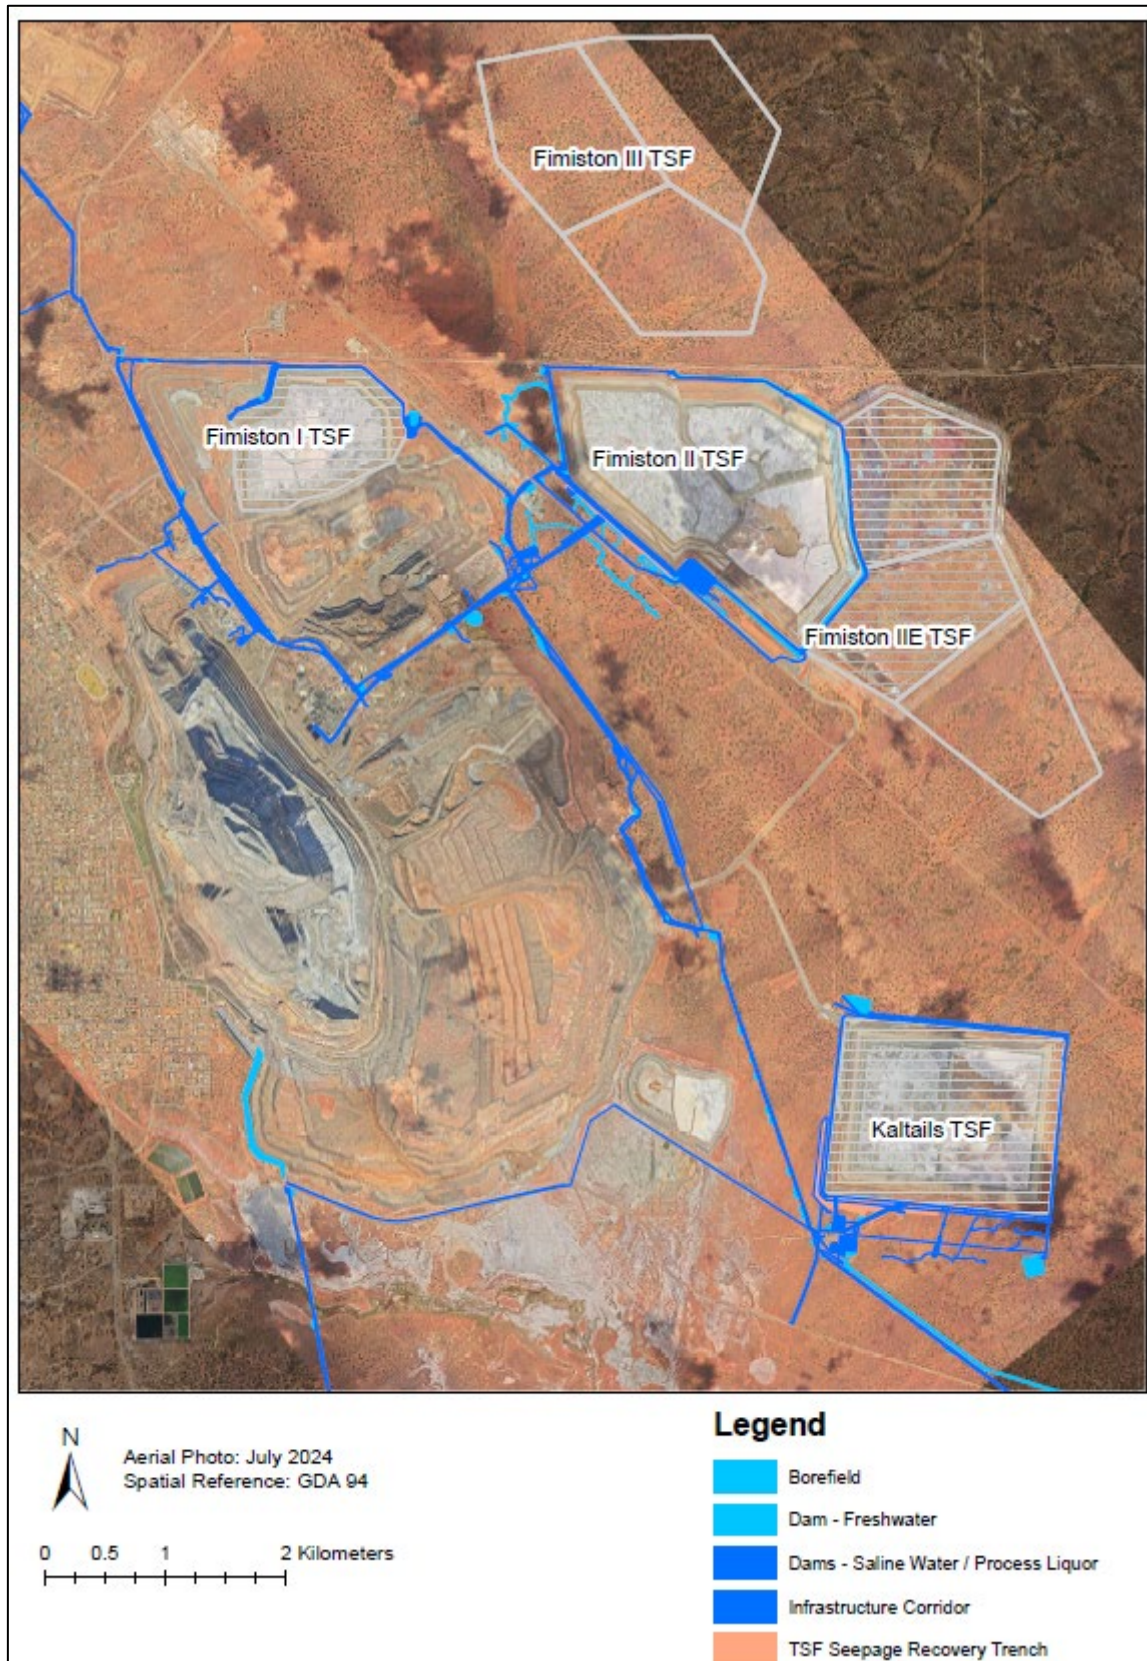
**Figure 5-83: Water Containment Facilities Domain and Site Dams Feature**

This feature consists of lined fresh and saline water dams, Fimiston seepage interception borefield (Eastern borefield, between Fimiston I and Fimiston II TSFs), Kaltails seepage interception borefield (Kaltails TSF borefield) and Trafalgar Production Borefield and associated bundled pipelines at the Fimiston Operational Area (Figure 5-83). The borefields have DWER licences. The site dams are used for fresh or saline water storage or management. All dams used for the storage of process and saline waters are lined. The saline water transfer ponds have been reported to the DWER as a potentially contaminated site (AOC88). Site dams will be progressively rehabilitated when they are no longer required (Figure 5-83).

The Fimiston Seepage and Groundwater Interception System (Figure 5-83) is located around the Fimiston I and Fimiston II TSFs and consists of production and monitoring bores (called the Eastern Borefield), trenches, pipelines and dams.

The Kaltails Seepage Interception System (Figure 5-83) is located around the Kaltails TSF and consists of production and monitor bores, trenches, pipelines and dams.
