# KCGM Mine Closure Plan 2025 (v1) Volume 1 of 3

Mineral Field 26

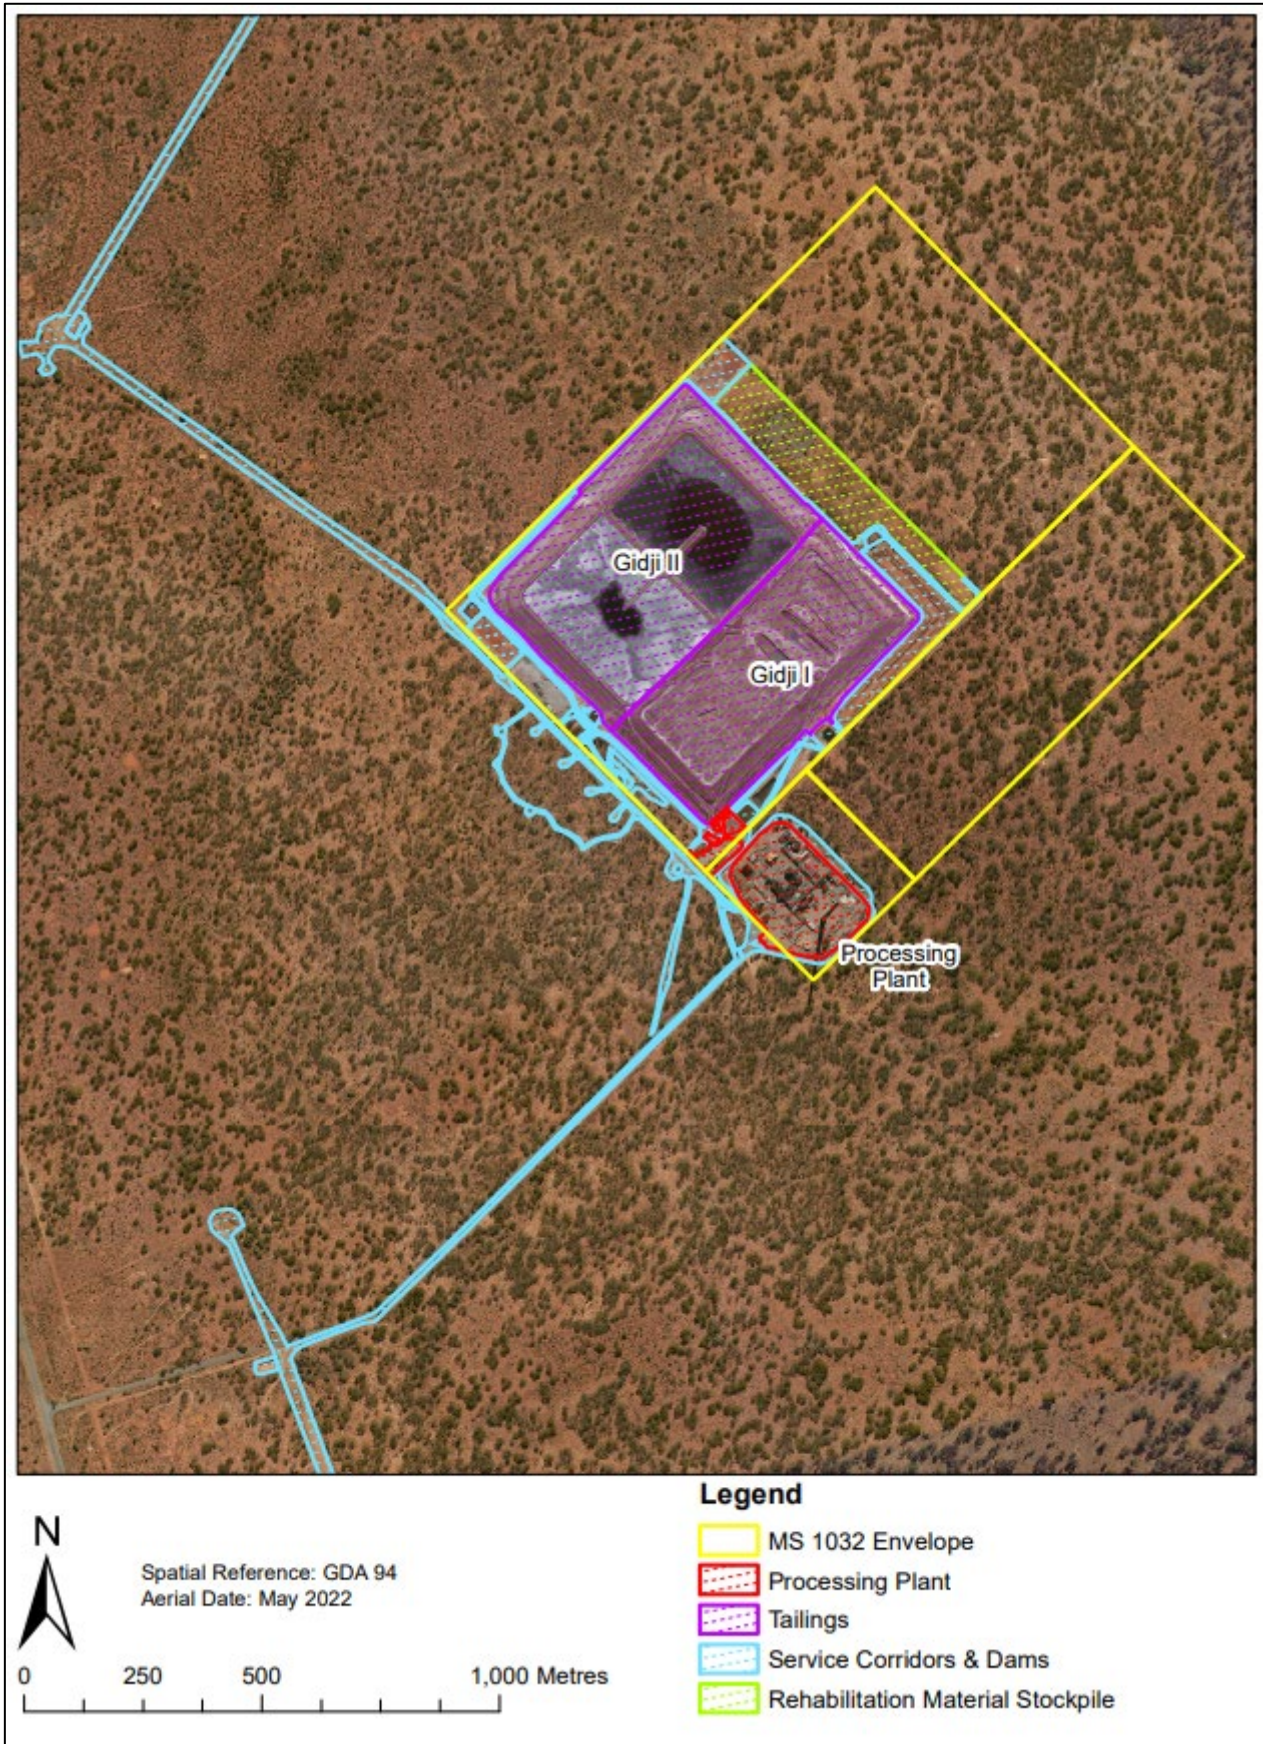
Figure 5-84: Gidji Operational Area, including Processing Plant and Tailings Storage Facility

The Gidji Operational Area is located 17 km north of Kalgoorlie-Boulder. The Gidji Operational Area consists of two main areas – the Gidji Plant and Gidji TSFs. The Gidji Operational Area, shown in Figure 5-84, will remain operational until 2034.

The Gidji Tailings Delivery and Decant Return Water Pipelines (Figure 5-84) are currently active and will remain active until the planned completion of mineral processing in 2028. The pipelines are double skinned and banded.

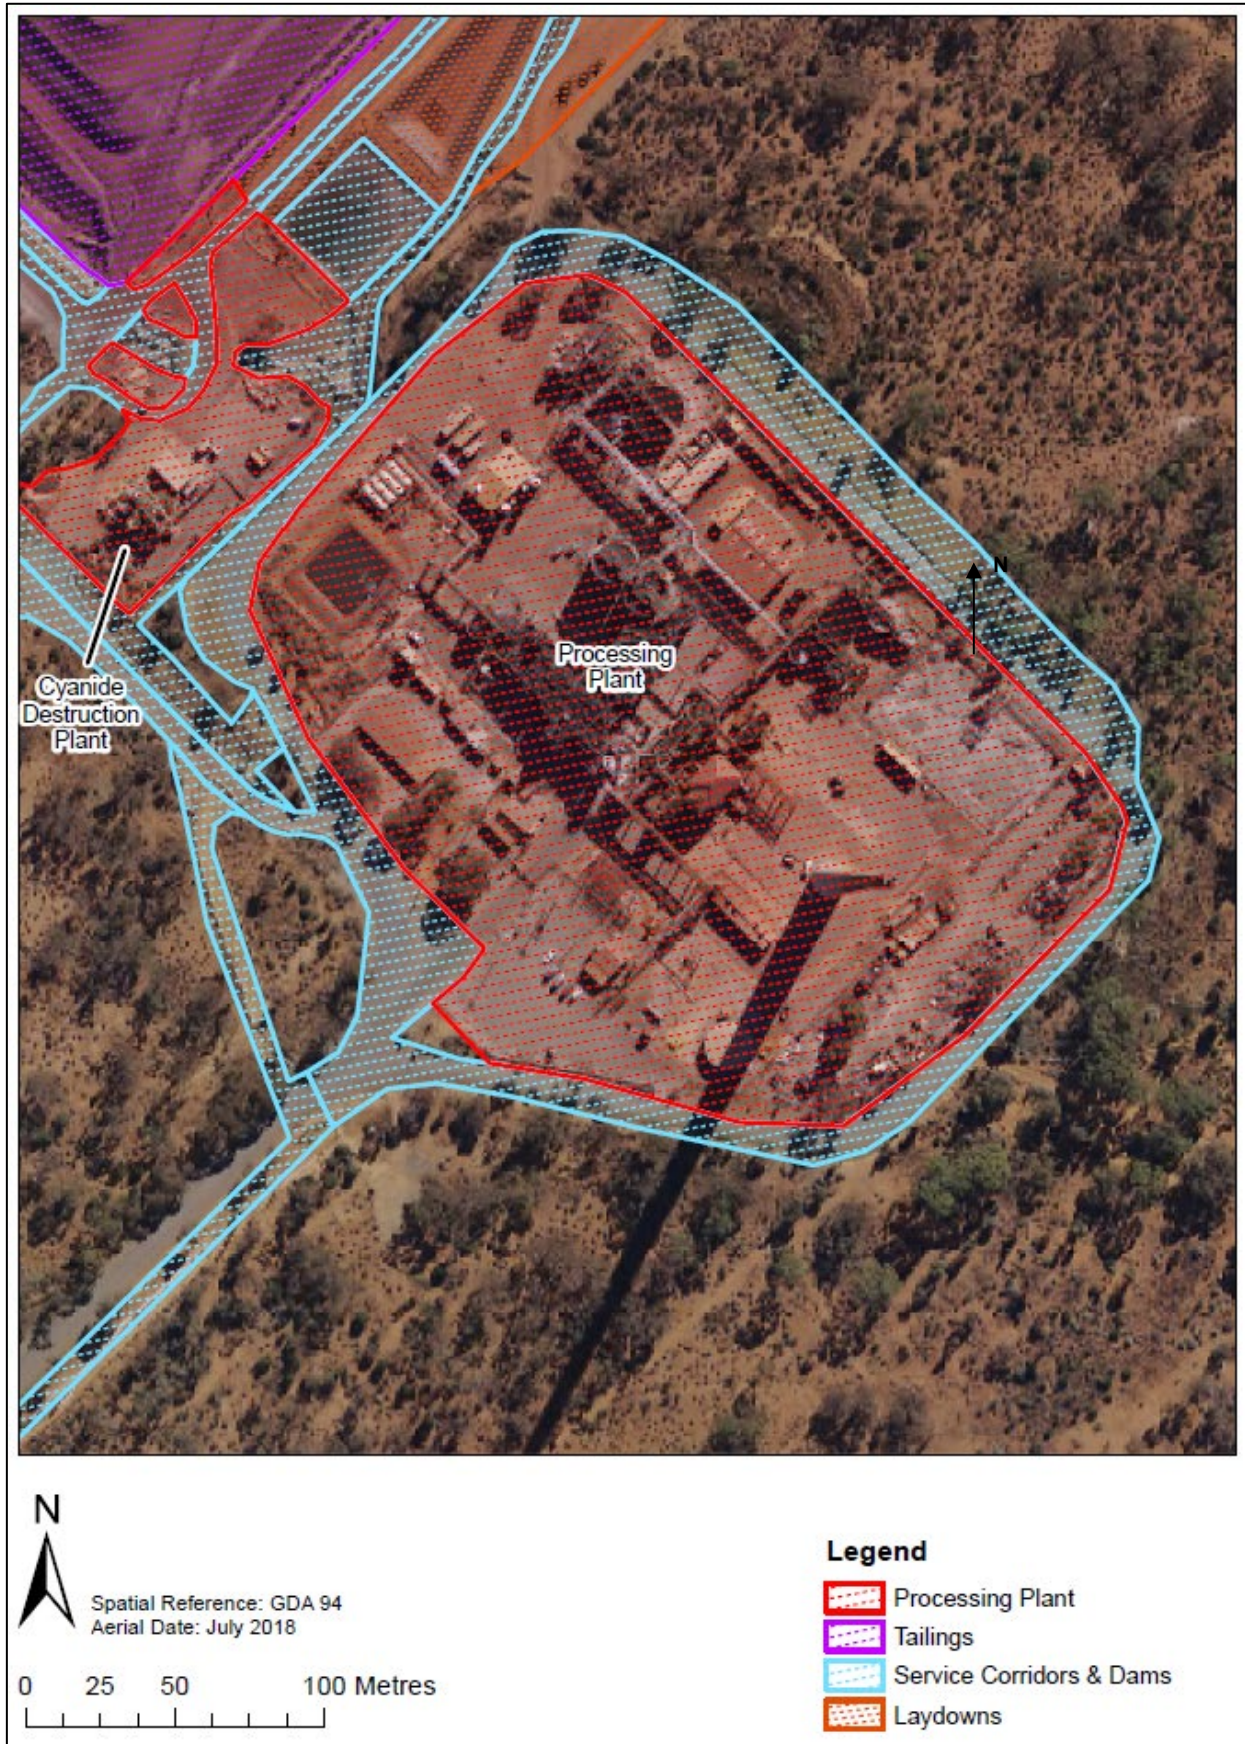
Figure 5-86: Gidji Processing Plant

The Gidji Processing Plant (Figure 5-85 and Figure 5-86) was commissioned in 1989 to treat concentrate from the Fimiston Plant. This provided the opportunity for the phased decommissioning of the remaining three in-town roasters and the establishment of a central roasting facility, Gidji, located 18 km north of the City. The facility covers approximately 5 ha. The Gidji Processing Plant is licenced for a throughput of 438,000 tpa of gold concentrate produced by the Fimiston Processing Plant.

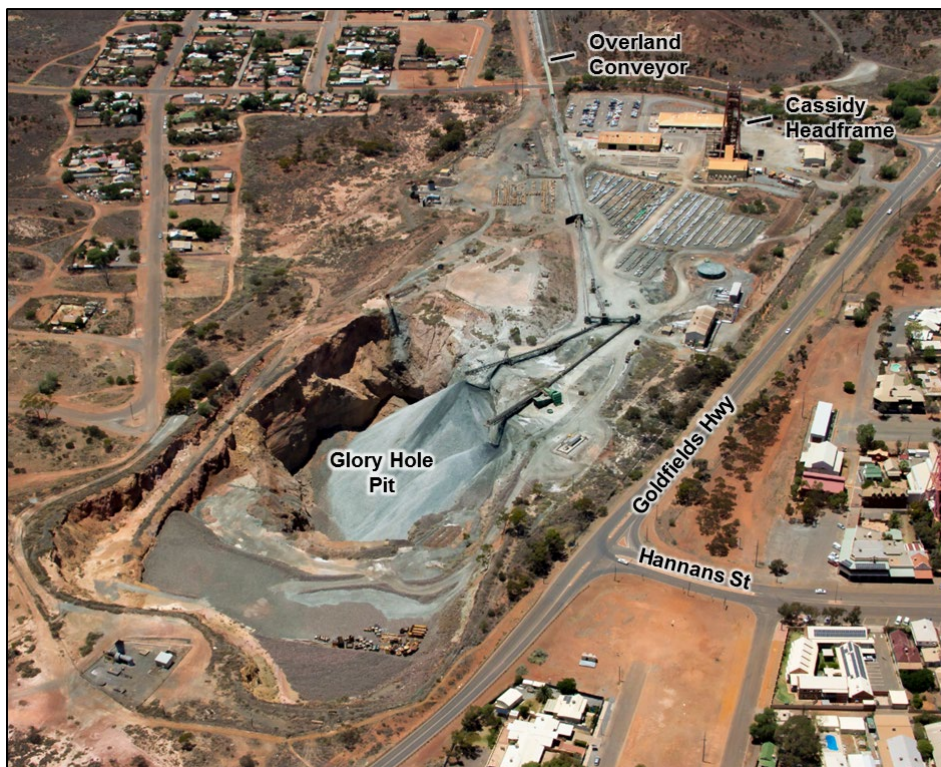
Figure 5-94: Mt Charlotte Mining Infrastructure

Mt Charlotte Mining Infrastructure includes (Figure 5-94):

- Glory Hole Pit;
- Underground Mine; and
- Surface Operations (including headframe, conveyor and core yard).

The Mt Charlotte (Glory Hole) Pit is located immediately to the north of the Cassidy Headframe, located at the eastern end of Hannan Street (Figure 5-94). It covers an area of 5 ha, has a maximum depth of 64 m, maximum length of 350 m and maximum width of 200 m. When the Mt Charlotte E1 crown pillar present in the underground workings below the pit was removed in 1978, the Mt Charlotte Open Pit was joined with the underlying stopes of the Mt Charlotte Underground Mine. The volume of the open pit is estimated at 953,700 m<sup>3</sup>. Crushed rock from the Fimiston

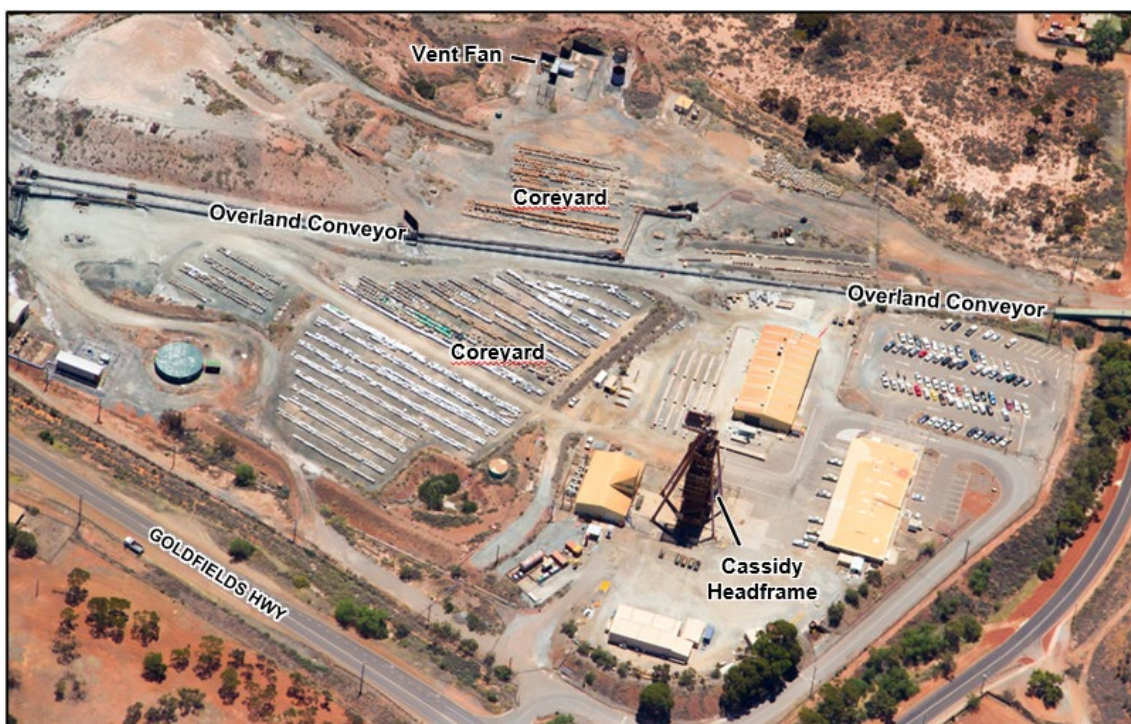
**Figure 5-95: Mt Charlotte Surface Infrastructure**

- Coreyards and shed;
- Cassidy Headframe and winder room; and
- Overland Conveyor.

Several sheds and disused offices (used when the headframe was the primary access point for the underground mine) also exist. Small workshops and hydrocarbon storage are also present.

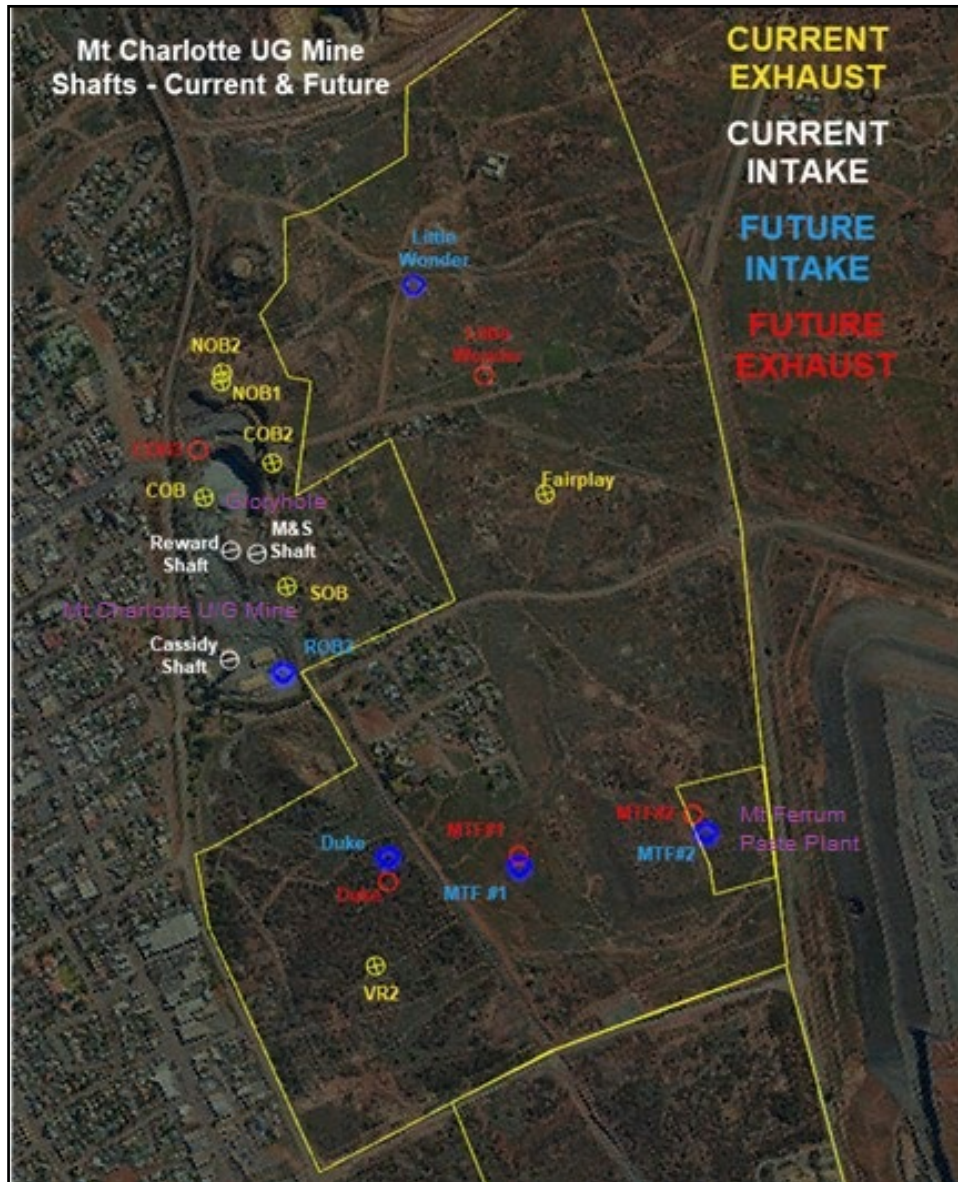
Figure 5-96: Location of Mt Charlotte U/G Mine Surface infrastructure

SHAFT OR VENT RISE	DIAMETER OR AREA
COB 3 Exhaust Rise	5 m diameter
MTF #1 Exhaust Rise	5 m diameter

MTF #2 Exhaust Rise	5 m diameter
Little Wonder Exhaust Rise	5 m diameter
Duke Exhaust Rise	6 m diameter

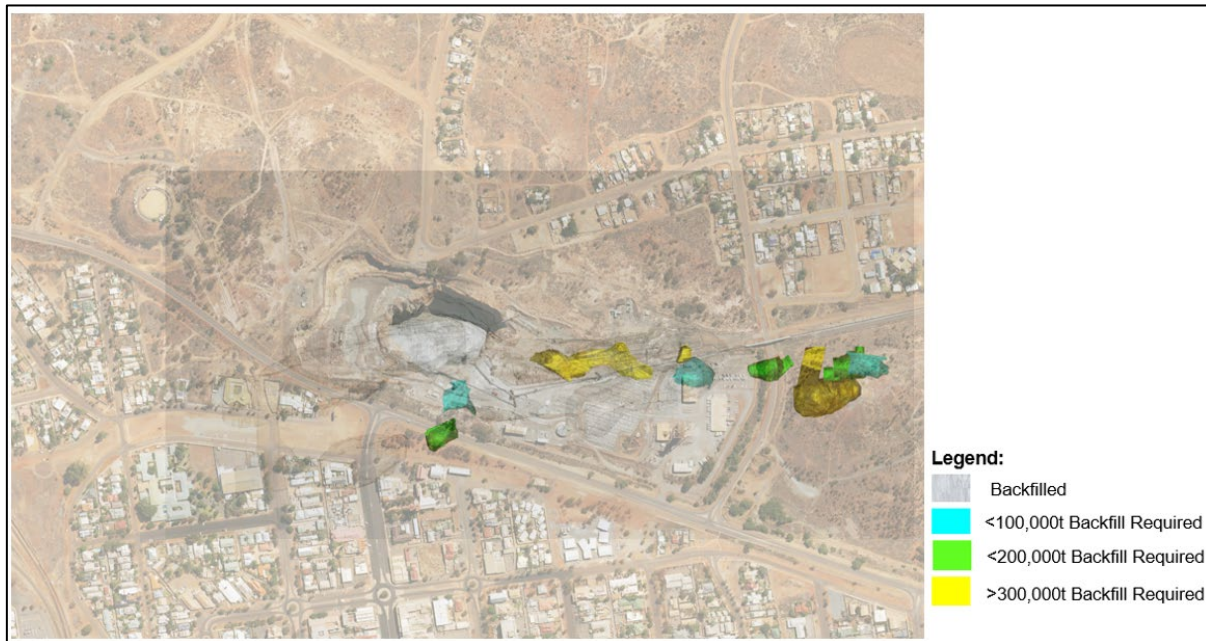
**Figure 5-100: Projection of Various Mt Charlotte (Cassidy area) Mine Voids to Surface**

The overall risk to surface infrastructure is limited by the depth of the primary voids below surface. Figure 5-100 shows the “footprint” of the mine void levels projected to surface.

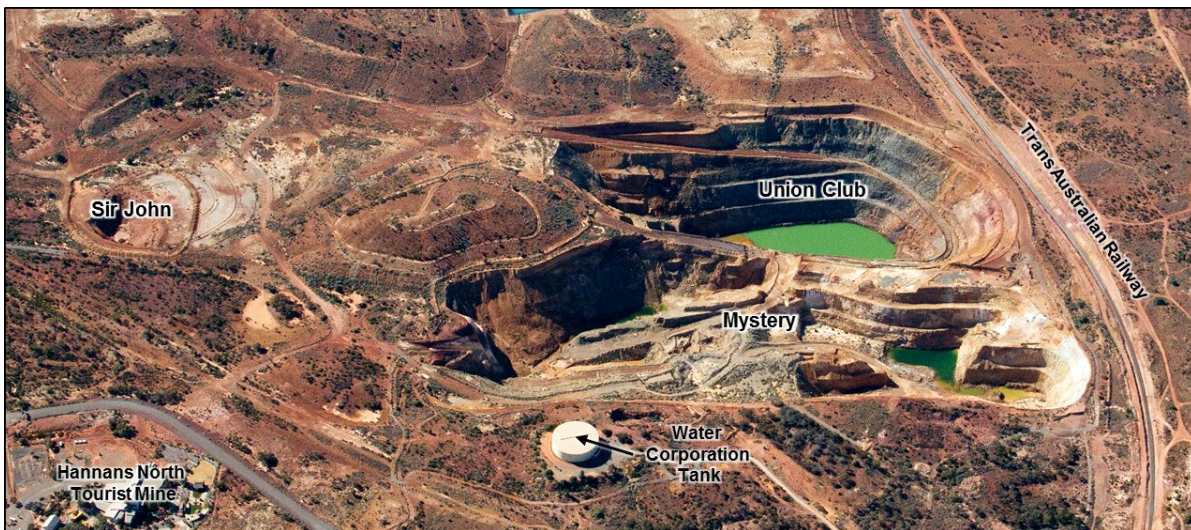
**Figure 5-102: Mt Percy Open Pits and Surrounding Infrastructure**

Features of the Mining Infrastructure Domain at the Mt Percy Operational Area include the Mystery and Union Club Open Pit and Sir John Open Pit (Figure 5-102). Most of the mining at Mt Percy occurred pre KCGM ownership, with the area rehabilitated by 2001. The dimensions of the Open Pits are summarised in Table 5-14.

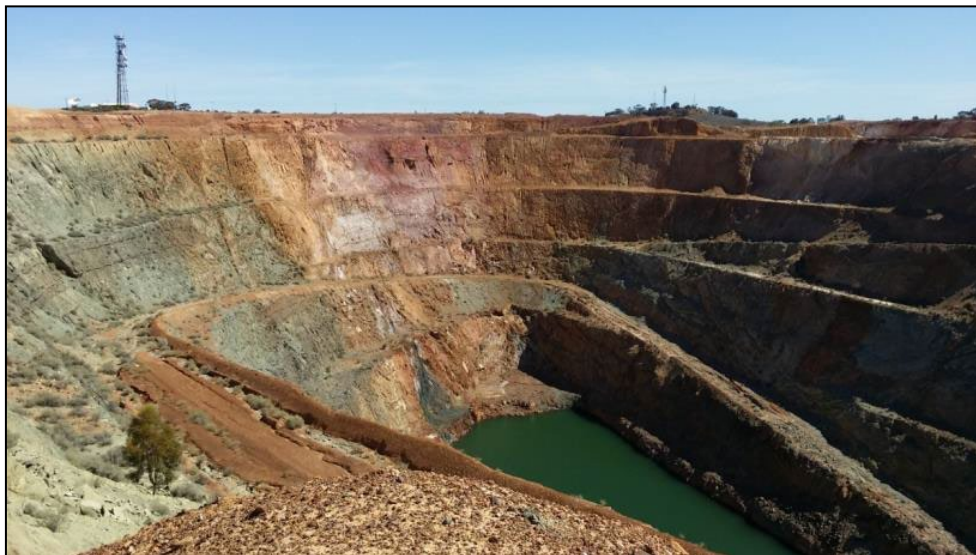
**Figure 5-103: Union Club Pit Southern Wall**

Since the mid-1990s the south wall (Figure 5-103) of both the Mystery and Union Club Open Pit received geotechnical scrutiny in the form of:

KCGM geotechnical engineers consider that given the competent nature of the materials exposed in the south wall, the tight slope curvature and the presence of well-defined rock structure, a circular failure mechanism is considered to be unlikely. Failure of rock slopes is usually controlled by rock structure and circular failure within slopes is generally associated with weak materials such as extremely weathered overburden and soil waste rock dumps. Circular failure analysis, although not particularly relevant to these pit slopes, did help to reinforce the notion that deep seated failures affecting the rail line reserve are extremely unlikely (KCGM, 2012). It is believed that seismicity would not trigger overall slope failure but would be more likely to shake loose blocks from individual batters.

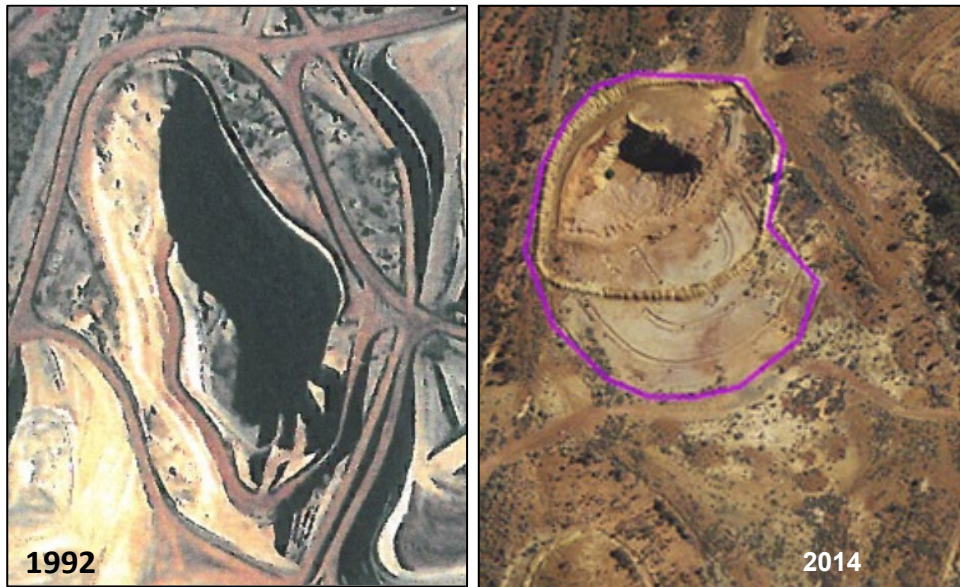
Figure 5-104: Sir John Open Pit Feature (showing extent of backfill) 1992 to 2014

After mining of the Sir John Pit was completed, the pit was partially backfilled with mine waste, tailings material was removed from the vicinity of the Hannans North Tourist Mine (formerly the Australian Prospectors and Miners Hall of Fame site) and Black Flag Beds shale was removed from a cleanup of the Mt Percy ROM Pad (Figure 5-104). The Sir John Open Pit was reported to the DWER as a potentially contaminated site (AOC31).

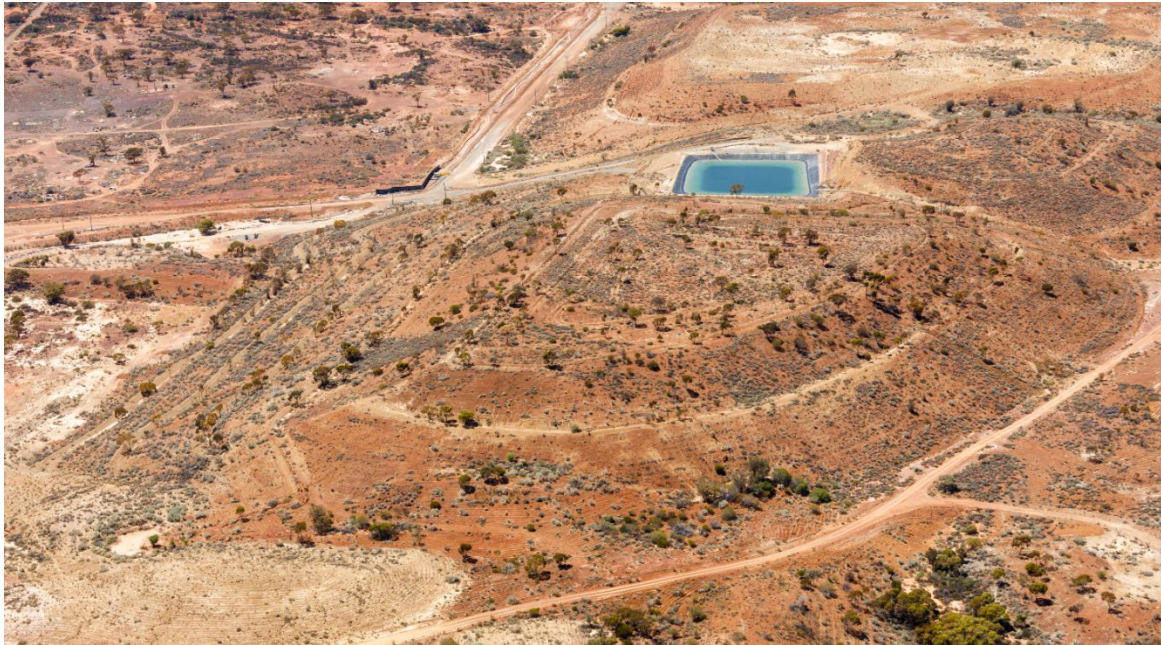
**Figure 5-105: Sir John WRD Progress of Rehabilitation 2021**

The Sir John WRD (Figure 5-105) was rehabilitated in 1993 by re-shaping to approximately 16°, sheeting with lateritic rehabilitation materials, contour ripping and seeding. Monitoring transects were installed for the first time in 2010 and 2011 and monitoring in 2011 classified this area as “On track, continue monitoring” (Outback Ecology, 2012b). Visual inspections from 2012 to 2014 have noted that the WRD has good vegetation condition (Figure 5-106) with multiple life stages and evidence of reproduction present; however, there are some minor erosion gullies.

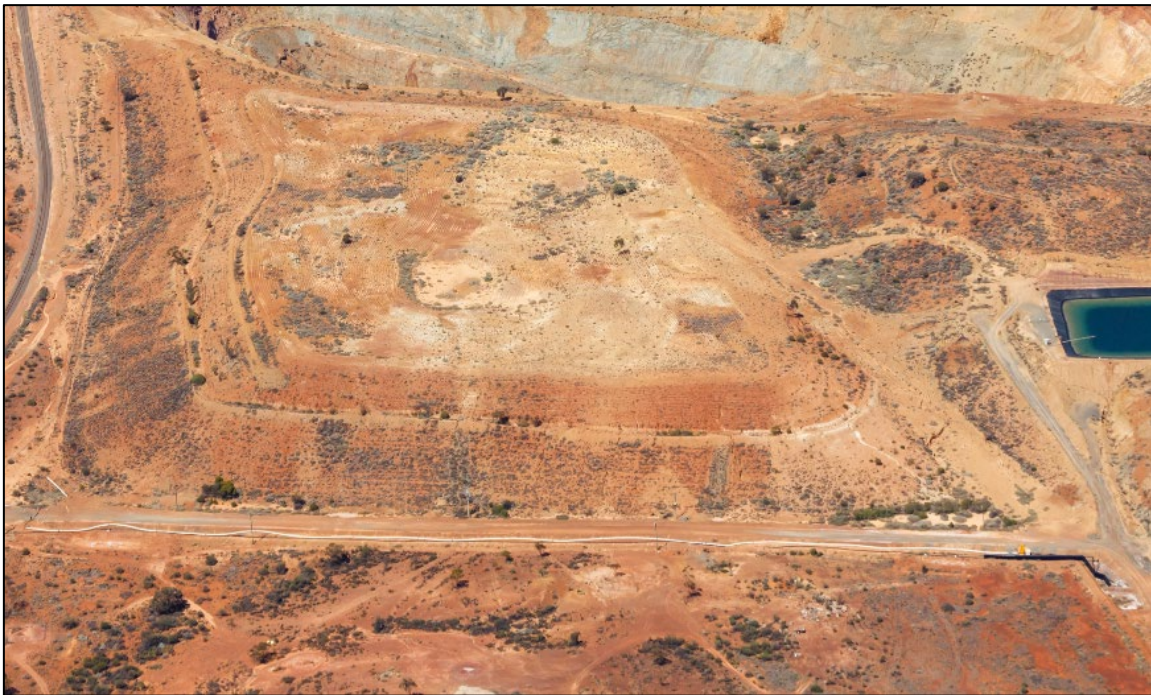
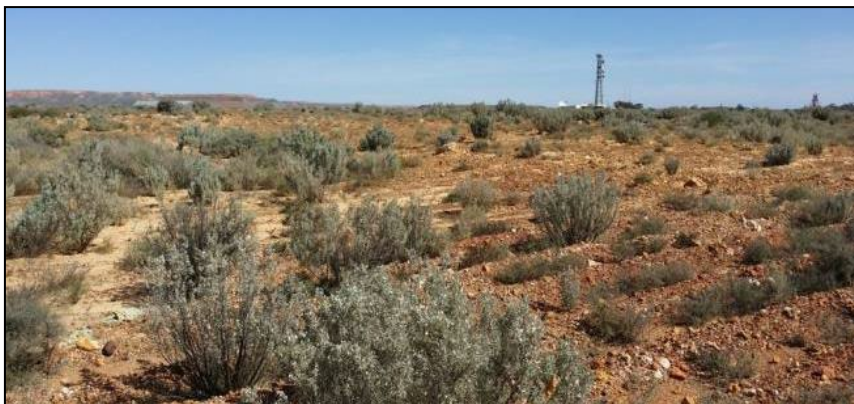
Figure 5-107: Union Club WRD Upper Surface (Bottom 2014; Top 2021)

EFA monitoring in 2011 classified this area as “On track, continue monitoring” (Outback Ecology, 2012b). Visual inspections from 2012 to 2014 indicate that lower storey vegetation is comprised mostly of salt tolerant species, such as *Atriplex* (Figure 5-107). Upper storey species were sparse on the batter and top of the dump, with *Casuarina sp.*

observed in areas where water was ponding at the dump toe. Erosion gullies were observed from the mid-slope drainage berm (cut in after material placement) located in the upper third of the outer slope.

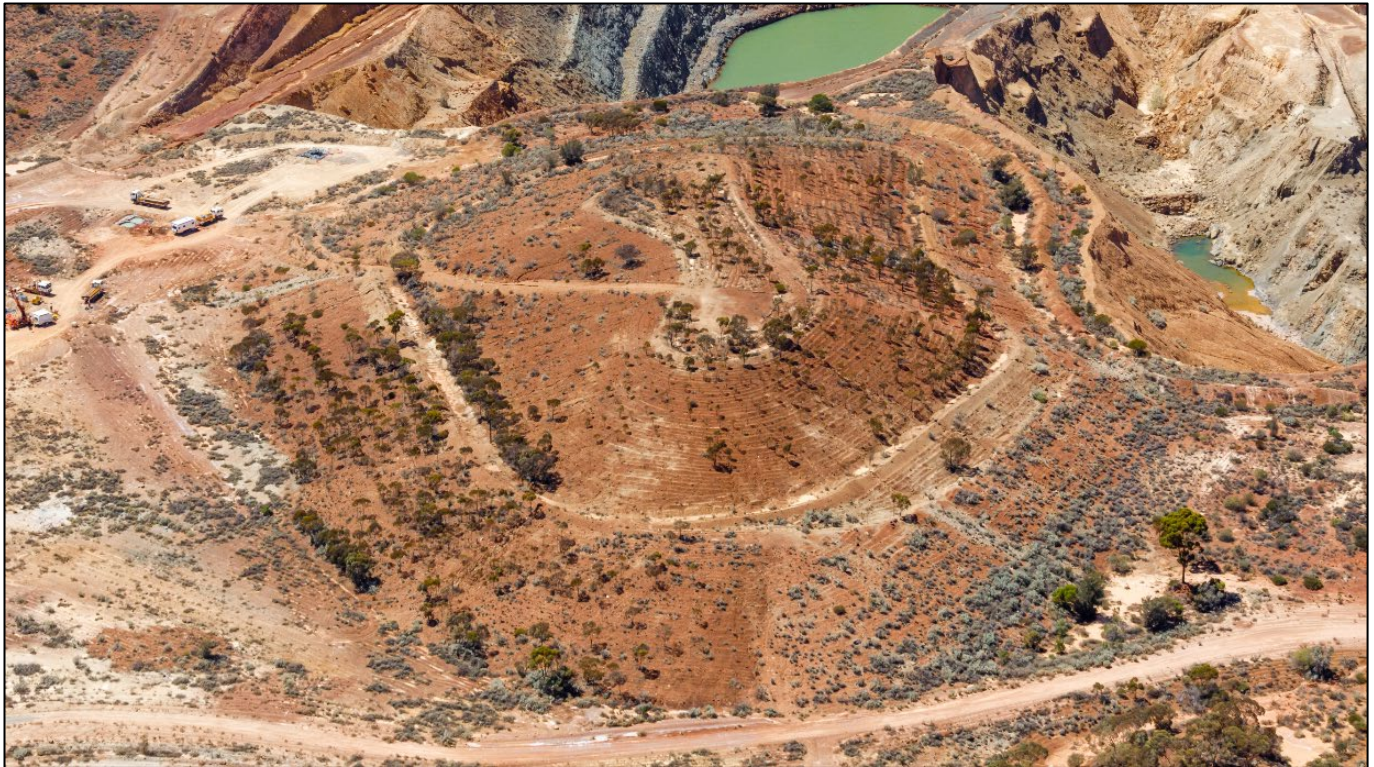
Figure 5-108: Mystery WRD (2021)

LFA monitoring in 2011 classified this area as “Below expectation” (Outback Ecology, 2012b). However, visual inspections from 2012 – 2014 indicate that vegetation appears to be in good condition (Figure 5-108), with multiple life stages and evidence of reproduction. A review by botanical professionals in 2012 described the vegetation community as a low mixed *Eucalyptus spp.* woodland over a sparse to open mid *Atriplex nummularia* shrubland over a sparse to open low *Atriplex vesicaria*, *Maireana pyramidata* and *M. glomerifolia* shrubland over isolated *Enneapogon caerulescens* grasses, with the surface relatively erosionally stable.

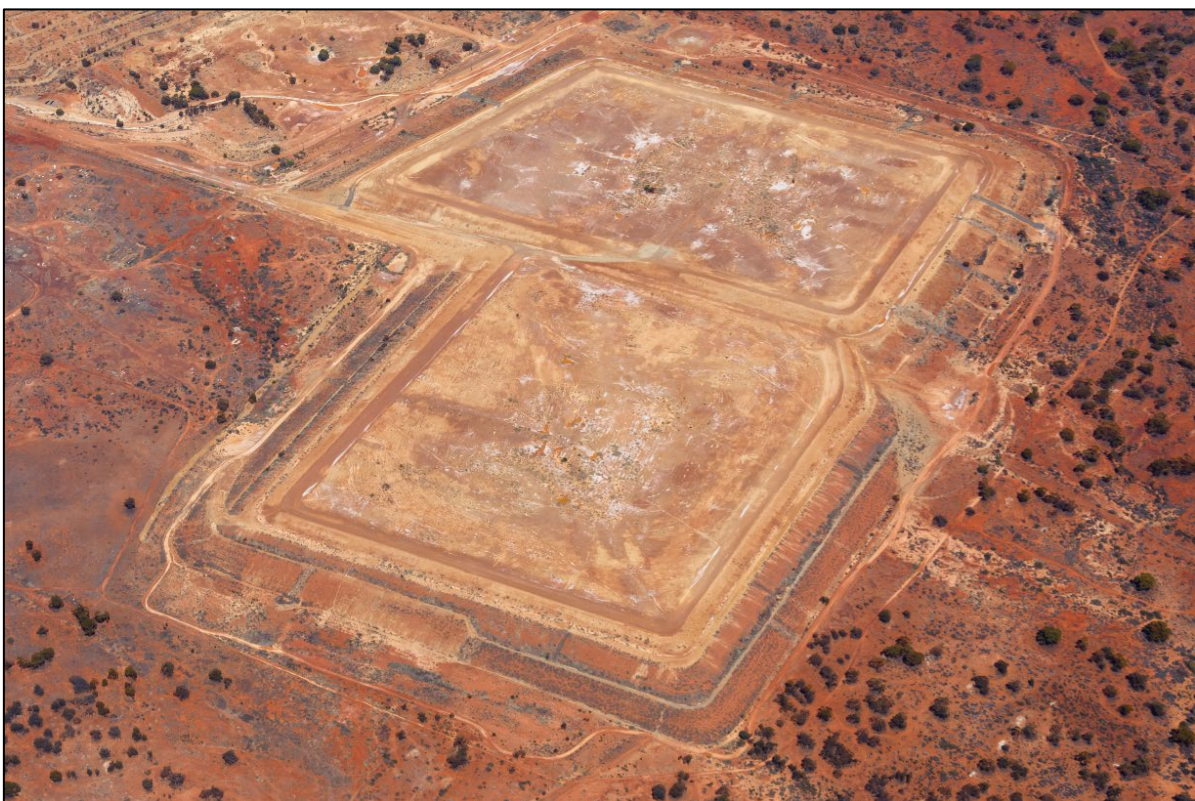
Figure 5-109: Mt Percy TSF (2021)

The Mt Percy TSF (Figure 5-109) was operational between 1985 and 1997. The facility consists of two cells, covering approximately 55 ha. The starter embankment was constructed of clayey run of mine oxide waste followed by upstream lifts constructed of selected run of mine waste to produce external batters of approximately 16 to 20°. Deposition was as sub-aerial slurry discharge via multiple spigot discharge points around the perimeter. It was decommissioned and rehabilitated in 2001.

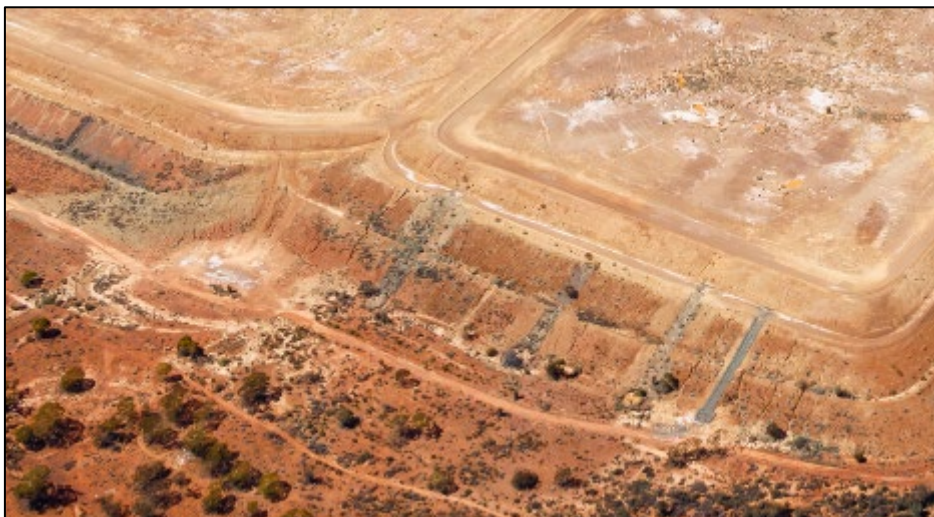
**Figure 5-110: Erosion and Water Control Repairs on Mt Percy TSF Completed in 2019 (2021)**

Visual observation of the feature shows that excessive erosion of the external batters is occurring in some areas outside of the monitoring transects. Rock lined drop drains have been installed in some areas in response to erosion occurring after the rehabilitation was completed (Figure 5-110). Significant gullying has occurred in the central area of the northern side due to inadequate water control.

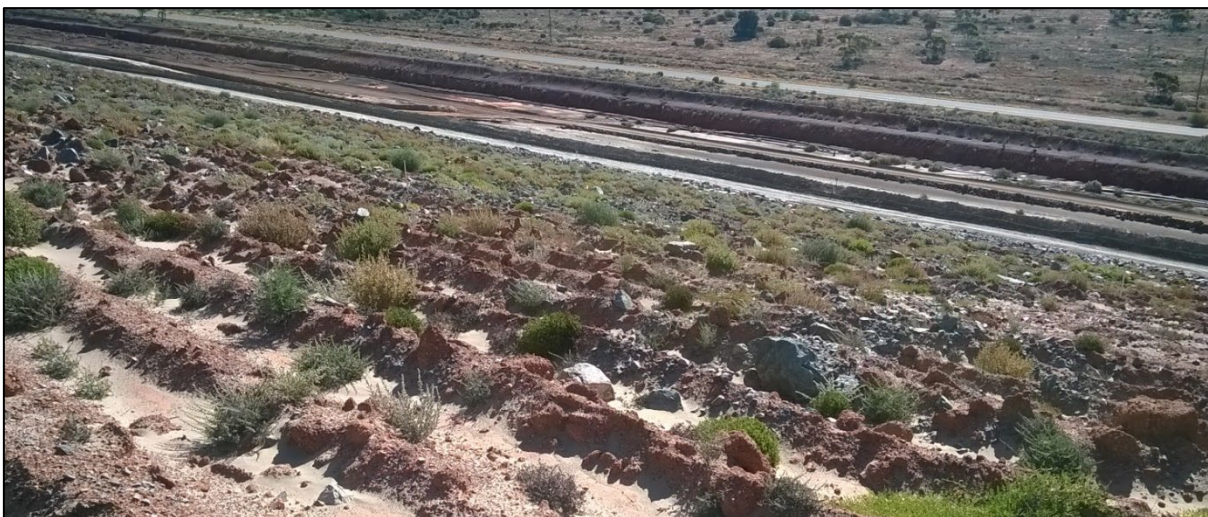
**Figure 5-118: Fimiston I TSF Trial Observed Germination after Rains (July 2017)**

After rock capping, the trial area was topsoiled using material from a stockpile that was approximately 5 m high and significantly compacted (Figure 5-117). After receiving good rainfall, germination occurred from seed stored within the seedbank, evidencing the amount of viable seed contained in the topsoil stockpile (more than 15 years old) (Figure 5-118).
