KCGM

# KCGM Mine Closure Plan 2025 (v2) Volume 2 of 3

Mineral Field 26

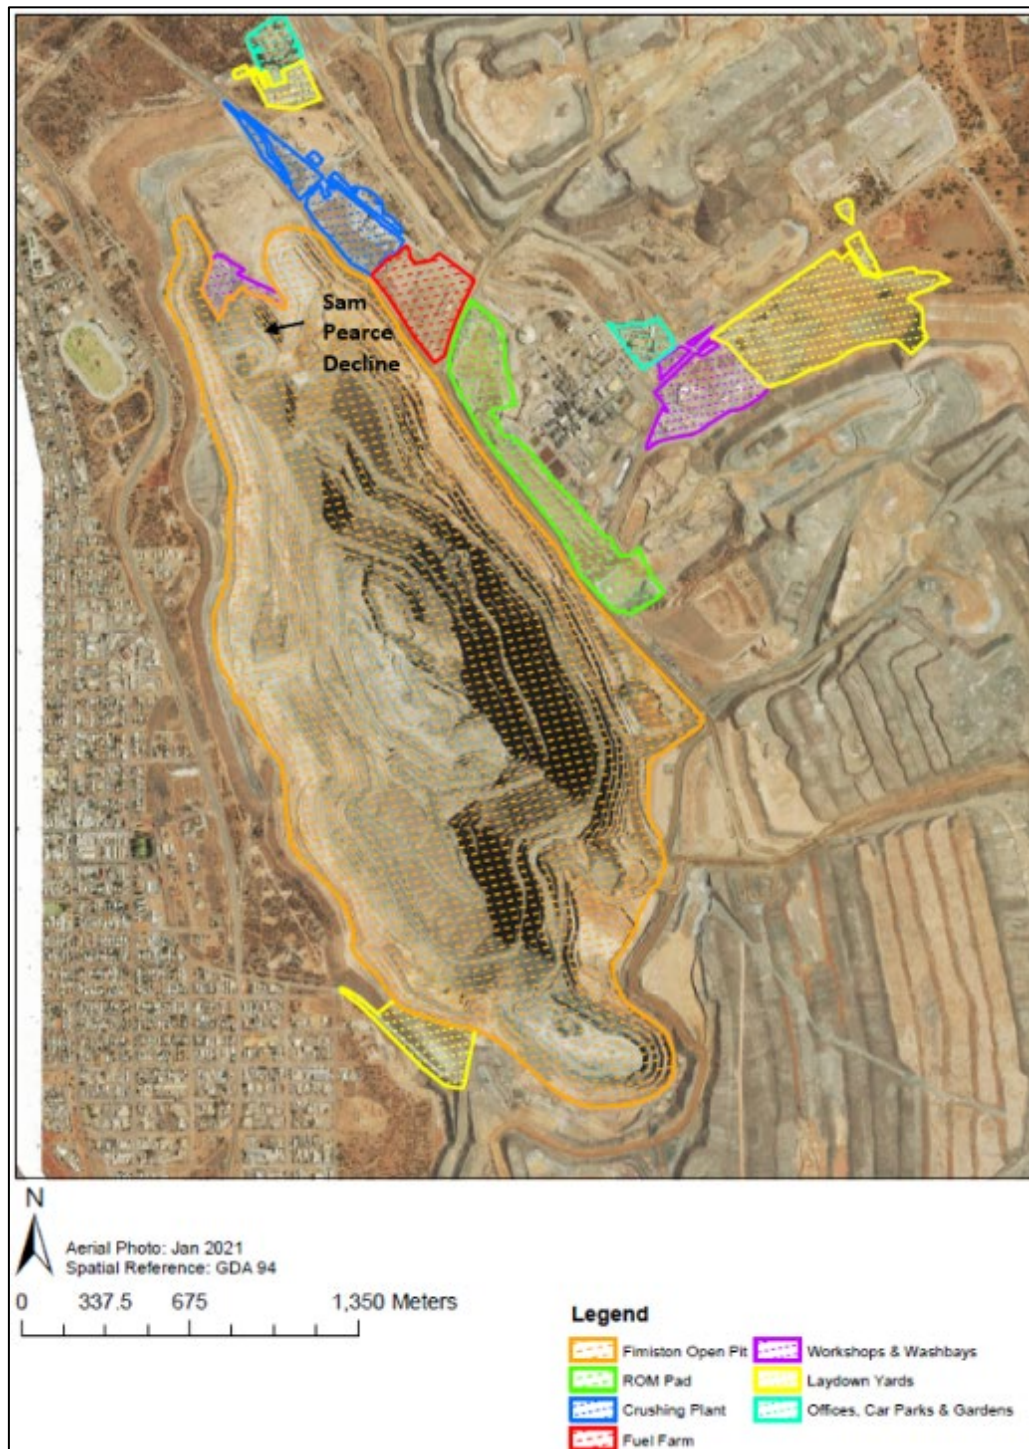
**Figure 9-1: Fimiston Mining Infrastructure Domain (current)**

The features of the Fimiston Mining Infrastructure domain will remain active mining areas until 2034 (BP2025 LOM). Thereafter, a portion of the features are likely to remain operational during closure works (Table 9-3), allowing existing areas of disturbance to be used for closure works and laydown areas. The estimated final closure time frame is 2040 for major earthworks.

The location of the features of this domain are shown in Figure 9-1 and timing of closure and disturbance area are provided in Table 9-3.

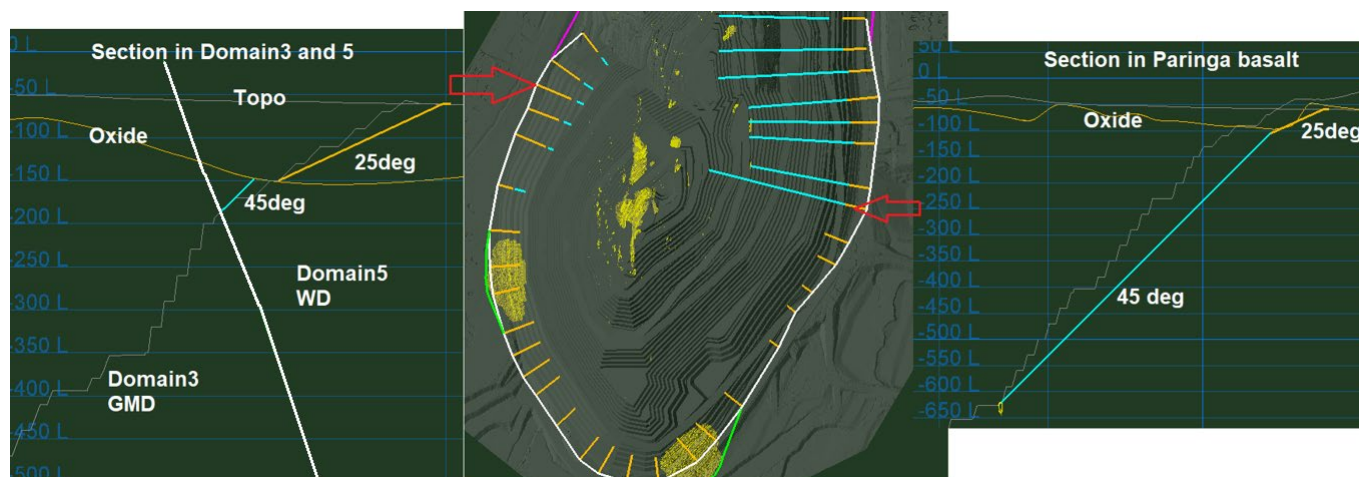
Figure 9-6: Fimiston Open Pit - example of ZOI calculation for the north west wall (GMD)

FoS of 1.5 was modelled as part of the geotechnical assessment for the Fimiston South project southern cutbacks and the eastern wall. The results of this modelling were used to adjust the ZOI line (10m offset) to develop a final ZOI line, as shown in **Error! Reference source not found.**. The Ivanhoe cutback pit design will result in excavation of a portion of the current Golden Pike west wall, resulting in outcrops of different lithologies (i.e. not GMD) on the hanging wall side of Golden Pike fault, such as Williamstown Dolerite (WD), Kapai Slate (KS) and Devon Consols Basalt (DCB) (see **Error! Reference source not found.**). For those lithologies are not as competent as GMD, a 45 degree projection should start from the contact between the weaker lithologies and GMD in the fresh rock (followed by 25deg project in oxide and surface step out). This should result in ZOI extending further towards the west compared to the GMD calculation method. The ZOI has been updated for the new pit shell proposed for the Fimiston Ivanhoe Cutback project (**Error! Reference source not found.**).

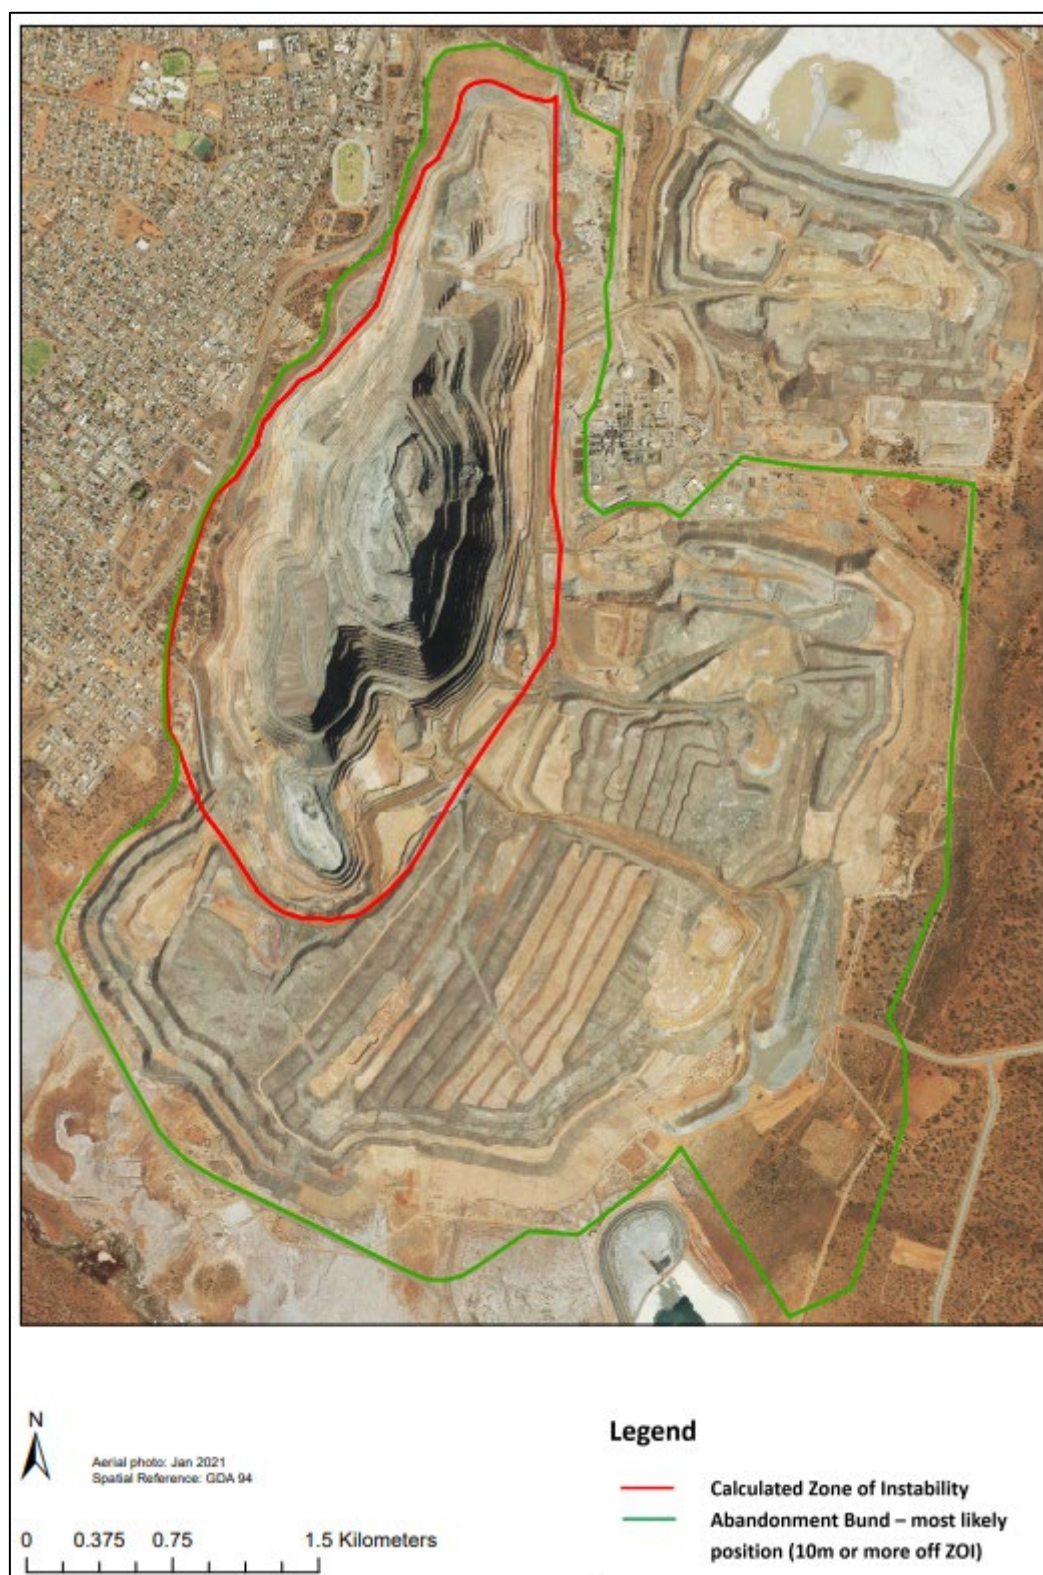
**Figure 9-10: Most practical location for Fimiston Open Pit final abandonment bund**

The abandonment bund location will be located outside the Zone of Instability, along the boundary of the Fimiston Open Pit, or in alternative practical locations. The most likely alternative location would be outside of the noise bund on the western side, and on the eastern toe, of the WRDs for the eastern side. This location has the added benefit of being possible to commence progressive rehabilitation works during the operational period. The portion of the abandonment bund located in the Fimiston South noise bund area will not have a noise bund between the abandonment bund and the pit post closure.

No Fimiston WRD have been designed within the Zone of Instability, as shown in Figure 9-10. If the operational noise bund should fall within the calculated zone of instability, the abandonment bund position will be outside and to the west of the calculated Zone of Instability line.

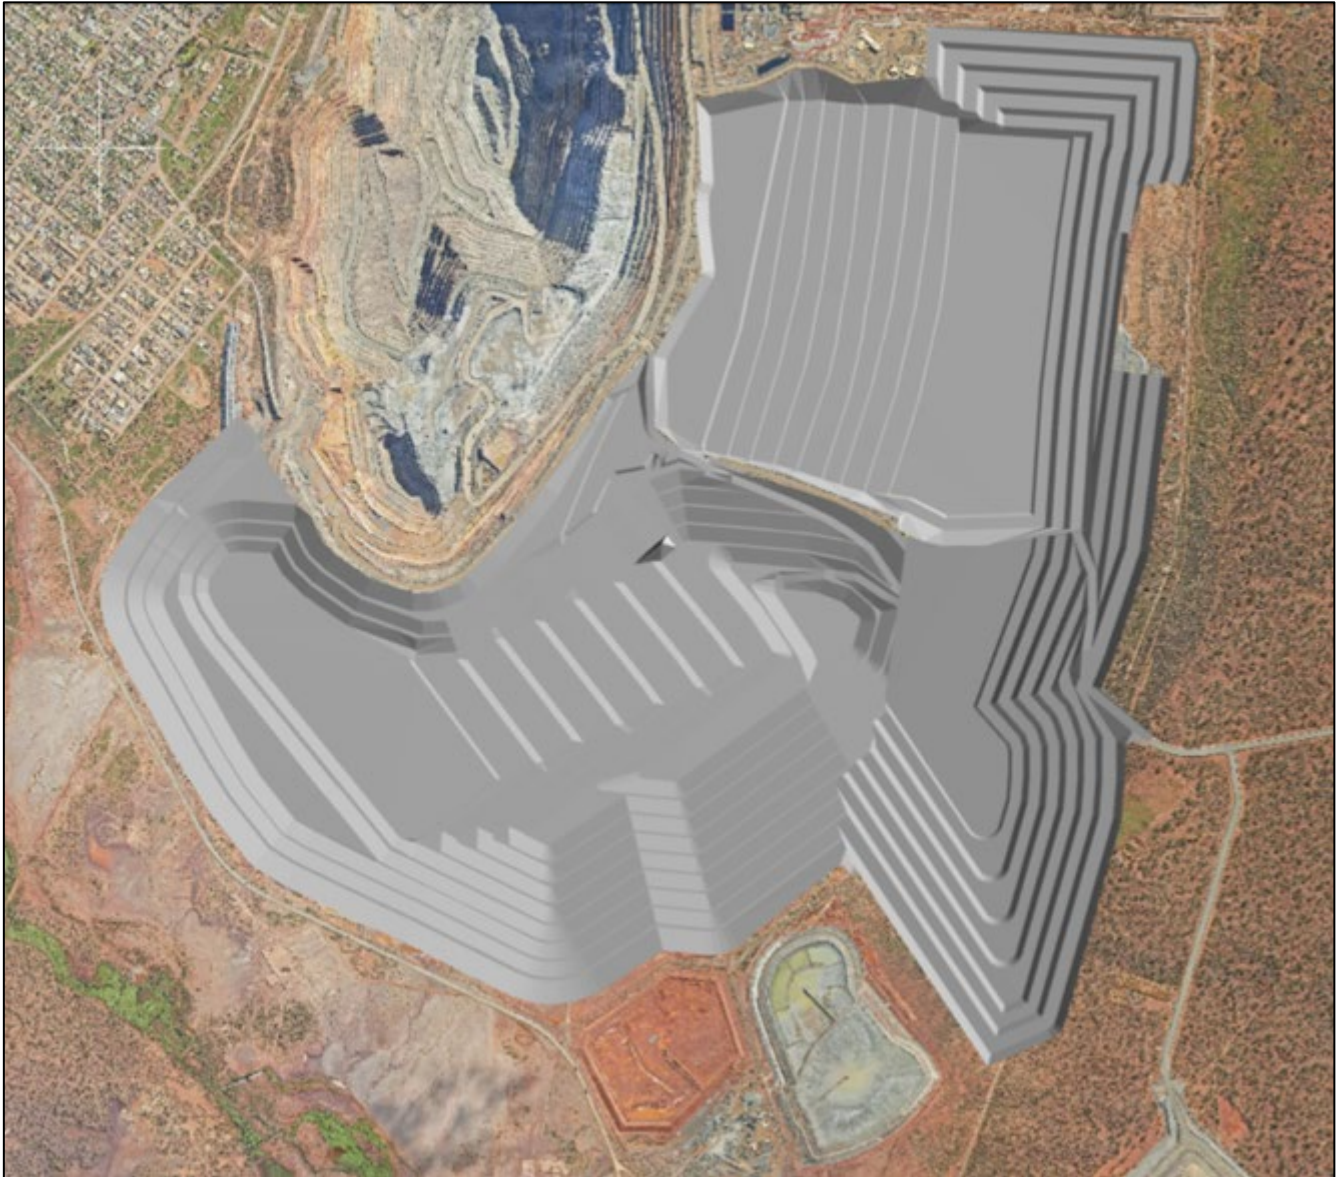
**Figure 9-14: Fimiston Waste Rock Dumps Final Design (mine site grid)**

The Fimiston WRD domain will remain active operational areas until 2034 (BP2023 LOM). Thereafter, stockpile areas are likely to remain operational until processing ceases at the Fimiston Mineral Processing Plant. The estimated final closure time frames are shown in Table 9-12, with approximately 6-12 months required thereafter to complete rehabilitation of the WRDs. All WRDs are currently active. Areas that are at final design have been progressively rehabilitated.

The new WRD final designs allow for the increased capacity requirements of the proposed cutbacks (recent S45c and S38 approvals/ Ivanhoe cutback), as shown in Figure 9-14. The WRD will require additional CASA controls such as lighting.

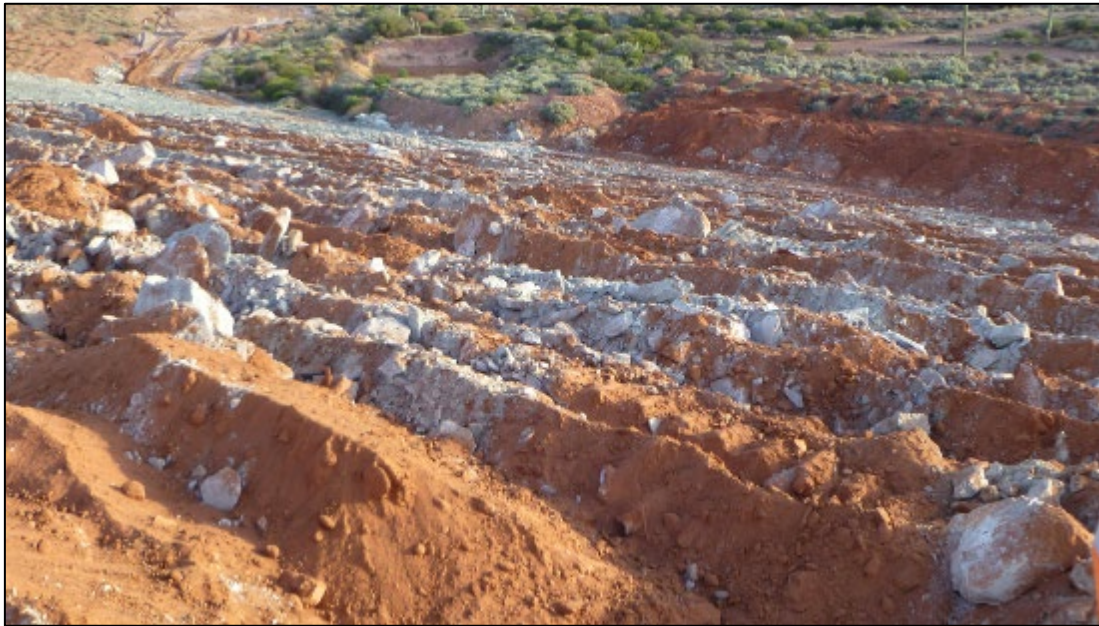
**Figure 9-16: Northern WRD after Ripping**

In 2014, the implementation of this design was trialled on the Northern WRD to assess constructability and practicality of the proposed design, and to test earthmoving techniques in order to establish the most cost effective means of implementation. This trial was considered successful.

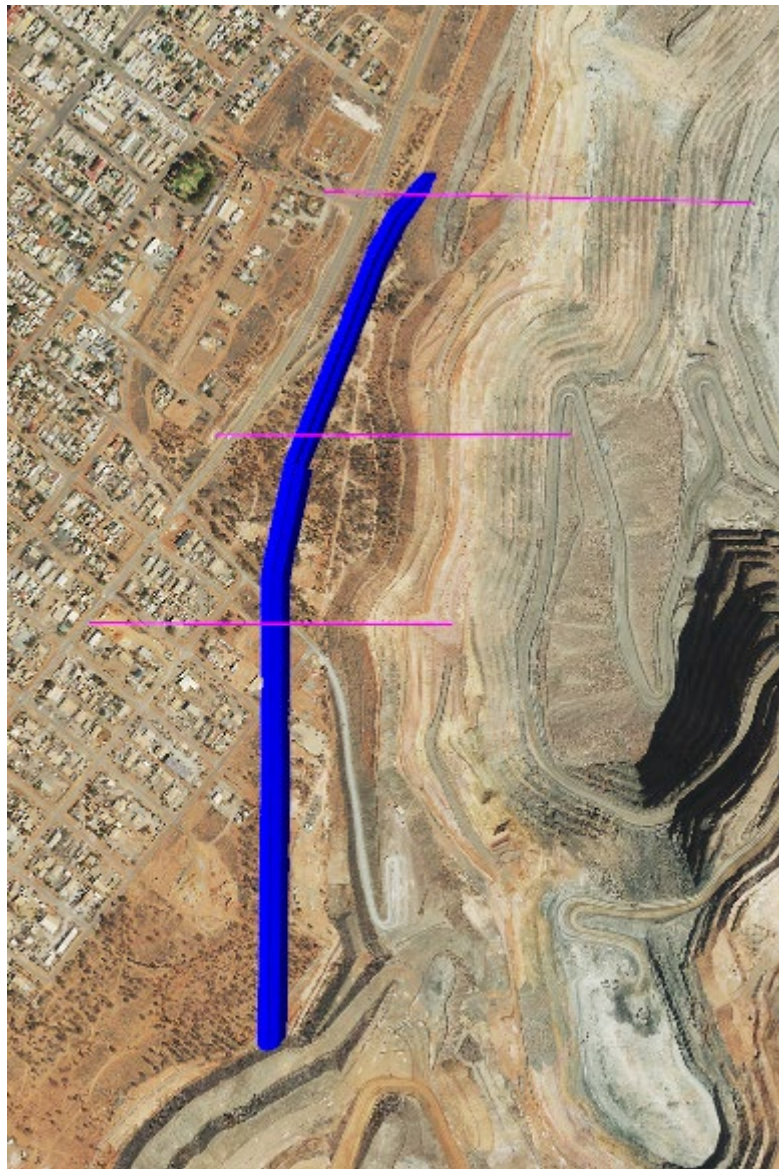
**Figure 9-22: Operational Noise Bund (not a closure landform)**

The operational NB for Fimiston South project will be used as a source of competent waste rock for the abandonment and any other closure landform or remedial works.

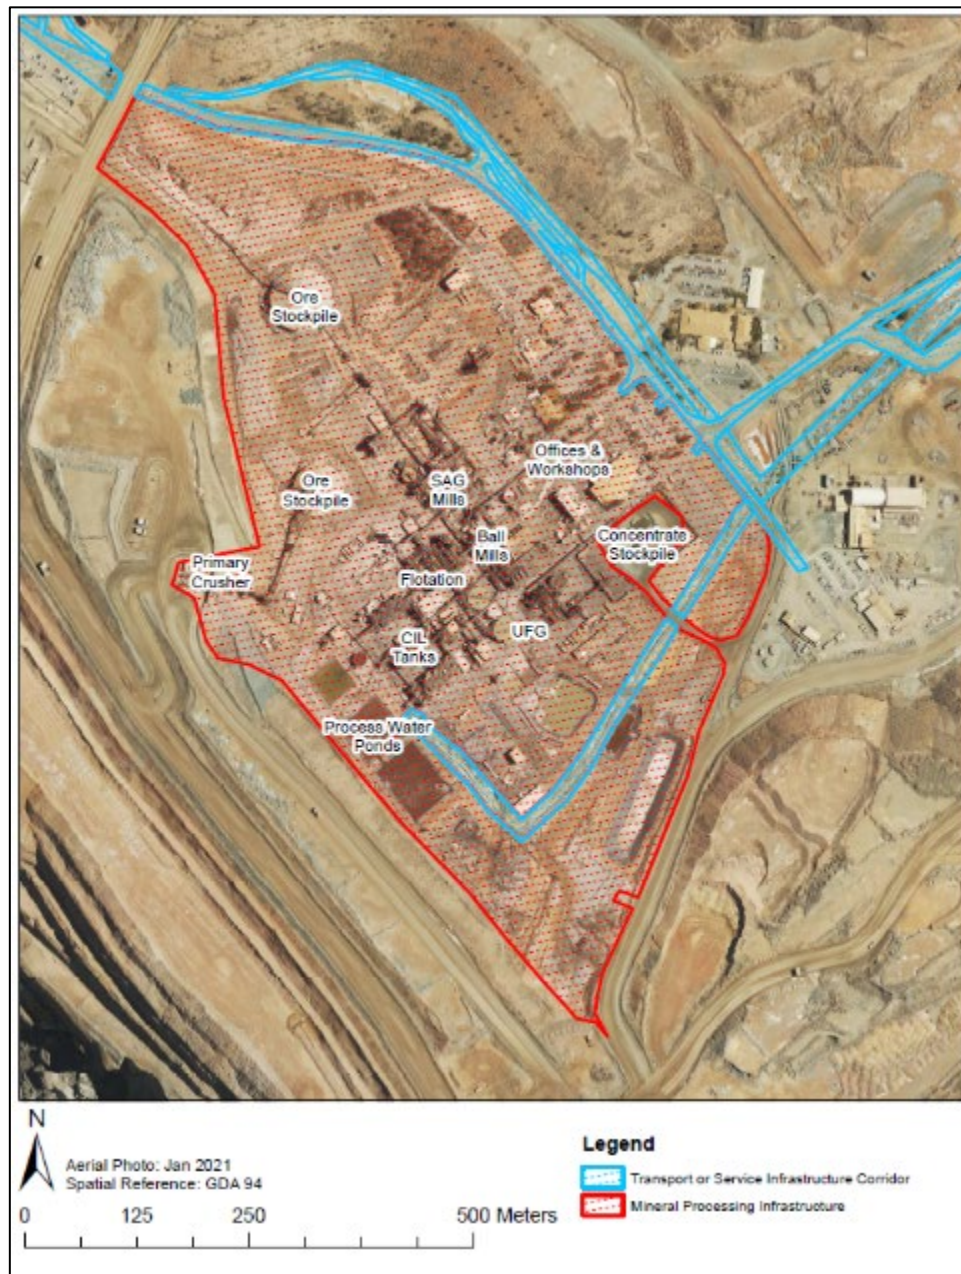
**Figure 9-25: Fimiston Processing Plant**

The Fimiston Mineral Processing Plant Domain consists of:

The Fimiston Processing Plant and associated infrastructure (Figure 9-25) will be demolished and the area rehabilitated to reflect the final land use. Contaminated Sites requirements will be planned during the operation phase, but can only be implemented during decommissioning when the footprint of the Processing Plant can be assessed. Both the Demolition Plan, with costing, and the Cyanide Decommissioning Plan have been updated and audited in 2014 and 2017. Key considerations for closure works at the Fimiston Processing Plant will be safety during decommissioning and demolition activities and Contaminated Sites requirements.

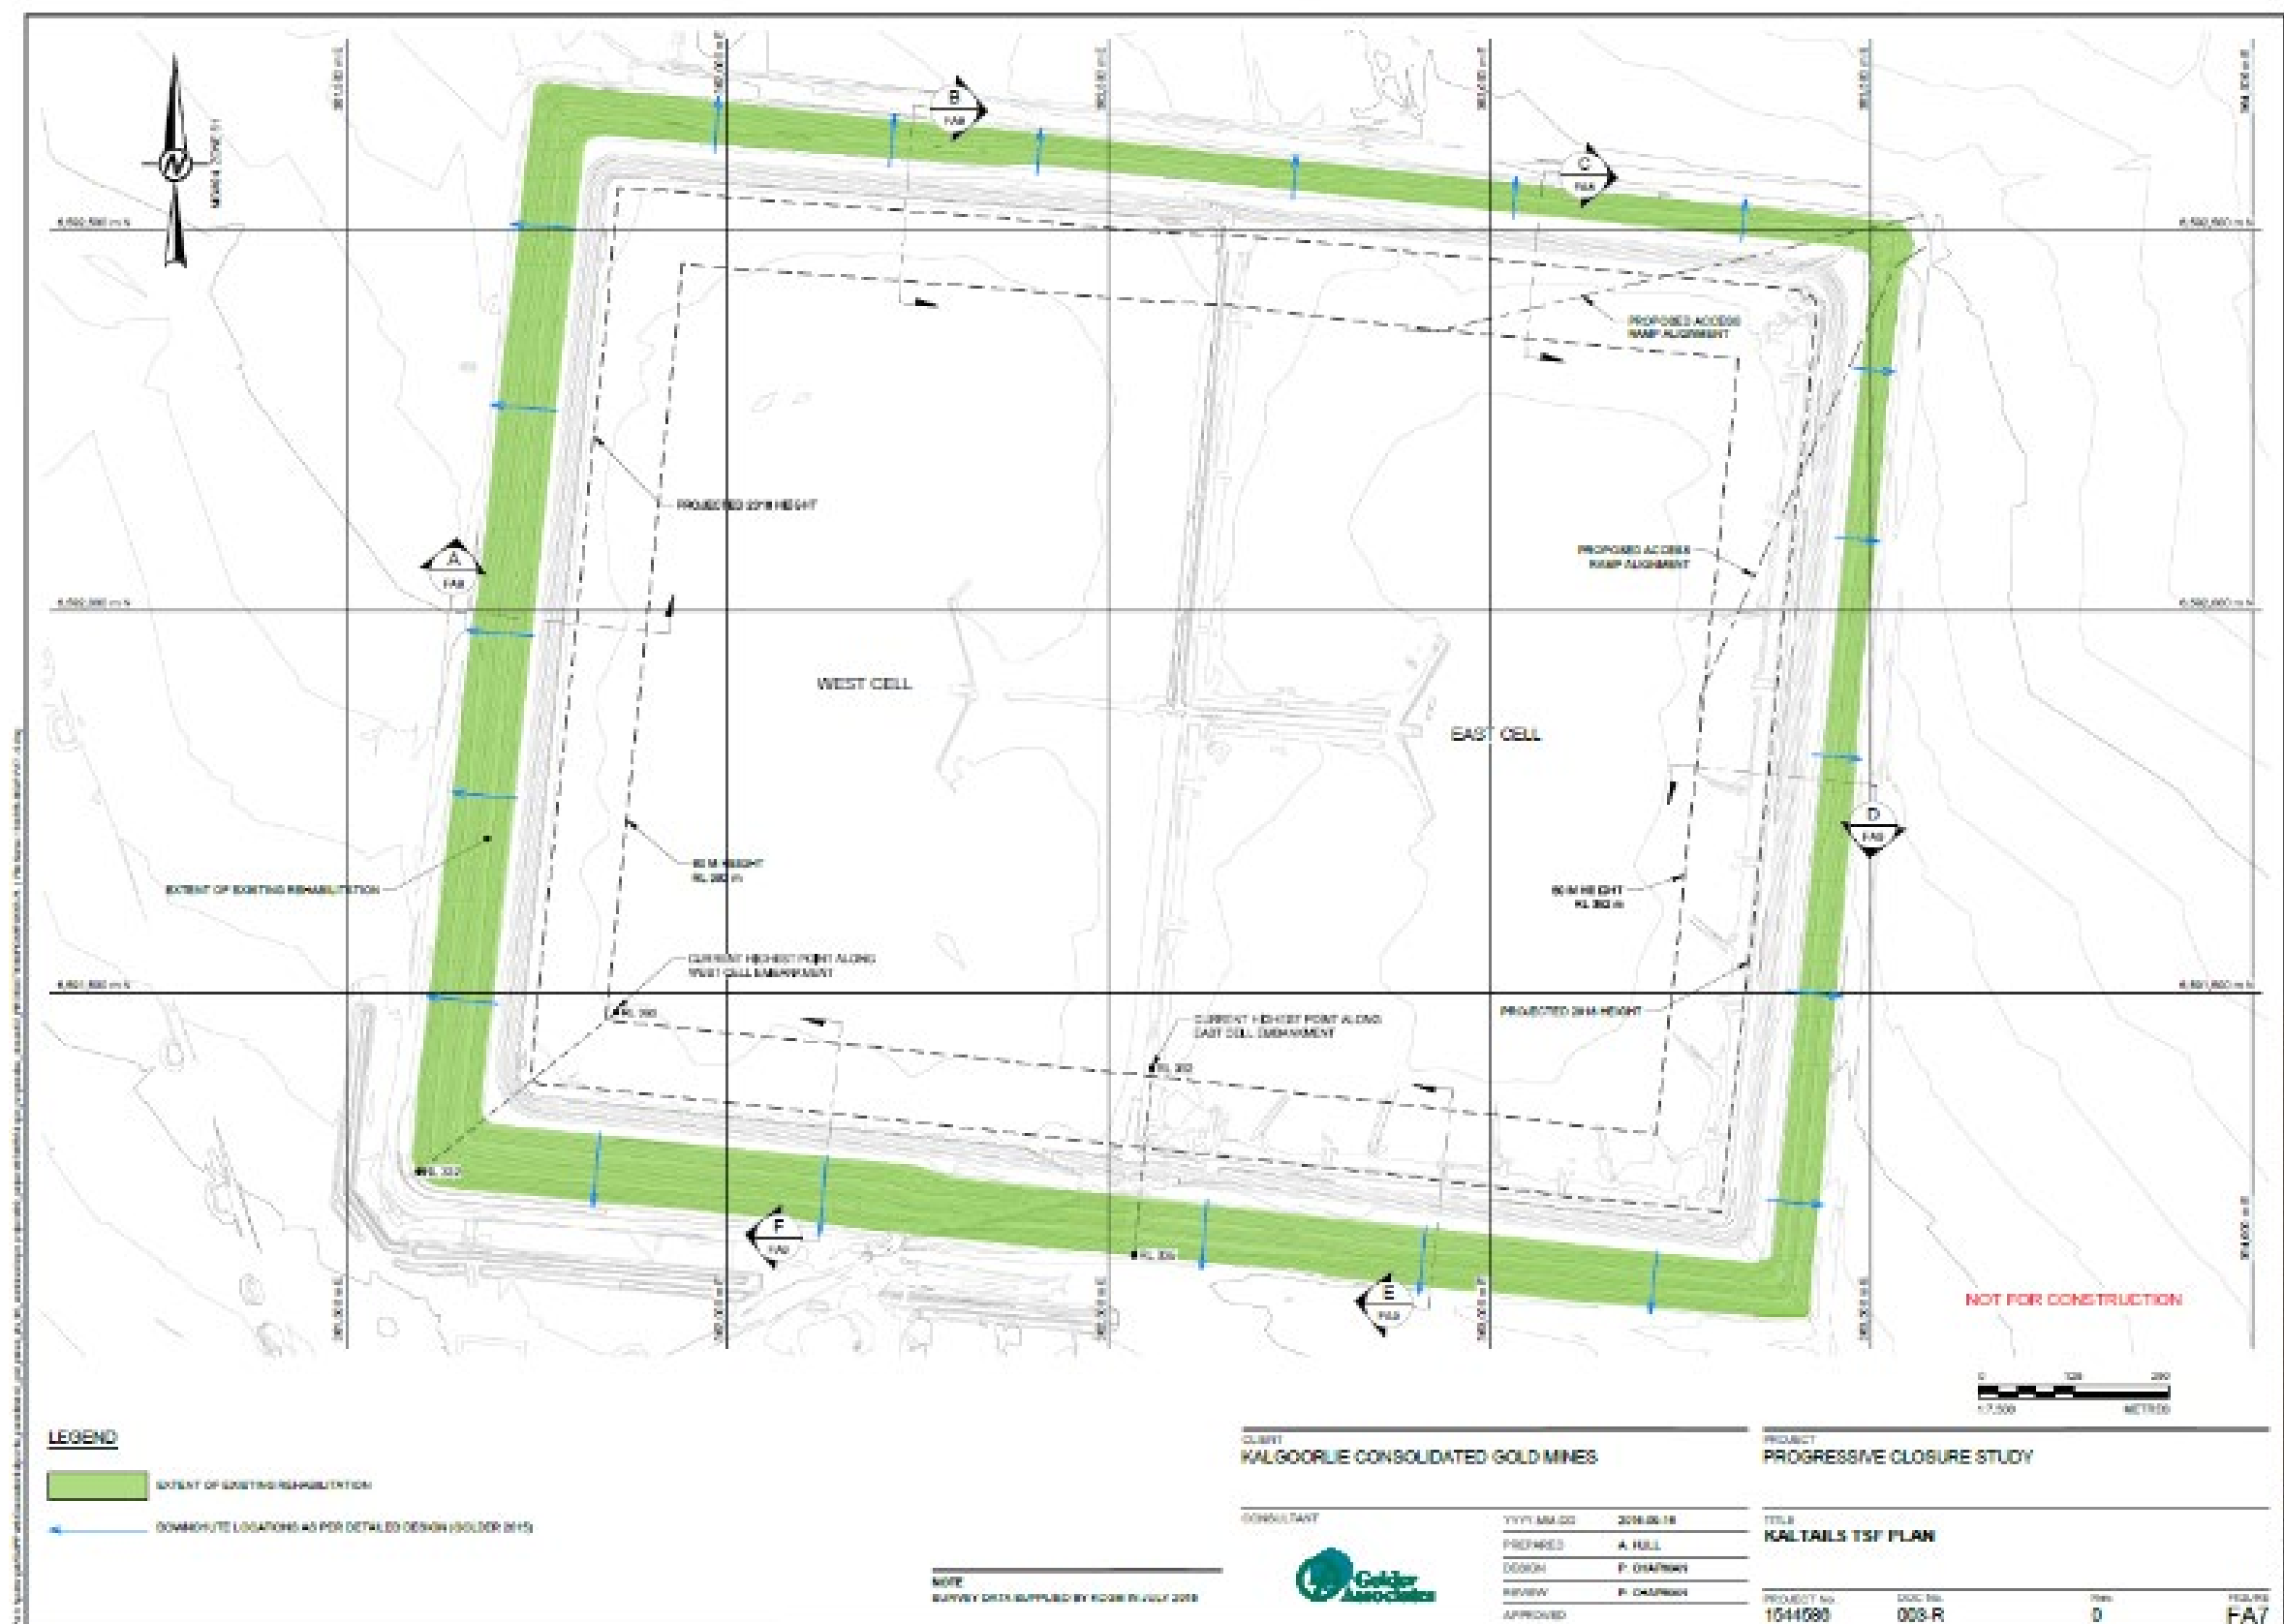
Figure 9-35: Kaltails TSF Closure Design

\* Note: design work undertaken prior to buttressing; Buttressing does not impact closure designs.

The lower slopes of Kaltails TSF were rehabilitated by the previous owners (Kaltails Retreatment State Agreement), and are considered complete. Upper embankment slopes can be rehabilitated during operations, with works implemented on the northern flank of Kaltails East in 2020/21. Figure 9-35 and Figure 9-36 illustrate the closure design for the Kaltails TSF.

The lower flanks of Kaltails were rehabilitated by the previous owners, with a substantial step in bench above the rehabilitated flanks. Stormwater from this bench drain will be diverted to ground level through downchutes, consistent with existing practice on the Fimiston TSFs. If required, further stormwater management systems such as simple diversion trenches will guide this stormwater water to suitable entry points in the catchment. A study has been completed to ensure that this stormwater from the TSFs, which comprises 1.8% of the total catchment area, this has confirmed that there will be no unfavourable impact on any downstream infrastructure such as roads.

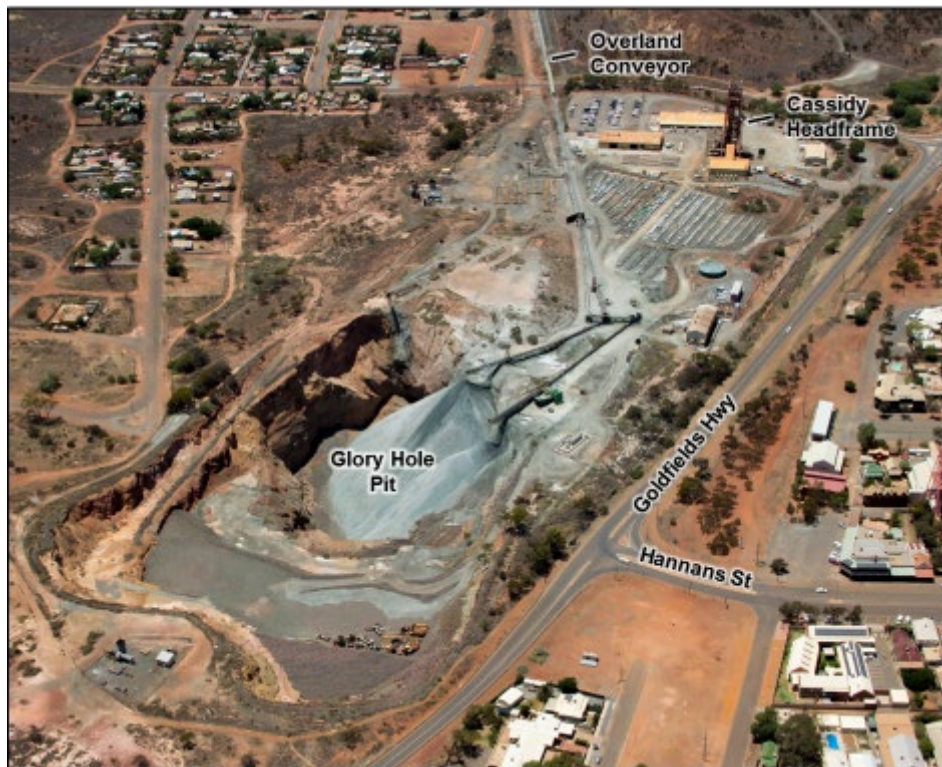
**Figure 9-38: Mt Charlotte Mining Infrastructure**

Mt Charlotte Mining Infrastructure includes (Figure 9-38):

- Glory Hole Pit;
- Underground Mine; and
- Surface Operations (including headframe, conveyor and core yard).

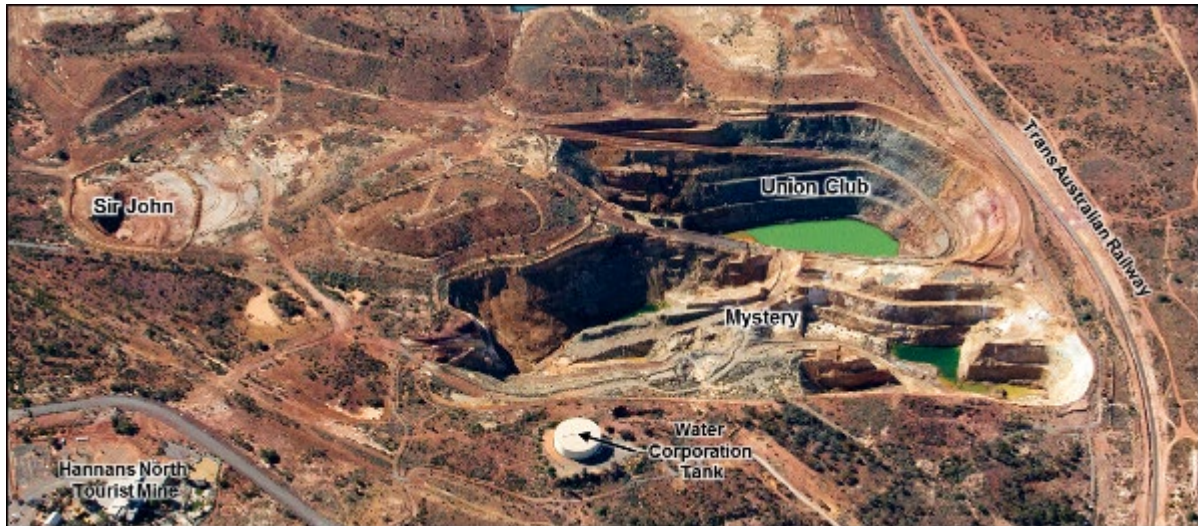
Features of the Mining Infrastructure Domain at the Mt Percy Operational Area include the Mystery and Union Club Open Pit and Sir John Open Pit (Figure 9-49). Most of the mining at Mt Percy occurred pre KCGM ownership, with the area rehabilitated by 2001.

Figure 9-49: Mt Percy Open Pits and Surrounding Infrastructure

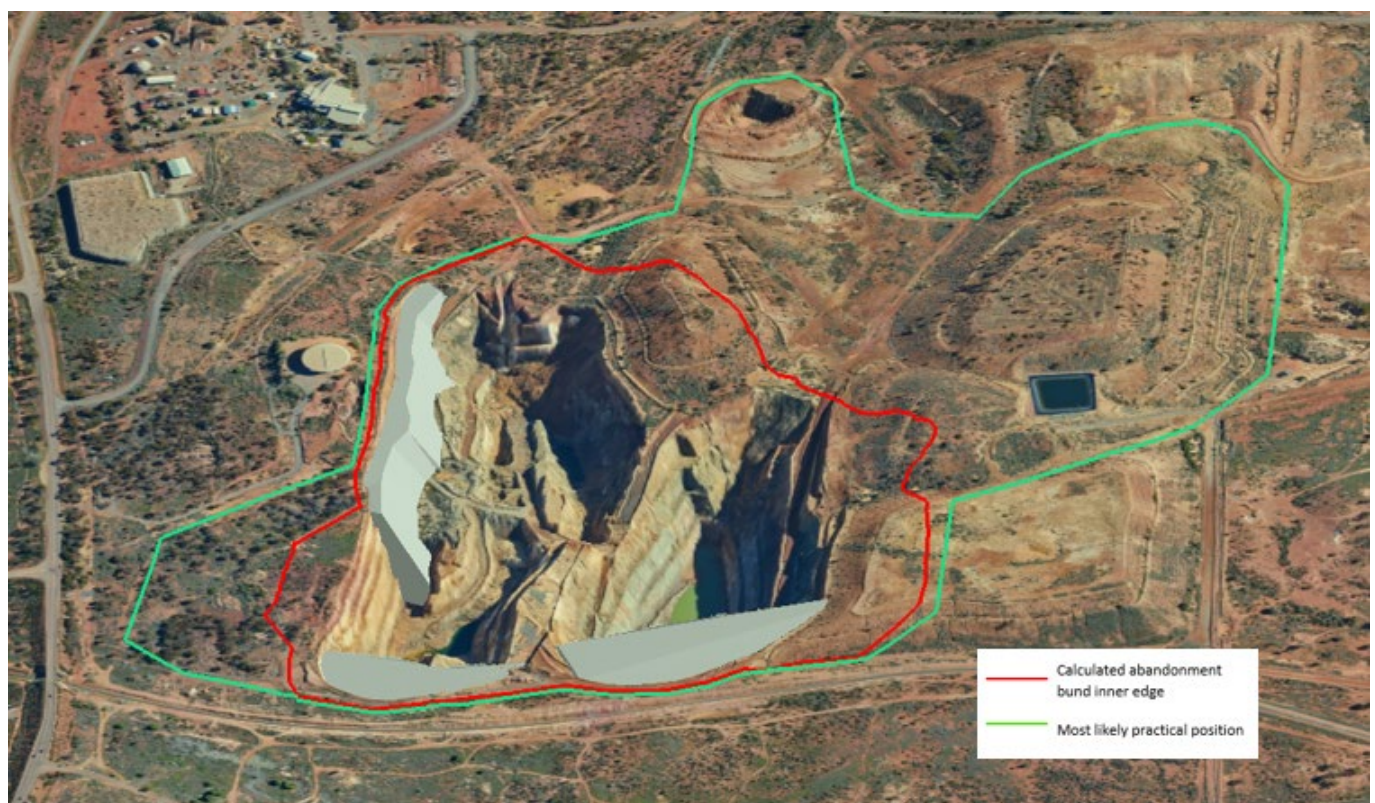
In addition, 2 WRDs, Mystery and Union Club, are potentially within the zone of instability. The proposed abandonment bund location has taken this into consideration (Figure 9-50).

For long term pit wall stability for the current pit shell at Mt Percy, 3 buttresses will be required, on the western and southern walls. Implementation of these buttresses will be undertaken to comply with the DMIRS geotechnical guidelines should a suitable alternative not be implemented.

**Figure 9-50: Zone of instability, Abandonment bund and Buttrressing for current Mt Percy pit shells**

In addition, 2 WRDs, Mystery and Union Club, are potentially within the zone of instability. The proposed abandonment bund location has taken this into consideration (Figure 9-50).

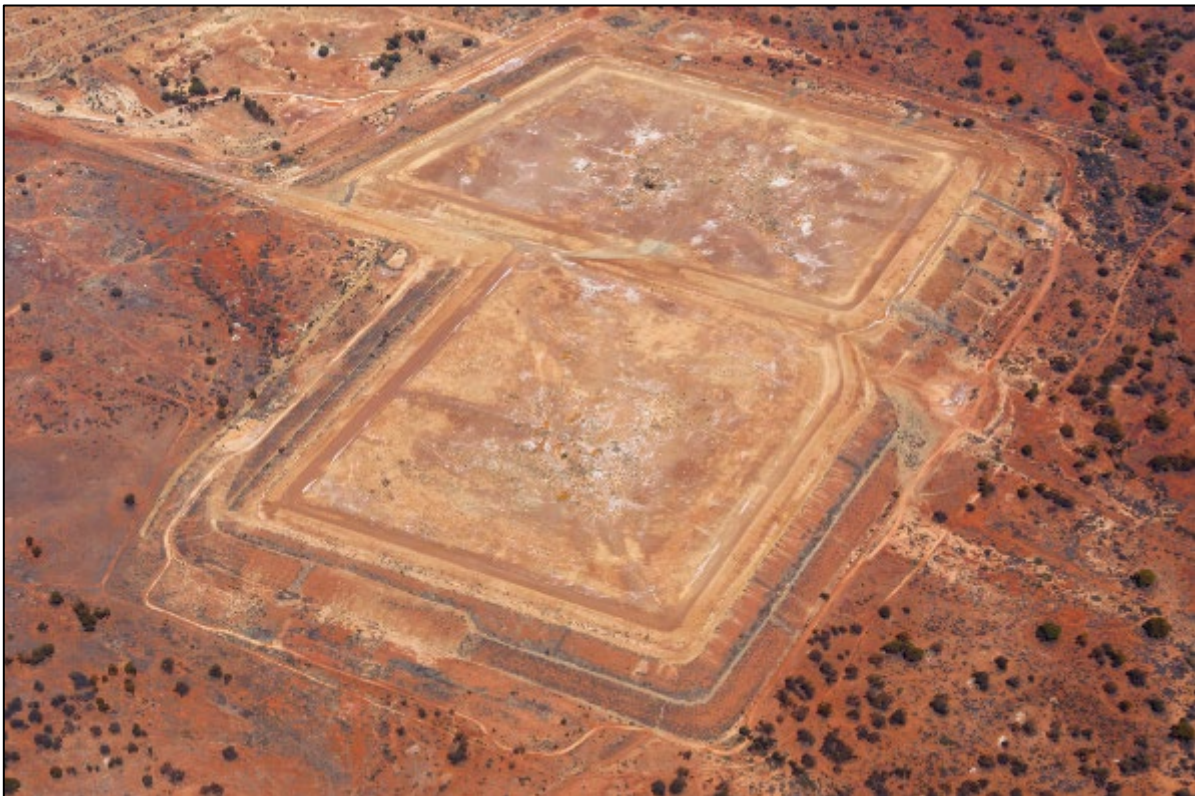
The Mt Percy TSFs are more than 30 years old, and were rehabilitated in the early 2000's, using oxide material from the upper lift of Union Club WRD.

**Figure 9-53: Mt Percy TSF (2021)**

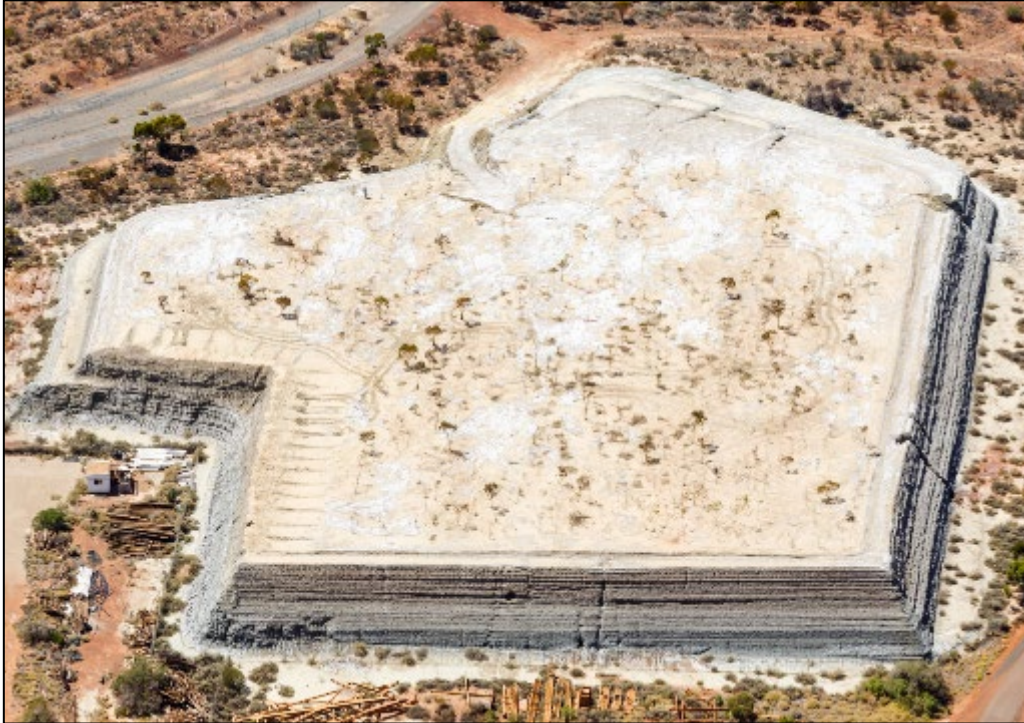
**Figure 9-55: Mullingar TSF adjacent to Hannans North tourist mine**

The Mullingar TSF is the last of the original hand packed TSFs on the Golden Mile. It has been suggested that it should be preserved due to its historic significance. However, Contaminate Sites legislation does not allow for this option, and the TSF will have to be evaluated for other closure options such as capping, removal or reprocessing.

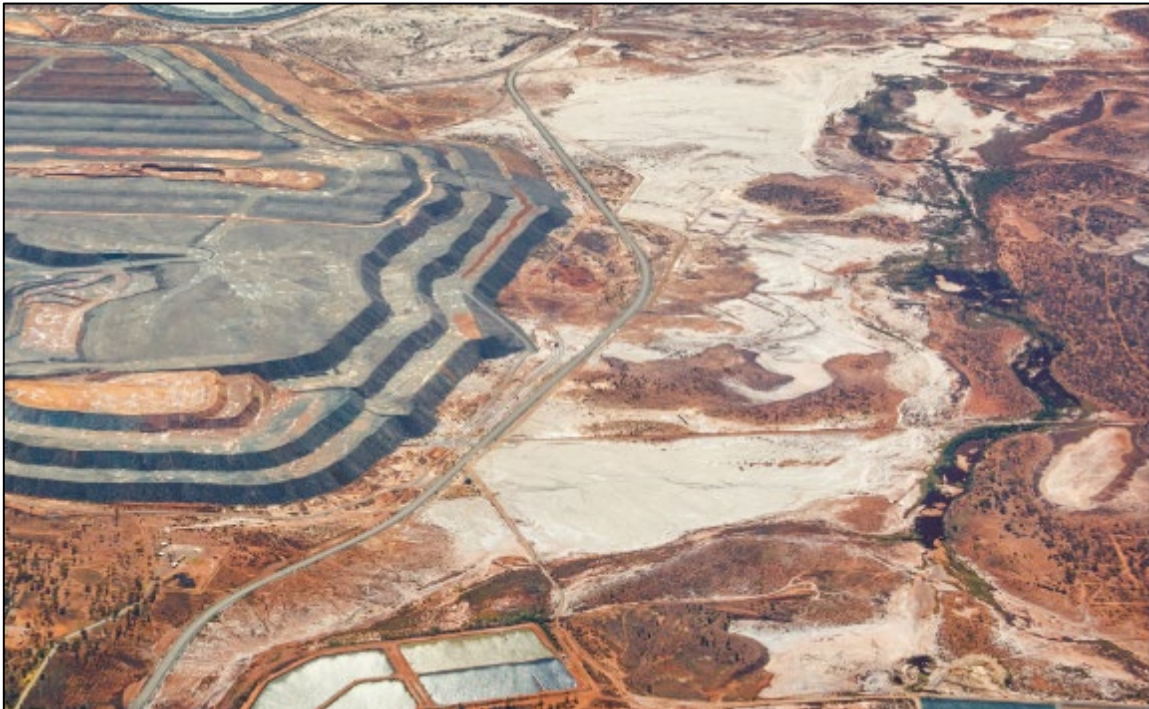
**Figure 9-56: Morrison Flats Historical Tailings (2021)**

Morrison Flats is a historic tailings footprint area left after the Kaltails State Agreement removed the historic TSFs for reprocessing through the former Kaltails processing plant. The State Agreement no longer exists.
